SAN DIEGO COUNTRY PARKS
AMERICANS WITH DISABILITIES ACT
AUDIT & TRANSITION PLAN
PHASE 2

THE COUNTY OF SAN DIEGO ADA AUDIT AND TRANSITION PLAN PHASE 2

Rick Engineering Company
5620 Friars Road
San Diego, California 92110
(619) 291-0707

Roy Davies Architect
8348 Center Drive, Suite B
La Mesa CA 91942

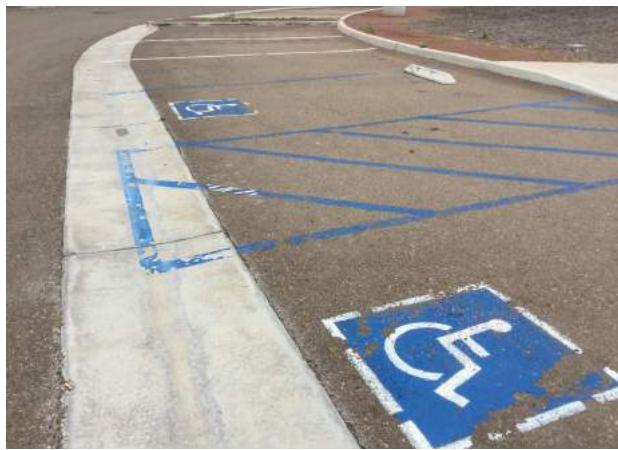
ADA PARKING SIGNAGE MISSING, FADED, OR VISUALLY IMPAIRED

NON COMPLIANT

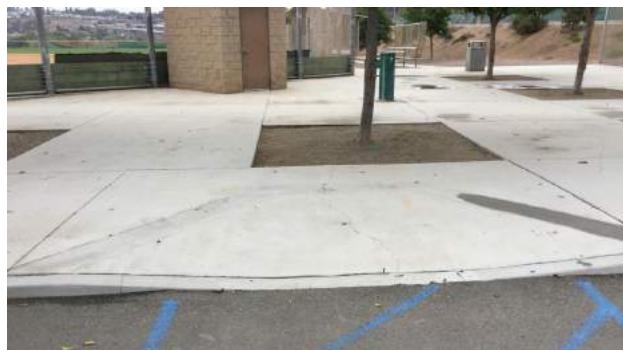
CURB RAMPS MISSING DETECTABLE WARNING STRIPS

NON COMPLIANT

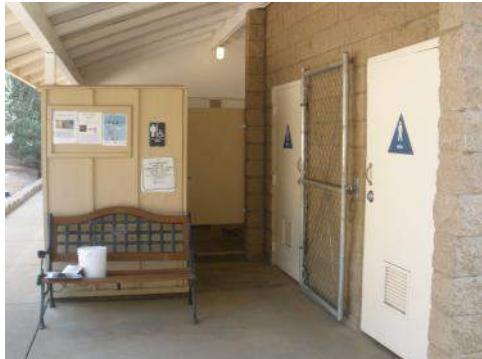
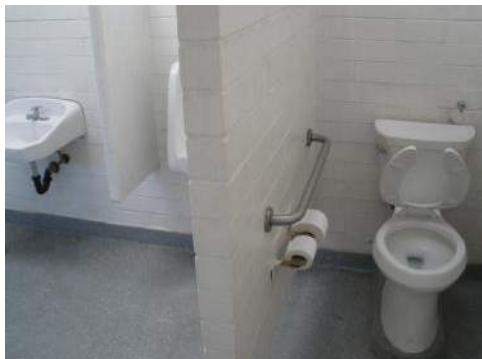
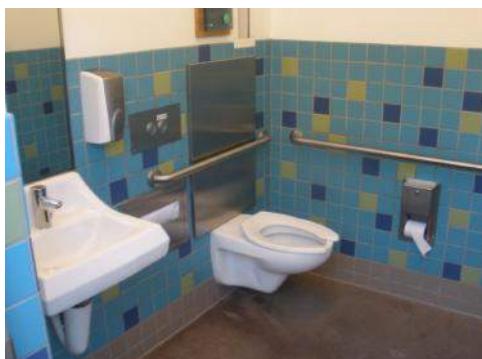
Of the Buildings surveyed, the majority of non-compliance was in the Restrooms and Showers. Typical Items found include:

- **Signage Missing or Incorrect**
ISA Entry Signage, Room or Door Signage, Directional/ Informational Signage.
- **Adjust Door Closer**
Sweep time is < 5 sec. and/or opening force is > 5 lbs.
