Task Order 11

HABITAT CONDITION ASSESSMENT

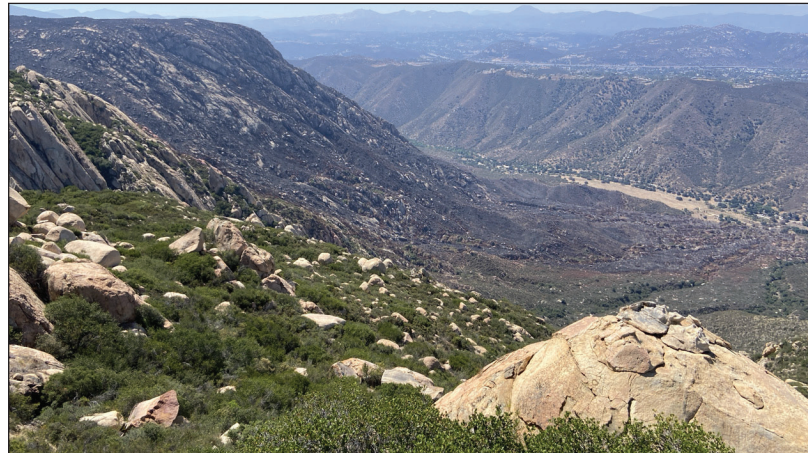
PHOTO 3: Overview of Monte Fire burn scar from above, facing southeast.

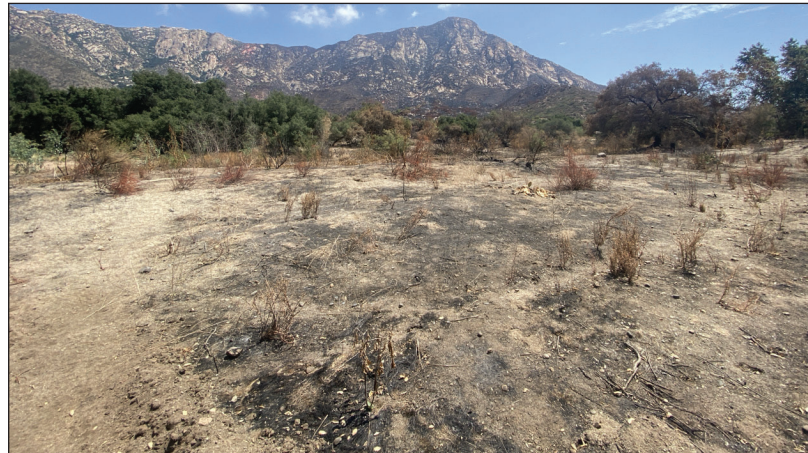
PHOTO 6: Burn scar of the Monte Fire in the easternmost corner of the park.
