SAN DIEGO COUNTRY PARKS
AMERICANS WITH DISABILITIES ACT
AUDIT & TRANSITION PLAN
PHASE 3

ADA AUDIT AND TRANSITION PLAN

PHASE 3

The County of San Diego Department
Of Parks and Recreation
5500 Overland Avenue
Suite 410
San Diego, CA. 92123

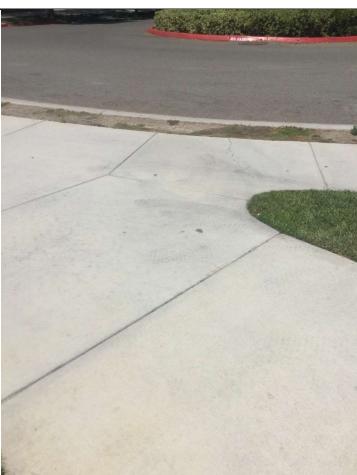
Site Photo

4-3 Walk**Category: 1****Issue: Walkway running slope is 6%.****Action: Regrade walkway and replace concrete.**

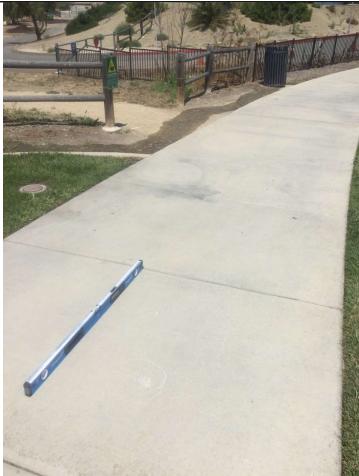
Site Photo

4-5 Walk**Category: 1****Issue: Surface slope of turning space is 3.5%.****Action: Provide level surface at point of turning. Regrade and replace concrete.**

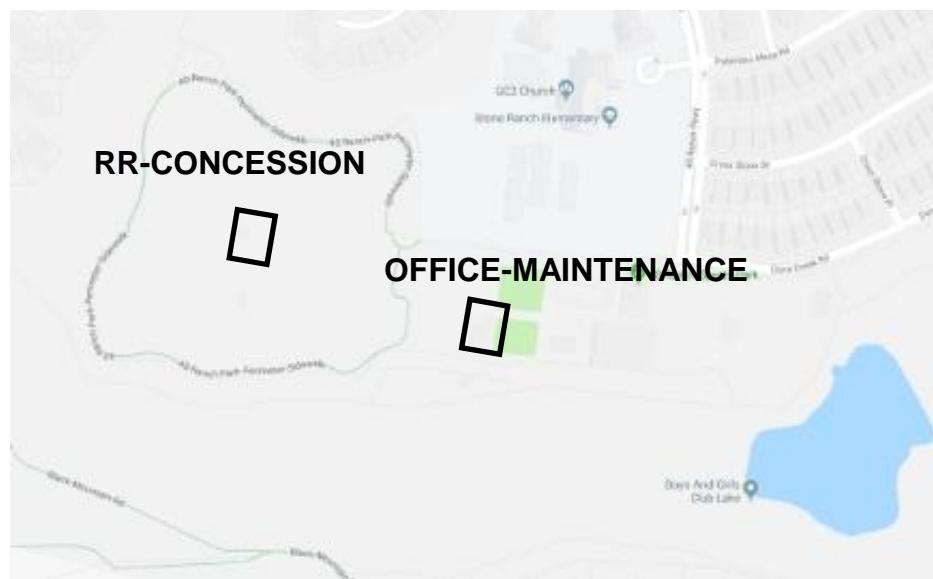
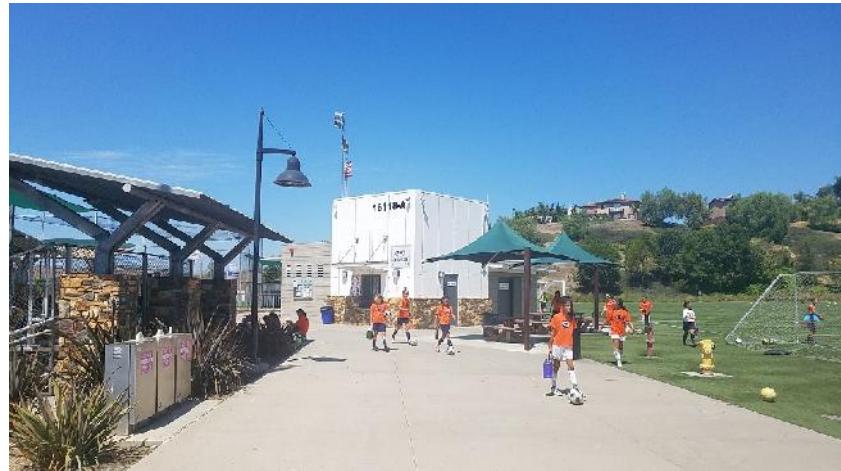
RESTROOM-CONCESSION

Estimated Cost: \$8,250

Replace or reposition Plumbing fixtures

Replace or modify Grab Bars

Replace or reposition Accessory Equipment

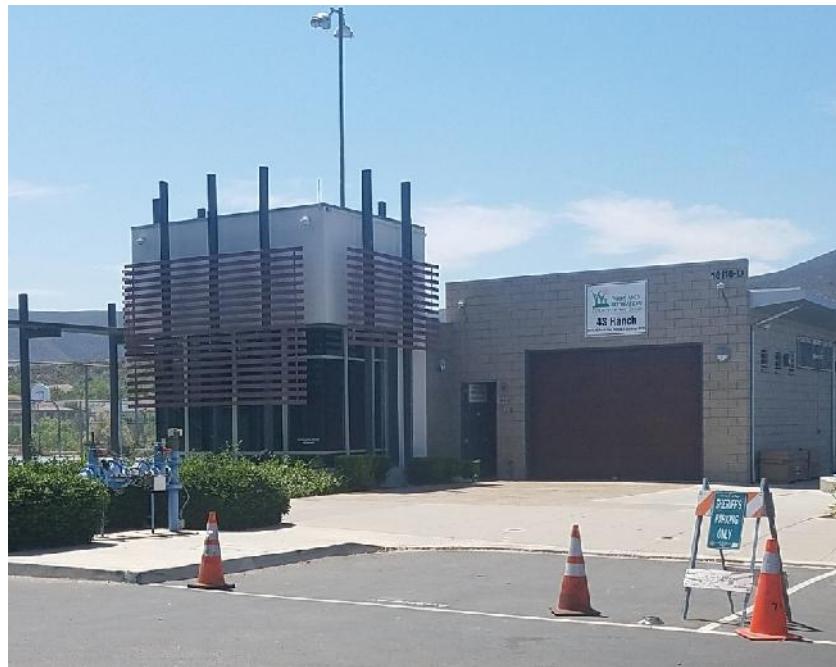
OFFICE-MAINTENANCE

Estimated Cost: \$11,700

Replace or reposition Accessory Equipment

Replace or modify Grab Bars

20-2 SingleUser Restroom- Unisex**Replace or reposition Plumbing fixtures**

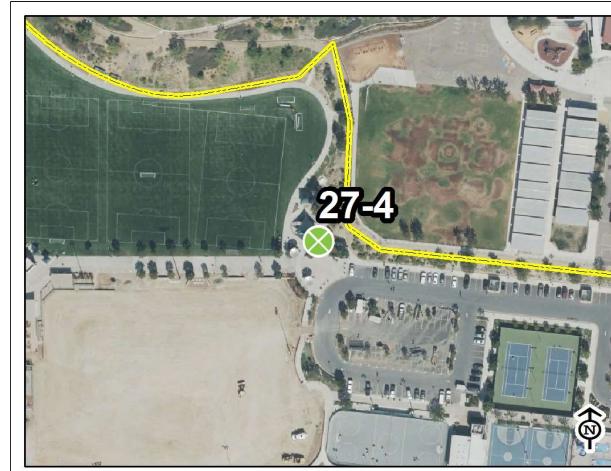
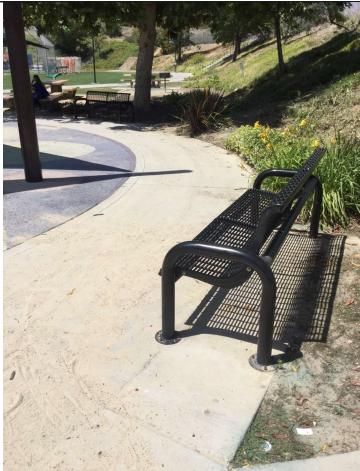
Site Photo

27-6 Assembly Area**Category: 3****Issue: Companion seating area slopes 2.7%.****Action: Regrade companion seating area and replace concrete.**

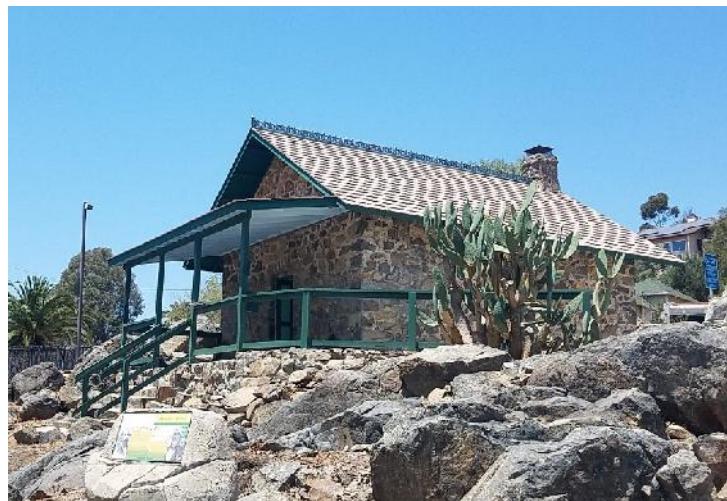
MUSEUM

This Report does not make any assumptions about the status or specifics of the Historical Designation of the Museum and/or Property. The California Historical Building Code is the reference document for alterations to Historical Properties.

Add ISA Signage
ISA Signage is missing from Entry
CBC: 11B-216.6 / ADA 216

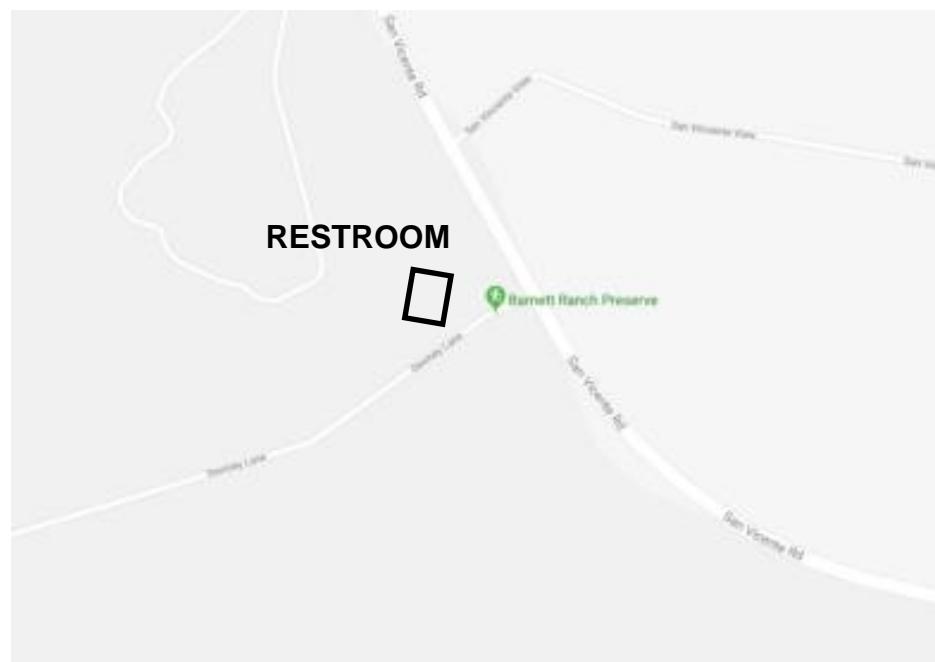
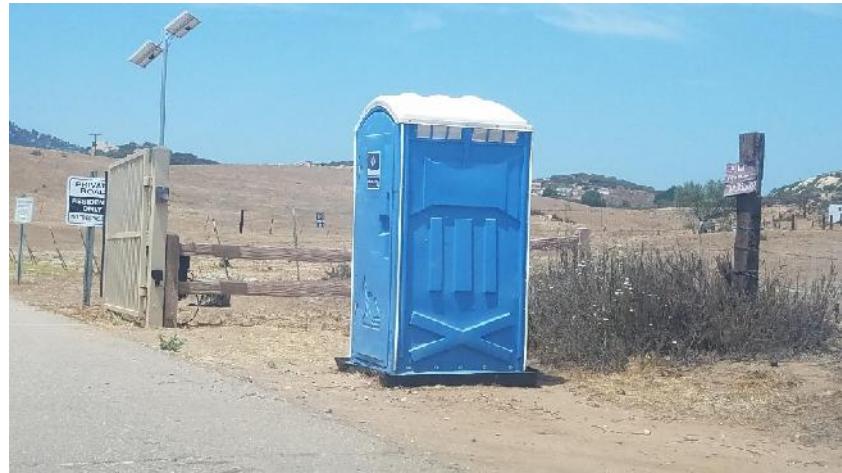
RESTROOM

Estimated Cost: \$25,000

It is suggested to replace this unit with a Prefabricated Restroom, compliant with California Accessibility standards.

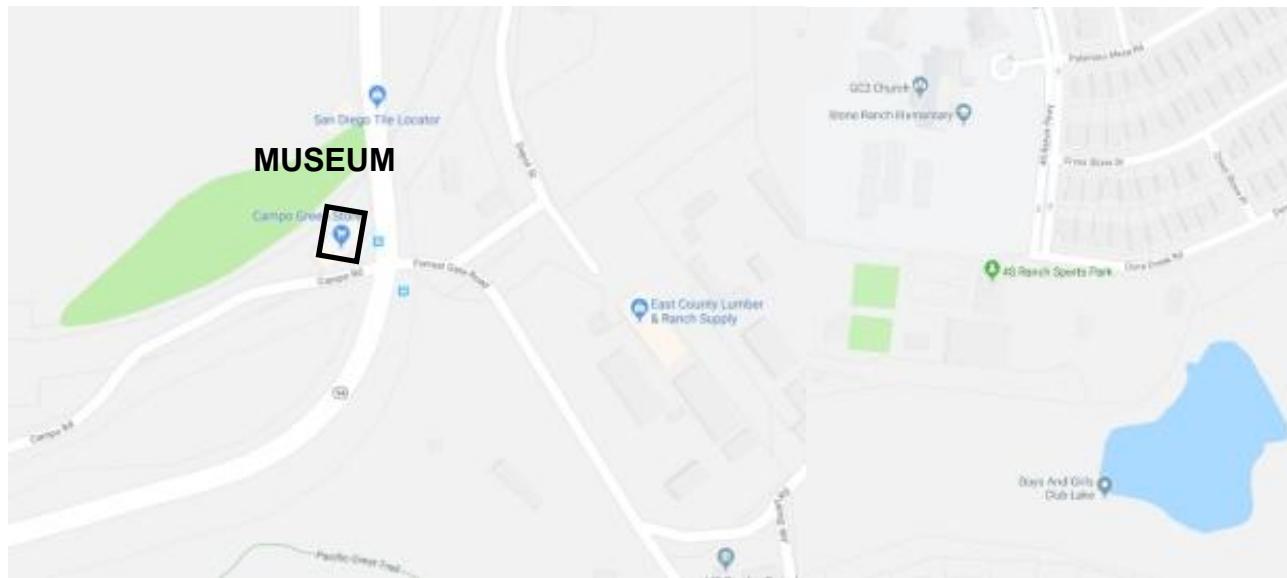
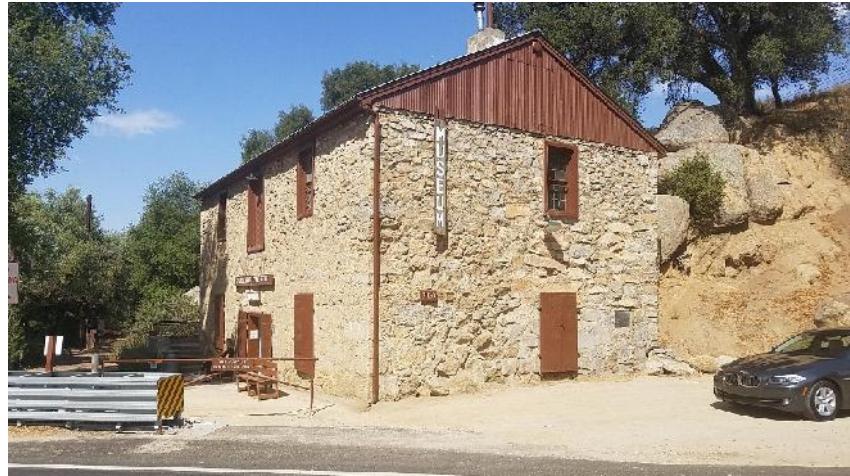
MUSEUM

ISA Signage is missing from Entry
CBC: 11B-216.6 / ADA 703

Replace Door Hardware

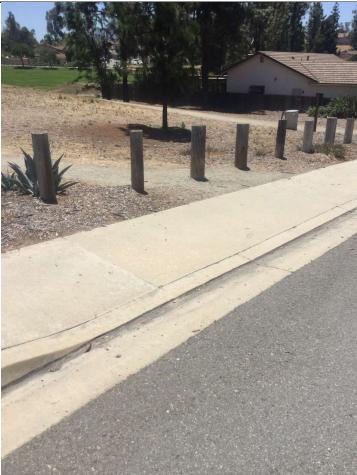
Site Photo

3-3 Curb Ramps**Category: 1****Issue:** No landing provided for driveway apron.**Action:** Replace driveway apron per SDRSD G-14A.

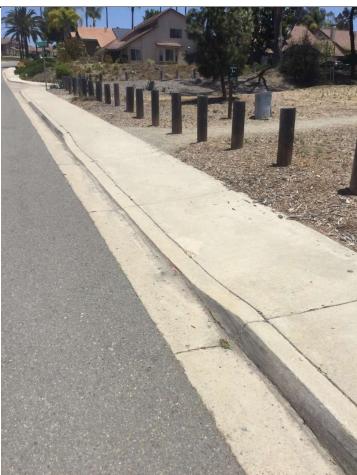
Site Photo

3-4 Curb Ramps**Category: 1****Issue:** No landing provided for driveway apron.**Action:** Replace driveway apron per SDRSD G-14A.

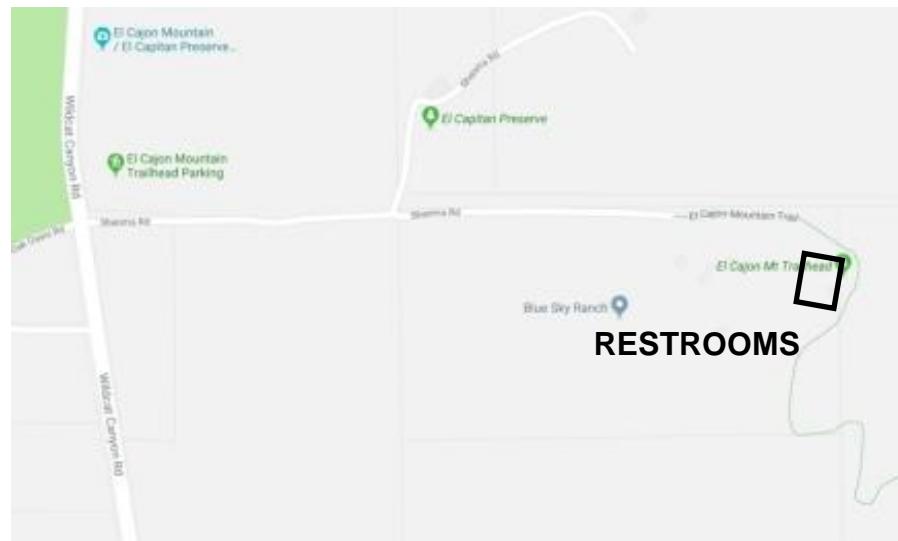
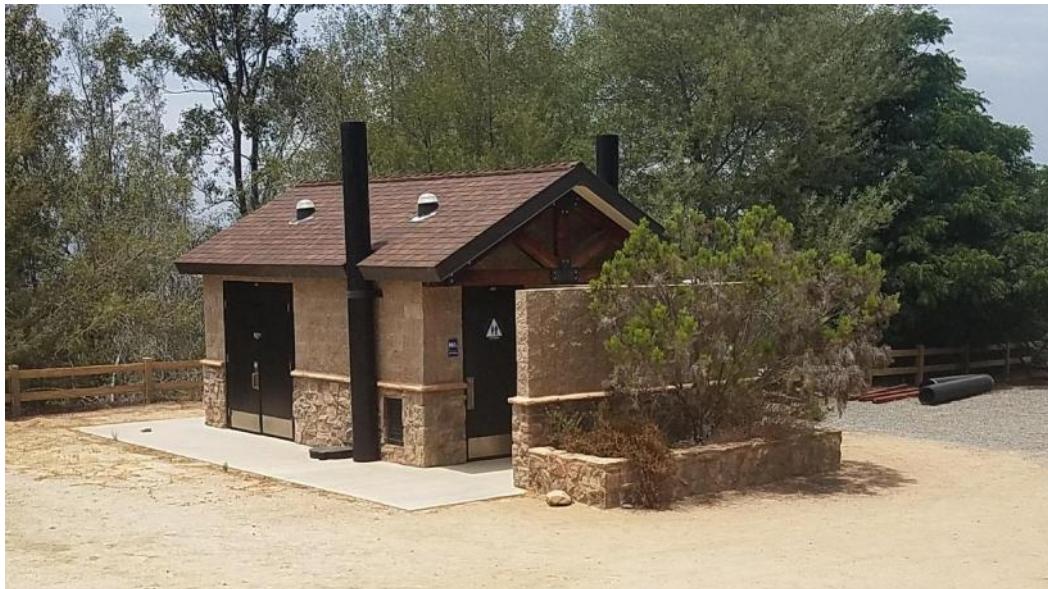
RESTROOMS

Estimated Cost: \$250

Replace or reposition Accessory Equipment
Soap Dispenser is 42 1/2" aff (40" max)
CBC 11B- 603.5 / ADA 603

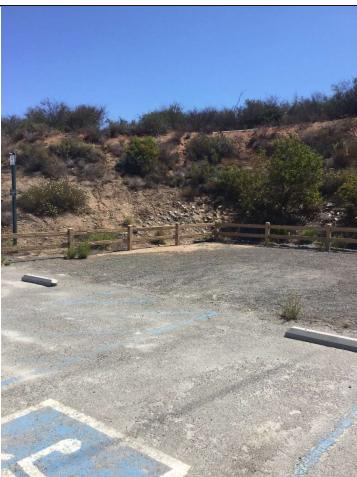
Site Photo

1-2 Parking Area**Category: 2****Issue:** Missing ISA signs for both spaces.**Action:** Install ISA signs at both parking stalls.

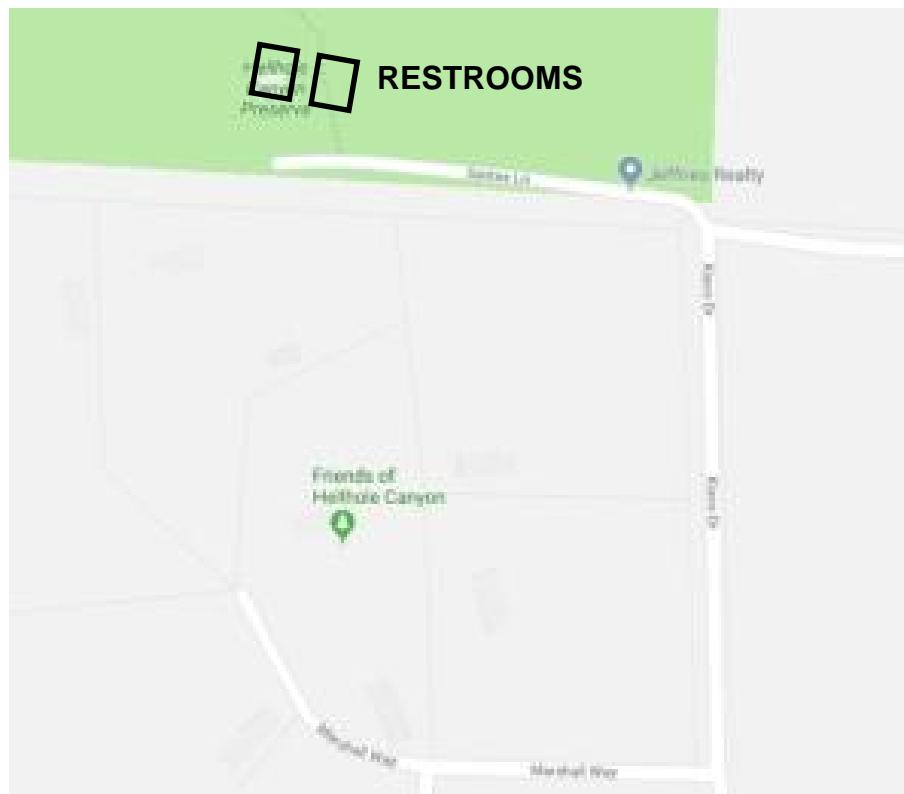
RESTROOMS

Door Closer missing.

Replace or modify Grab Bars

36" Side GB (42" min./ 48" recommended)

Replace or reposition Plumbing fixtures

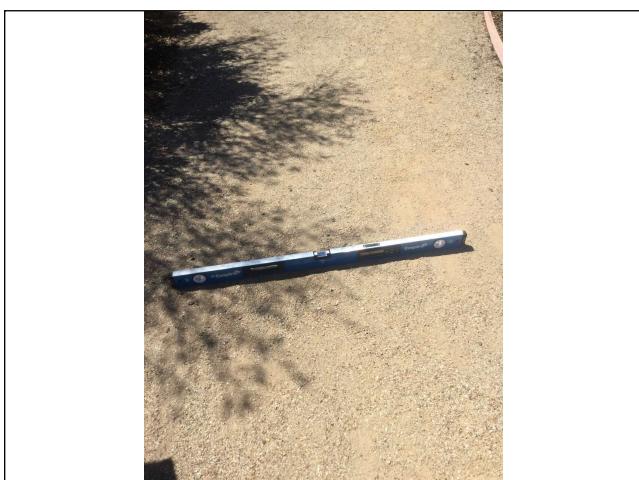
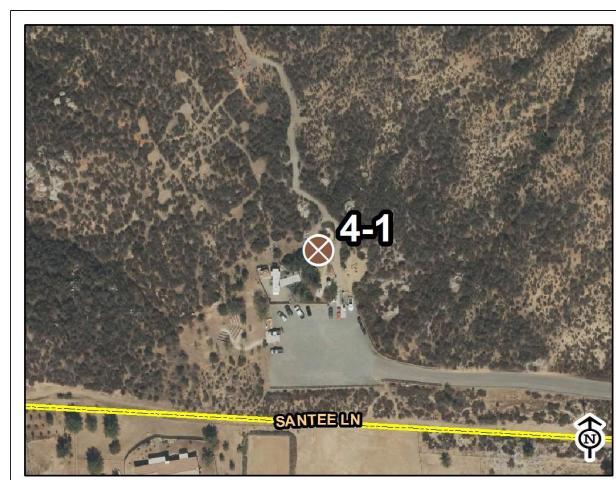
Site Photo

4-2 Walk**Category: 1****Issue: Cross slope at 3%. Walkway has uneven surface.****Action: Regrade walkway and replace DG.**

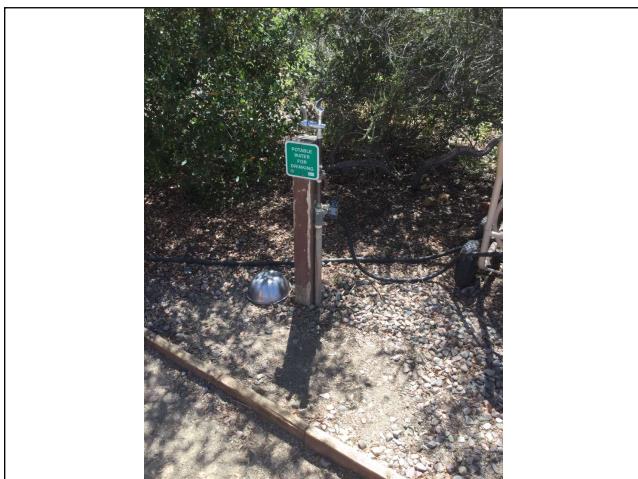
10-1 Drinking Fountain**Category: 3****Issue:** No accessible route to drinking fountain. No High-Low fountain provided.**Action:** Replace drinking fountain.

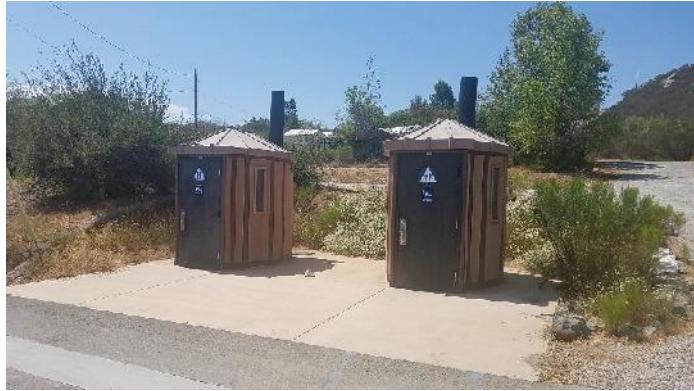
RESTROOMS

20-1 Unisex Restroom

Door Closer missing.
CBC: 11B-309.4, 11-B 404.2.7 / ADA 309, 404

36" Side GB (42" min./ 48" recommended)
CBC: 11B-604.5.1 / ADA 604

ISA Signage is missing from Entry
CBC: 11B-216.6 / ADA 703

Replace or modify Grab Bars

Replace or reposition Plumbing fixtures

Replace Door Hardware

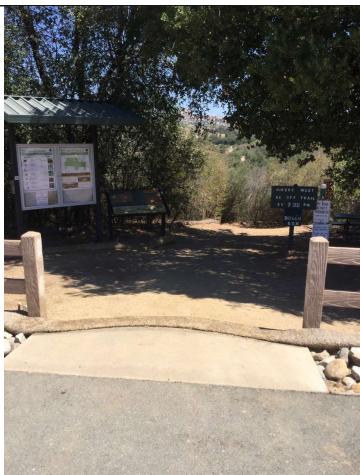
5-1 Ramp**Category: 1****Issue: Ramp running slope is 9%.****Action: Replace ramp.**

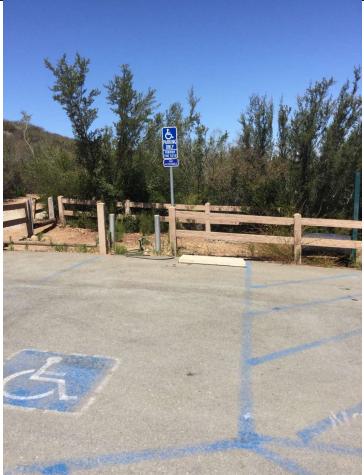
1-4 Parking Area**Category: 1****Issue:** Surface slope is at 11%.**Action:** Regrade parking stall, replace AC pavement, and restripe.

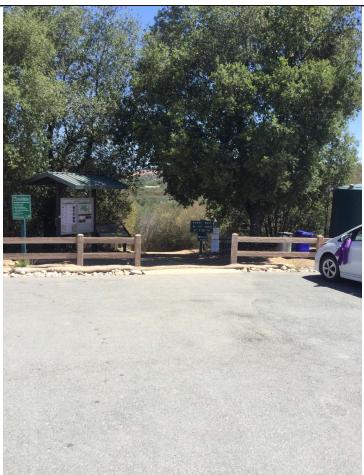
1-6 Parking Area**Category: 1****Issue:** No ADA parking stall provided for the trailhead. Surface slope is 7.5%.**Action:** Regrade and replace AC pavement near trailhead, and provide ADA parking stall with appropriate signage. All stalls shall comply with CBC 11B-502.

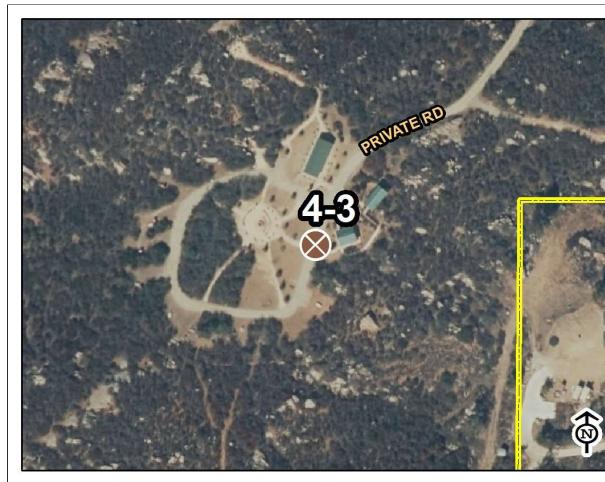
Site Photo

20-1 Single User Bathroom**Category: 2****Issue:** Surface slopes are at 2.5% and 4.5% for the restrooms.**Action:** Regrade area in front of one restroom and replace concrete.

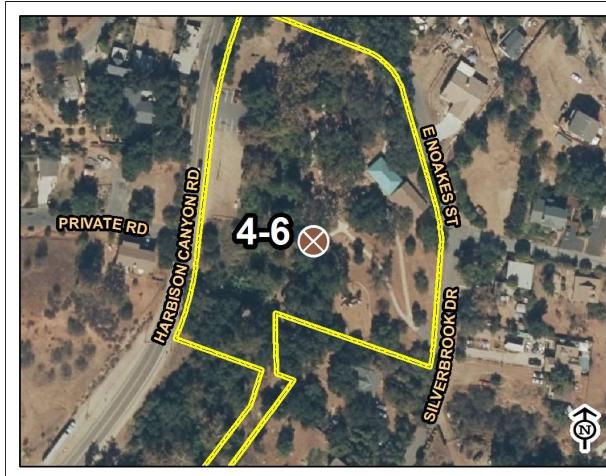
Site Photo

4-2 Walk**Category: 1****Issue: Walkway running slope of 5.9%.****Action: Rergrade walkway and replace concrete.**

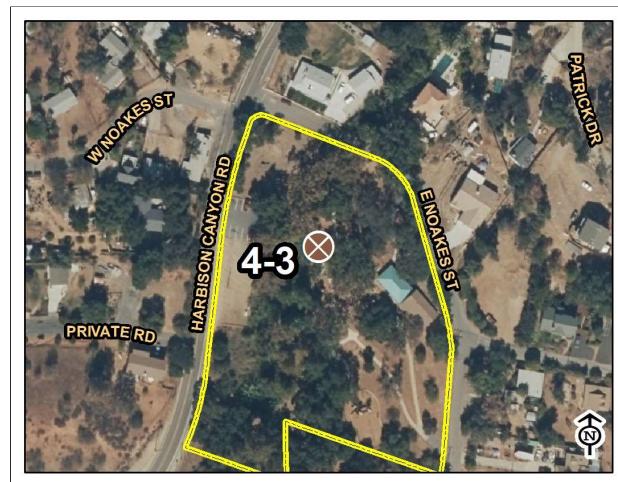
Site Photo

4-7 Walk**Category: 1****Issue:** Surface slope of turning space is 5%.**Action:** Provide level surface at point of turning. Regrade and replace concrete.

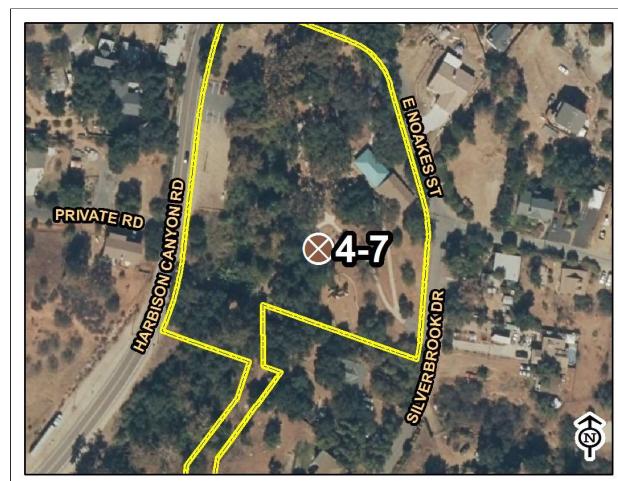
Site Photo

4-12 Walk**Category: 1****Issue: Surface slope of turning space is 4%.****Action: Provide level surface at point of turning. Regrade and replace concrete.**

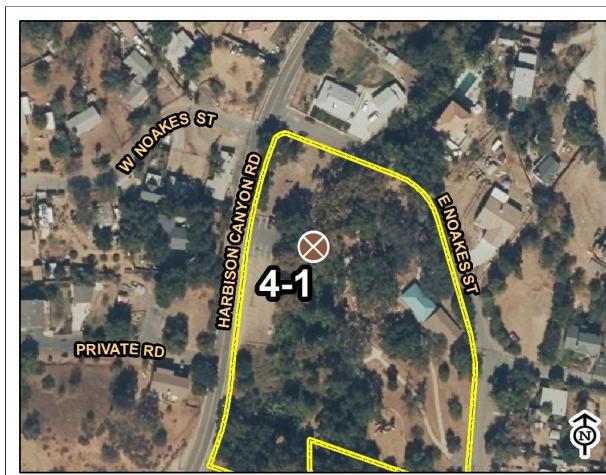
Site Photo

7-1 Hazard**Category: 2****Issue: Vertical changes in walkway exceed 1/2".****Action: Grind or patch concrete.**

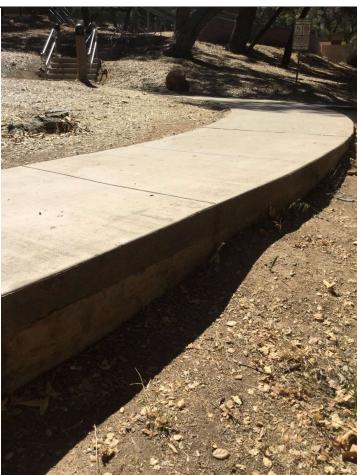
7-2 Hazard**Category: 2****Issue: Abrupt 4" or more vertical change.****Action: Regrade adjacent surface.**

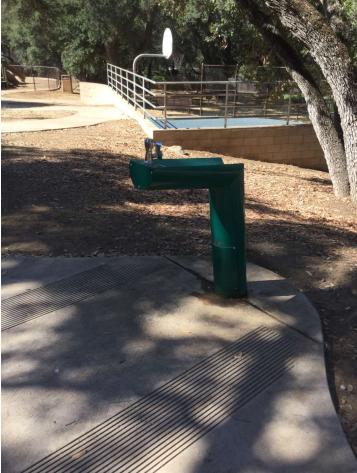
10-1 Drinking Fountain**Category: 3****Issue: No High-Low fountain provided.****Action: Replace drinking fountain.**

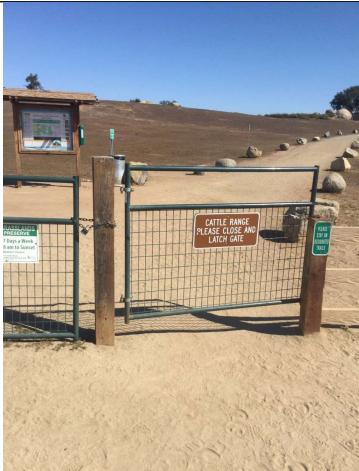
26-1 Trails**Category: 1****Issue: No accessible route to trailhead.****Action: Replace or modify gate and provide ADA access sign.**

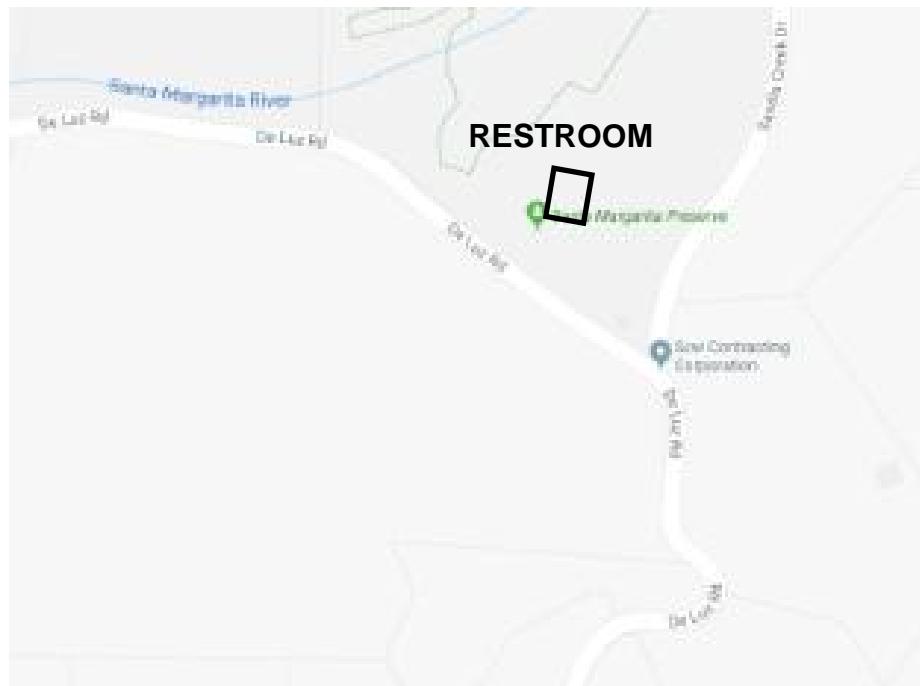
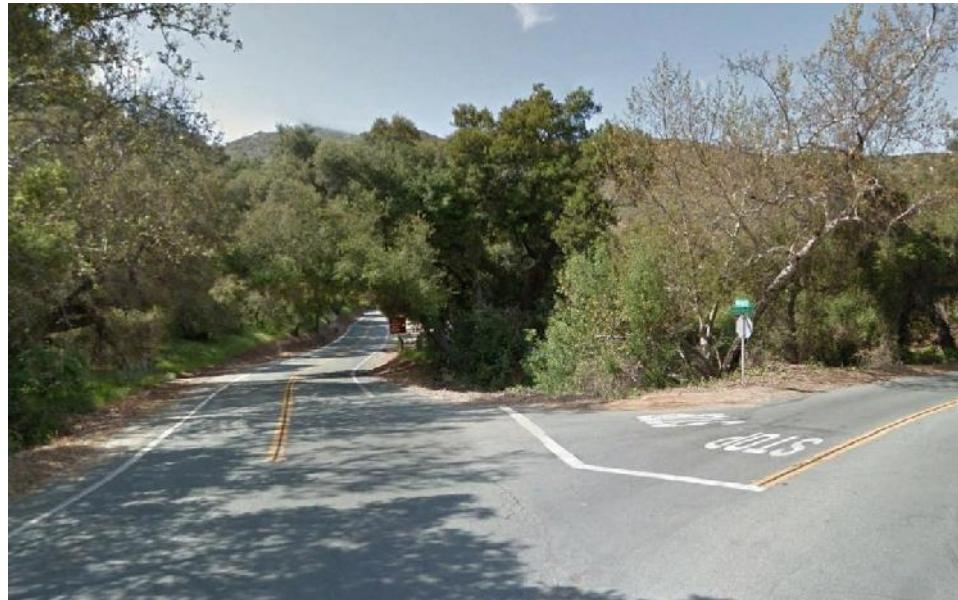
RESTROOM

20-1 Unisex Restroom

Estimated Cost: \$25,000

It is suggested to replace this unit with a Prefabricated Restroom, compliant with California Accessibility standards.

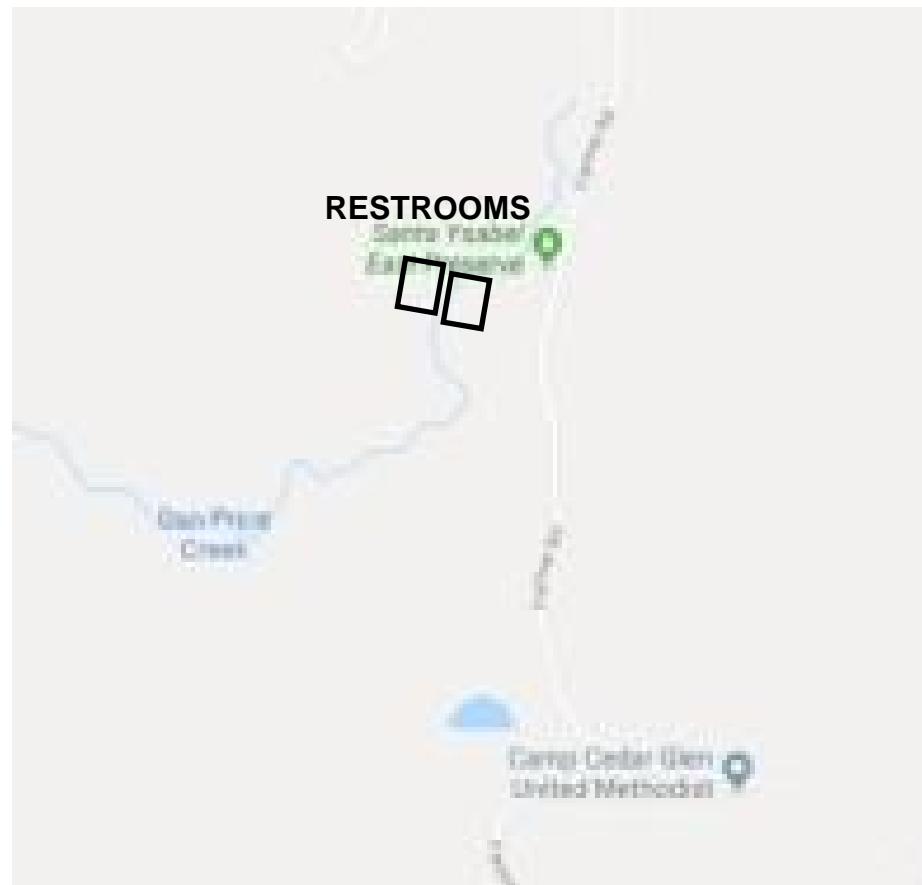
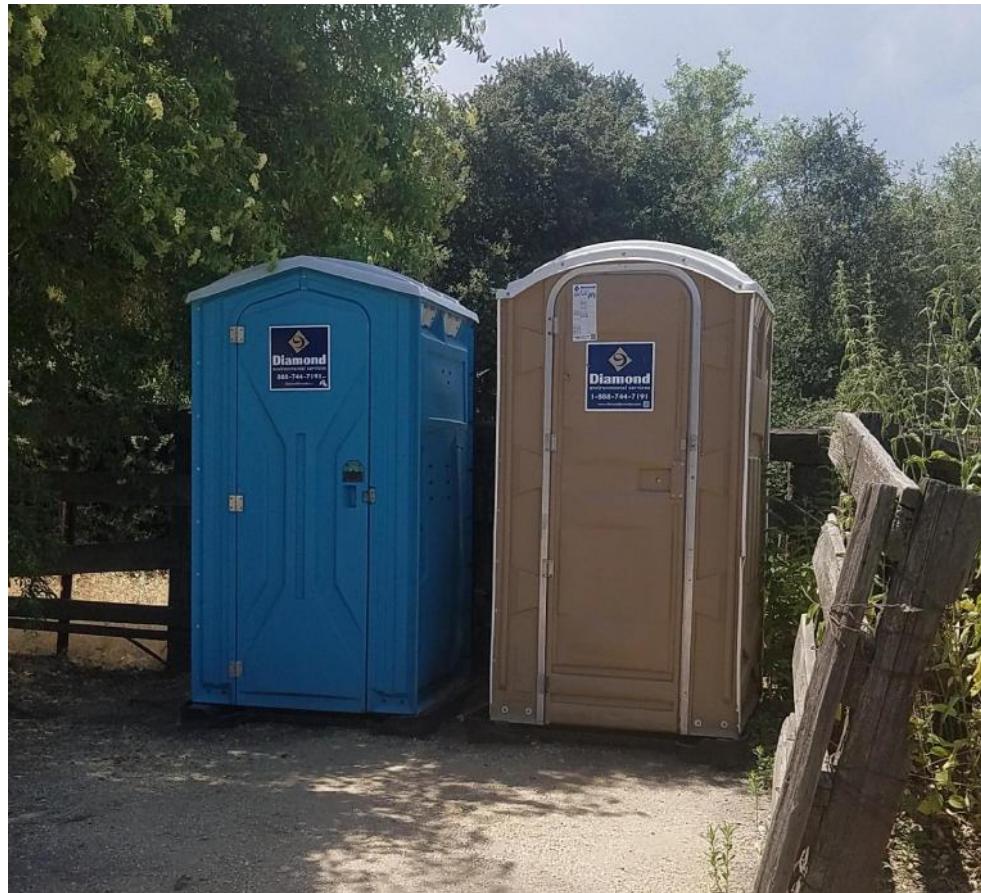
RESTROOMS

20-1 Unisex Restroom

Estimated Cost: \$25,000

It is suggested to replace this unit with a Prefabricated Restroom, compliant with California Accessibility standards.

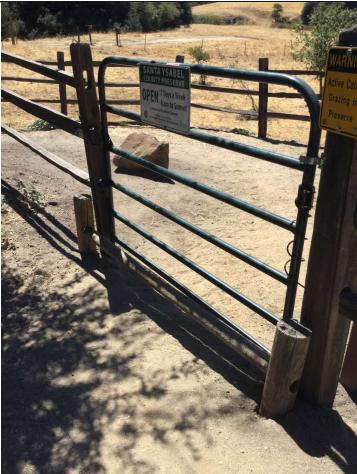
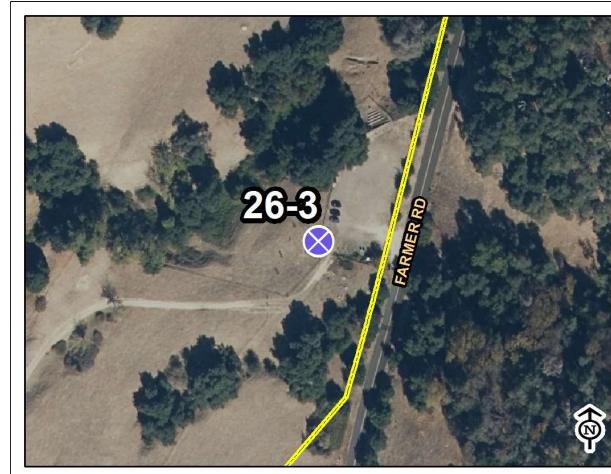
Site Photo

26-3 Trails**Category: 1****Issue: No accessible route to trailhead. Gate hardware is not accessible.****Action: Provide 48" wide minimum accessible path to trailhead. Replace or modify gate and provide ADA access sign.**

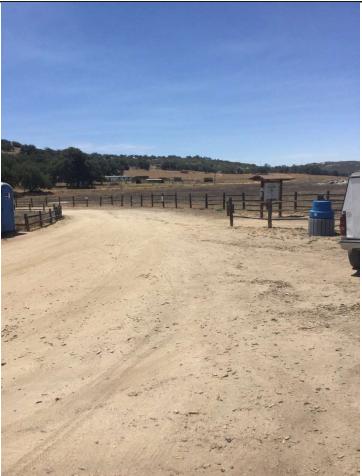
Site Photo

4-3 Walk**Category: 1****Issue: No accessible route to picnic table.****Action: Rergrade walkway and replace DG.**

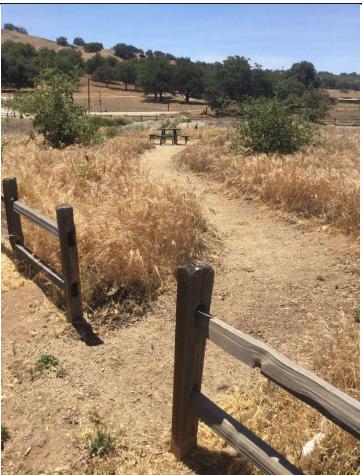
Site Photo

4-2 Walk**Category: 1****Issue: Cross slope at 5% throughout walkway.****Action: Regrade walkway and replace DG.**

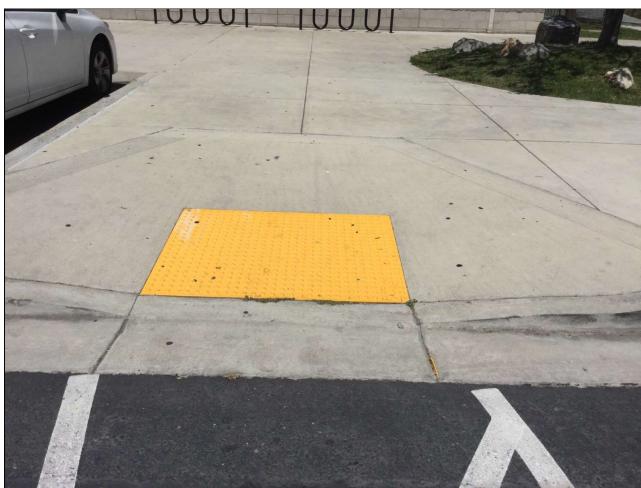
Site Photo

3-1 Curb Ramps**Category: 1****Issue: Flares slope 14%. No level landing provided.****Action: Replace curb ramp.**

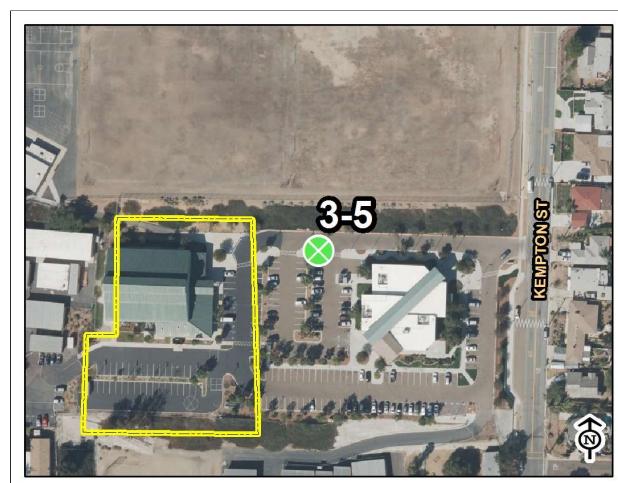
3-6 Curb Ramps**Category: 1****Issue: Flare slopes 18%.****Action: Replace curb ramp.**

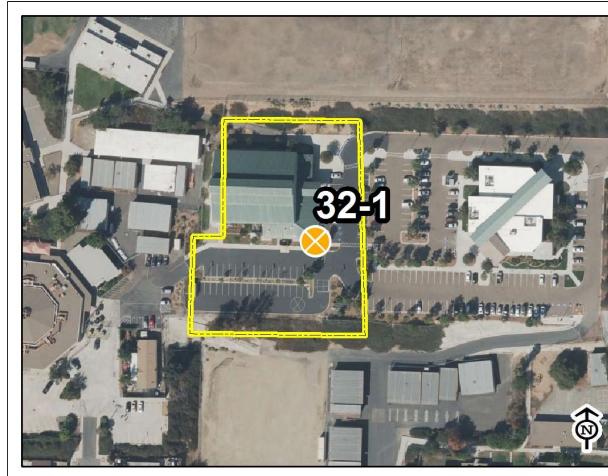
4-2 Walk**Category: 3****Issue:** No accessible route to upper sports fields. Walkway running slope is 12%.**Action:** Regrade walkway and replace AC pavement.

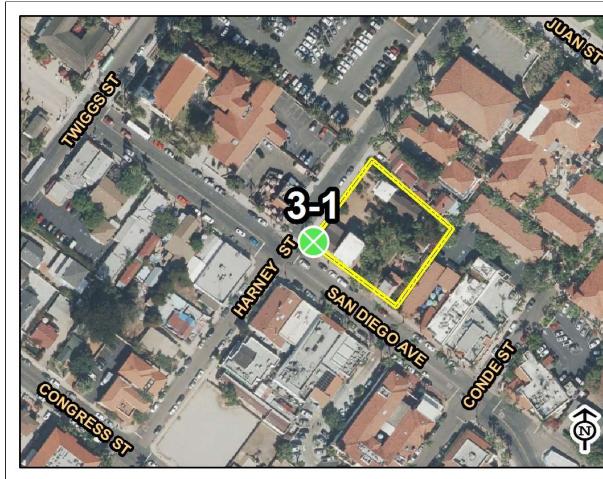
3-1 Curb Ramps**Category: 1****Issue: Flare slopes 14%. No landing provided. No detectable warnings provided.****Action: Replace curb ramp.**

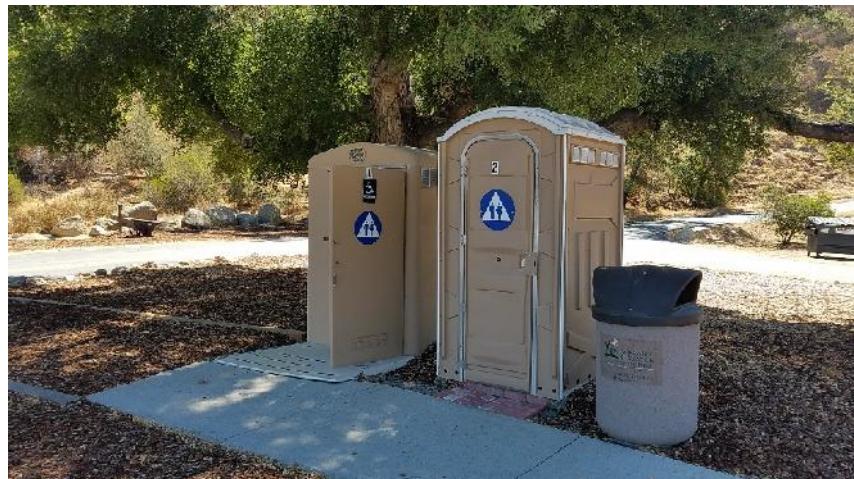
PORTABLE RESTROOMS (5)

20-1 Unisex Restrooms

It is suggested to replace at least (2) units with Prefabricated Restrooms, compliant with California Accessibility standards.

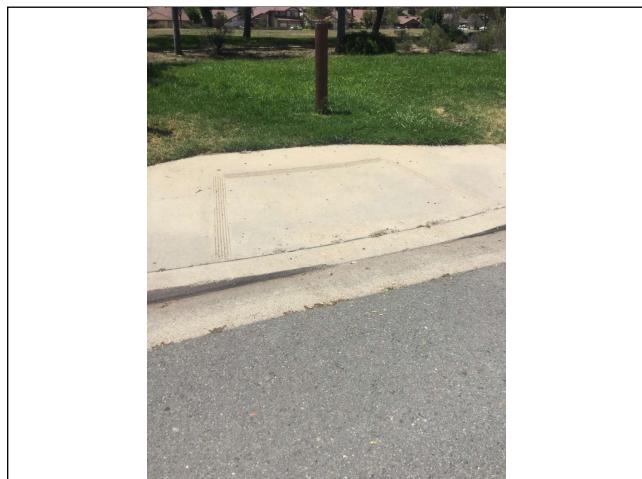
Site Photo

3-6 Curb Ramps**Category: 2****Issue:** No landing provided. No detectable warnings provided.**Action:** Regrade and replace concrete of landing. Install detectable warning tile.

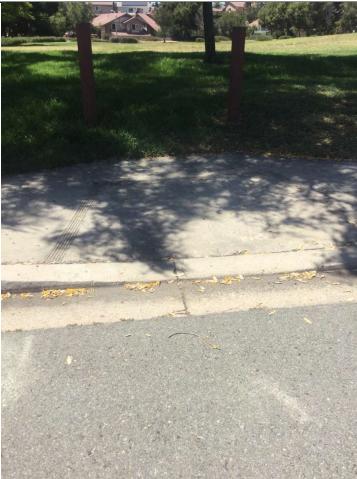
Site Photo

3-2 Curb Ramps**Category: 2****Issue:** No level landing provided. No detectable warnings provided.**Action:** Replace curb ramp.

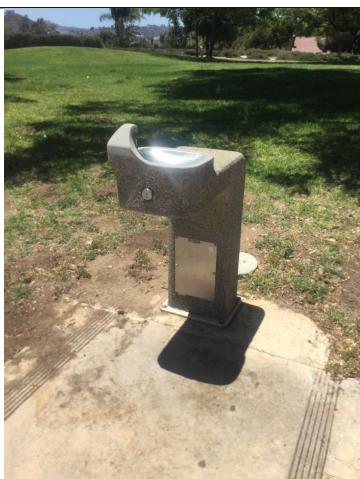
Site Photo

10-3 Drinking Fountain**Category: 3****Issue: No High-Low fountain provided.****Action: Replace drinking fountain.**

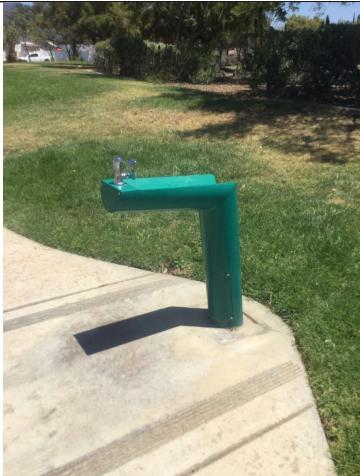
Site Photo

10-4 Drinking Fountain**Category: 3****Issue: No High-Low fountain provided.****Action: Replace drinking fountain.**

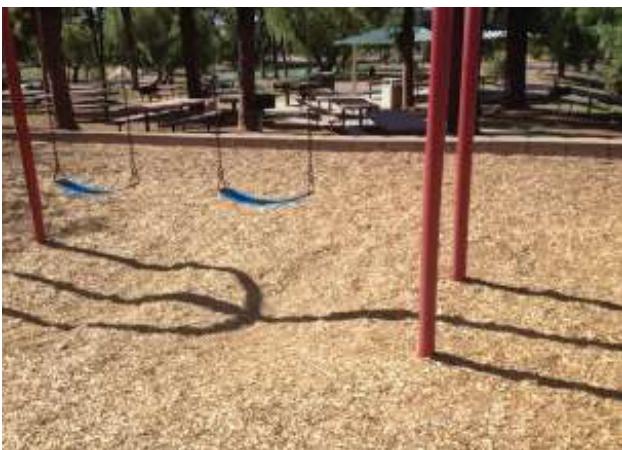
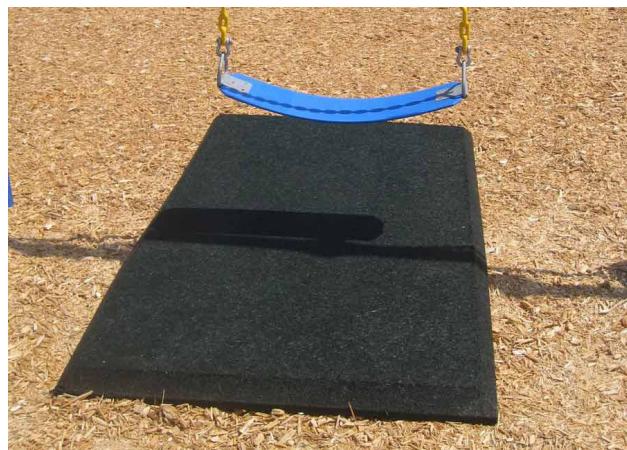
GRADE ISSUES AT SWINGS AND PLAY STRUCTURES

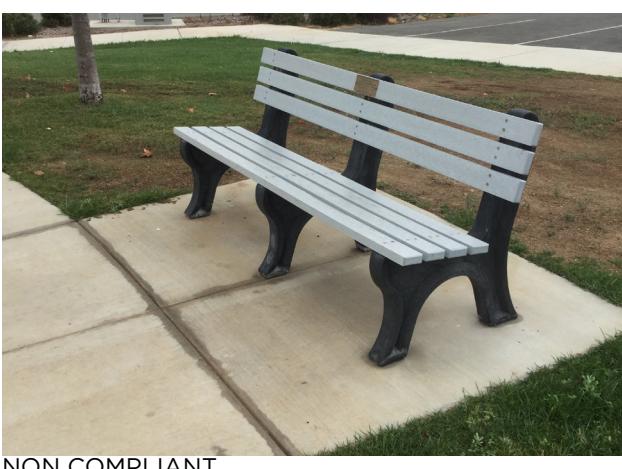
NO COMPANION SEATING AT ADJACENT TO BENCHES

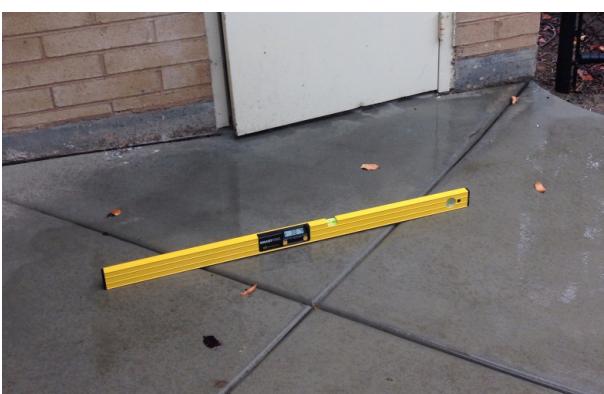
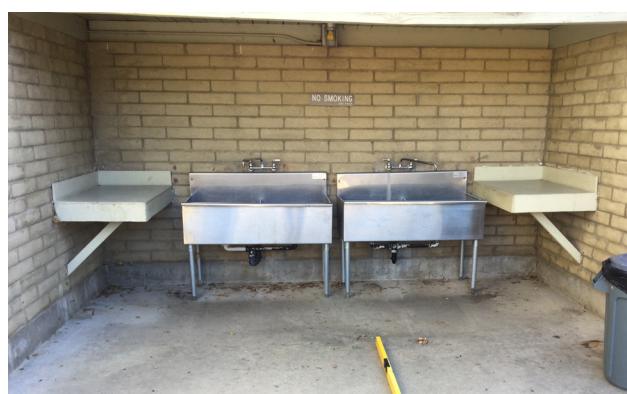
LEVEL LANDINGS NOT PROVIDED AT DOORS, GATES, AND OTHER REQUIRED LOCATIONS

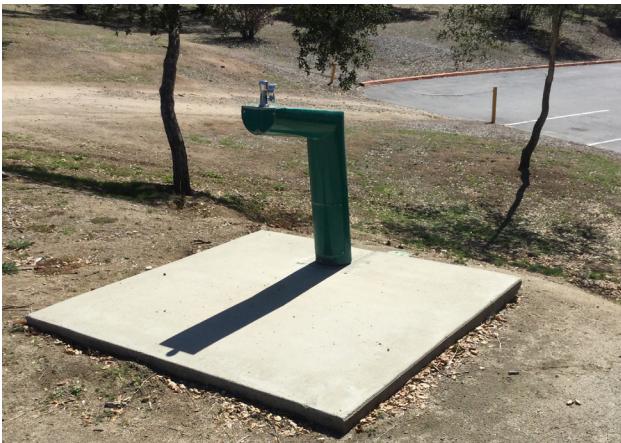
NO HIGH LOW WATER FEATURES/NO ACCESS TO WATER FOUNTAIN

NON COMPLIANT

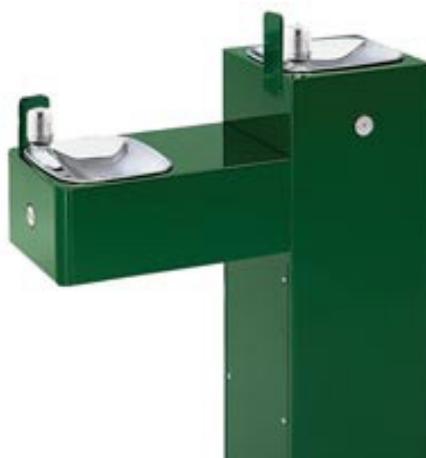
COMPLIANT

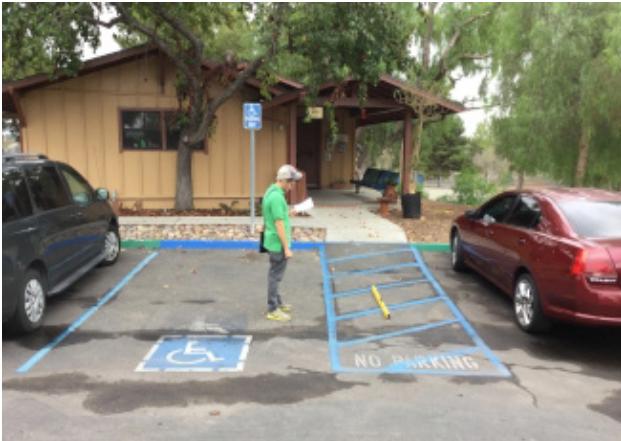
SLOPE ISSUES ON PARKING AND WALKING SURFACES

NON COMPLIANT

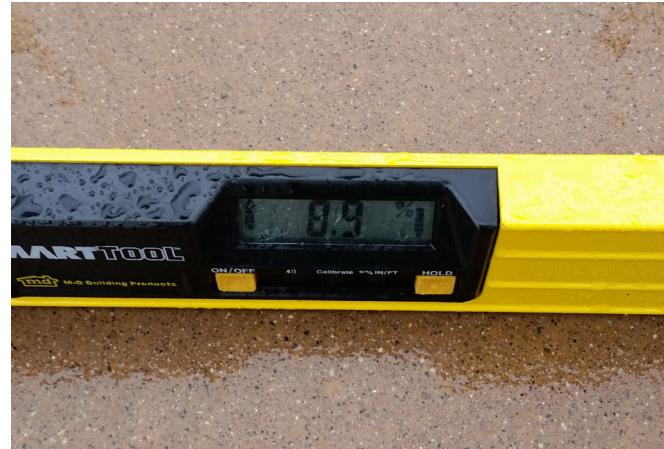
NON COMPLIANT

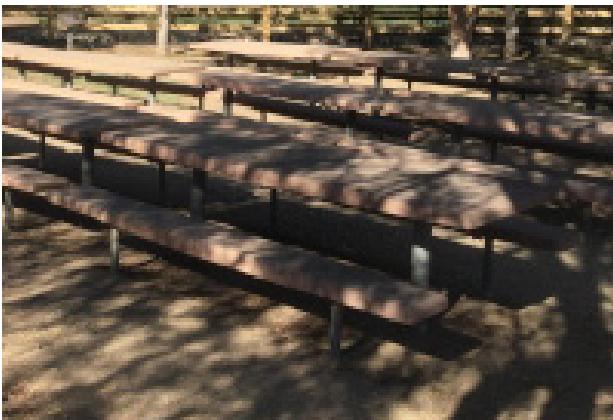
NON-ACCESSIBLE PICNIC BENCHES

NON COMPLIANT

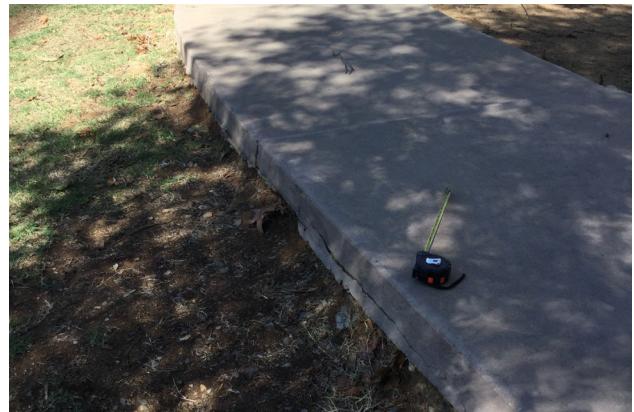
NON COMPLIANT

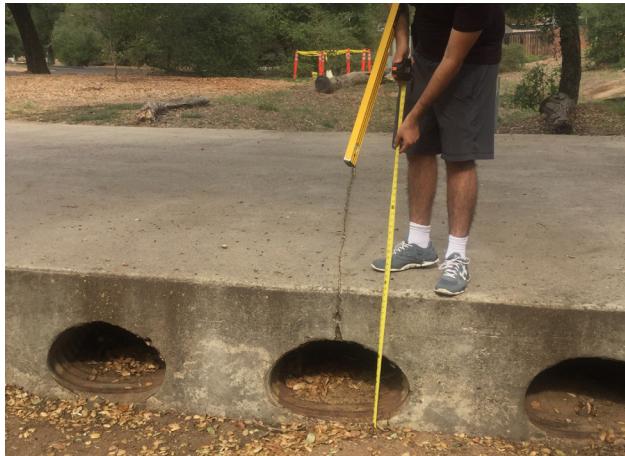
GRADE CHANGES REQUIRING GUARDRAIL

NON COMPLIANT

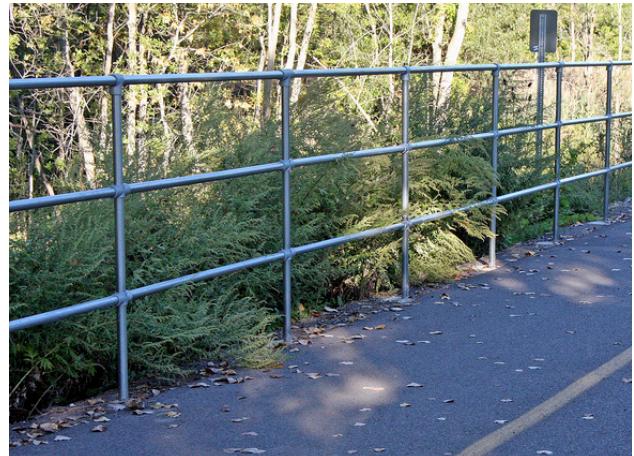
COMPLIANT

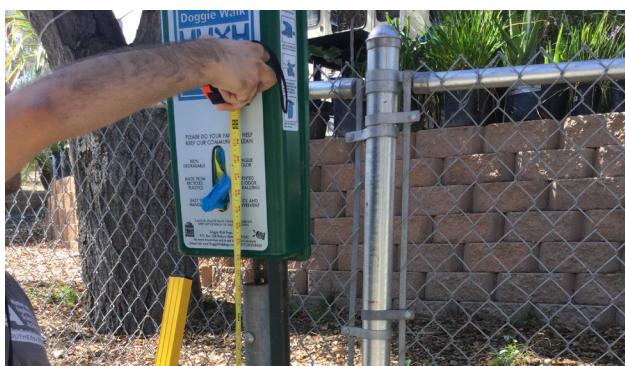
DOG WASTE BAGS/EXHIBITS OUT OF REACH

NON COMPLIANT

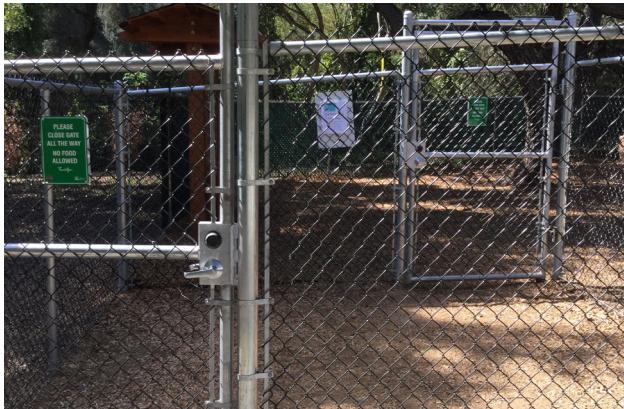
DOOR/GATE HARDWARE REQUIRING TIGHT GRASPING, PINCHING, OR TWISTING OF THE WRIST

NON COMPLIANT

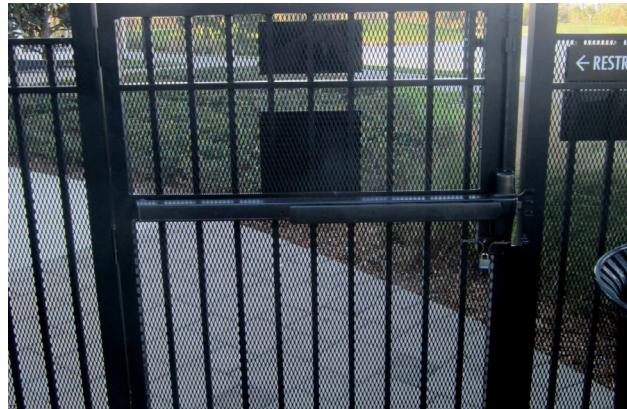
COMPLIANT
