SAN DIEGO COUNTRY PARKS
AMERICANS WITH DISABILITIES ACT
AUDIT & TRANSITION PLAN
PHASE 3

ADA AUDIT AND TRANSITION PLAN

PHASE 3

The County of San Diego Department
Of Parks and Recreation
5500 Overland Avenue
Suite 410
San Diego, CA. 92123

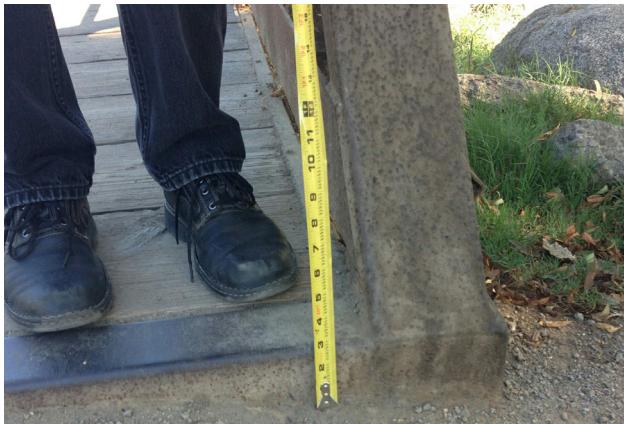
VERTICAL CHANGES ON WALKING SURFACES

NON COMPLIANT

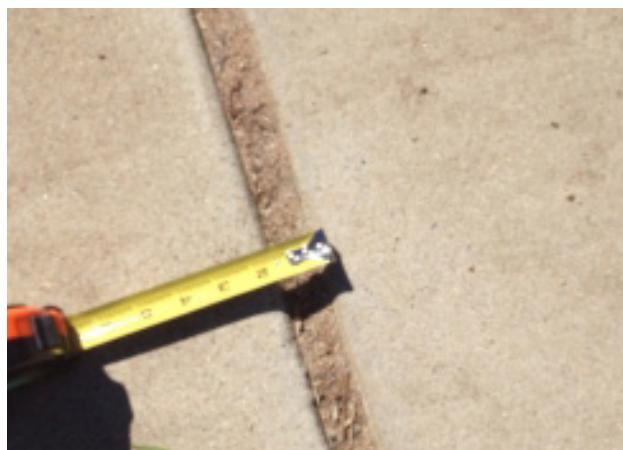
GAPS IN CONCRETE EXCEED 1/2"

NON COMPLIANT

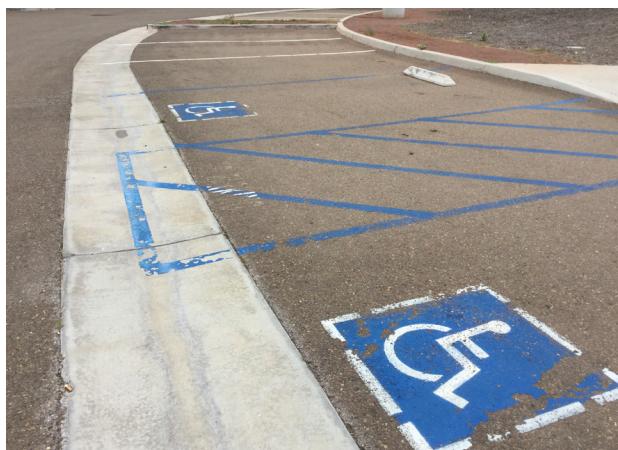
ADA PARKING SIGNAGE MISSING, FADED, OR VISUALLY IMPAIRED

NON COMPLIANT

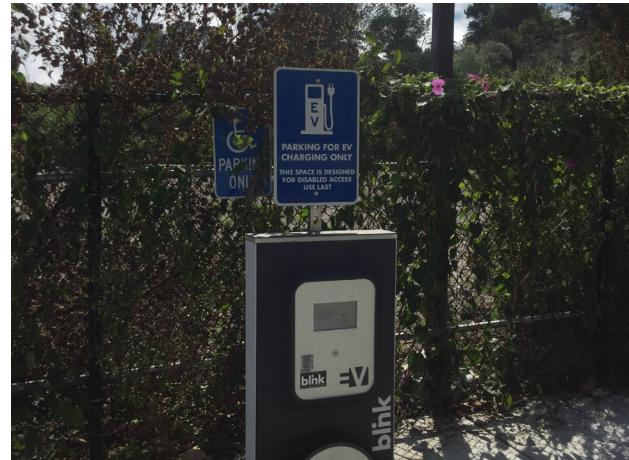
NON-COMPLIANT

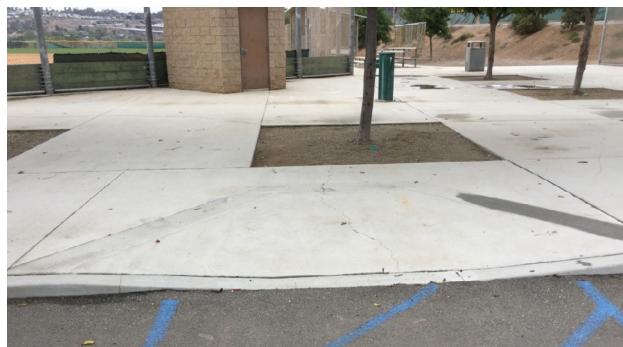
CURB RAMPS MISSING DETECTABLE WARNING STRIPS

NON COMPLIANT

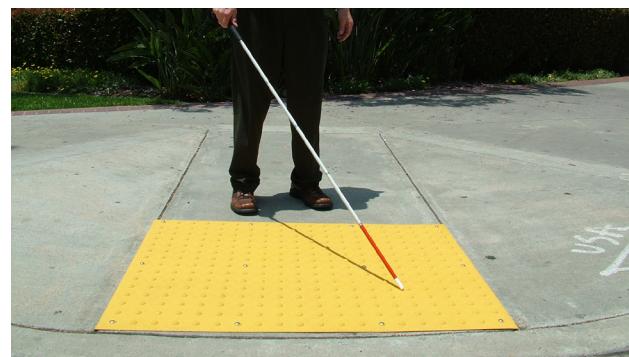
COMPLIANT

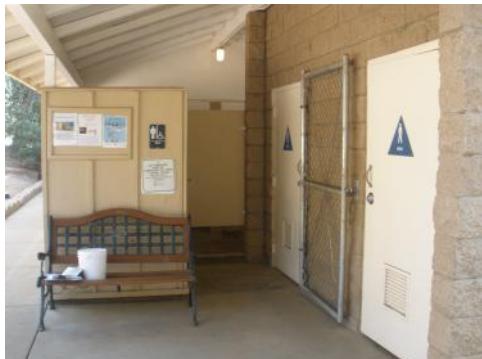
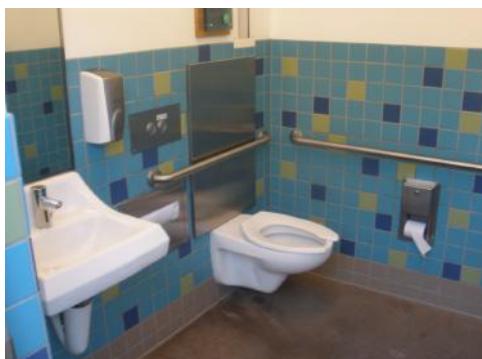
Of the Buildings surveyed, the majority of non-compliance was in the Restrooms and Showers. Typical Items found include:

- **Signage Missing or Incorrect**
ISA Entry Signage, Room or Door Signage, Directional/ Informational Signage.
- **Adjust Door Closer**
Sweep time is < 5 sec. and/or opening force is > 5 lbs.

- **Door Threshold**
Exceeds 1/2" (1/2" max with beveled edge)
- **WC Clearance**
Centerline of WC rough plumbing is outside the 17-18" range.
- **WC Side approach**
Less than 60" clear side approach from WC side wall to an opposite wall, fixture or other obstruction. Prior to 2010 CBC, this minimum equated to +/- 50" to 57" clear, depending on the type of WC.

- **WC Front approach**
Less than 48" clear from WC front lip to an opposite wall, door, fixture or other obstruction.
- **Grab Bar Position**
Rear Grab Bar extends less than 24" from centerline of WC and Sidewall Grab Bar extends less than 54" from WC back wall.

- **Accessory Equipment Positions**
Toilet Paper Dispenser is outside the 7"- 9" range measured to WC front lip and/or Accessory Equipment, within any 3048 maneuvering space, protrudes +4" from wall between 27"-80" aff.

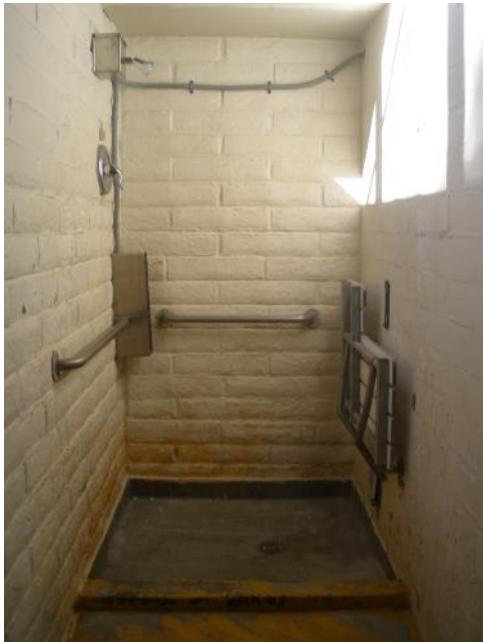
- **Pre-Shower Maneuvering Space**

Less than 36" x 60" maneuvering footprint adjacent to Shower Entry.

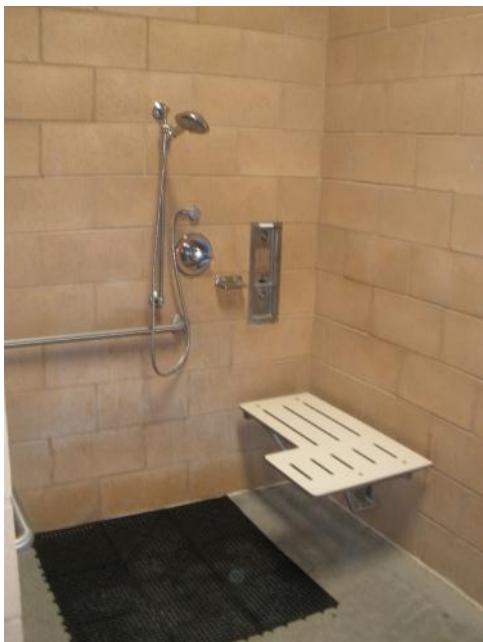
- **Floor Threshold**

More than 1/2" change in elevation entering the Shower Area.

Perfect, except the seat is installed backwards.
