SAN DIEGO COUNTRY PARKS
AMERICANS WITH DISABILITIES ACT
AUDIT & TRANSITION PLAN
PHASE 2

THE COUNTY OF SAN DIEGO ADA AUDIT AND TRANSITION PLAN PHASE 2

Rick Engineering Company
5620 Friars Road
San Diego, California 92110
(619) 291-0707

Roy Davies Architect
8348 Center Drive, Suite B
La Mesa CA 91942

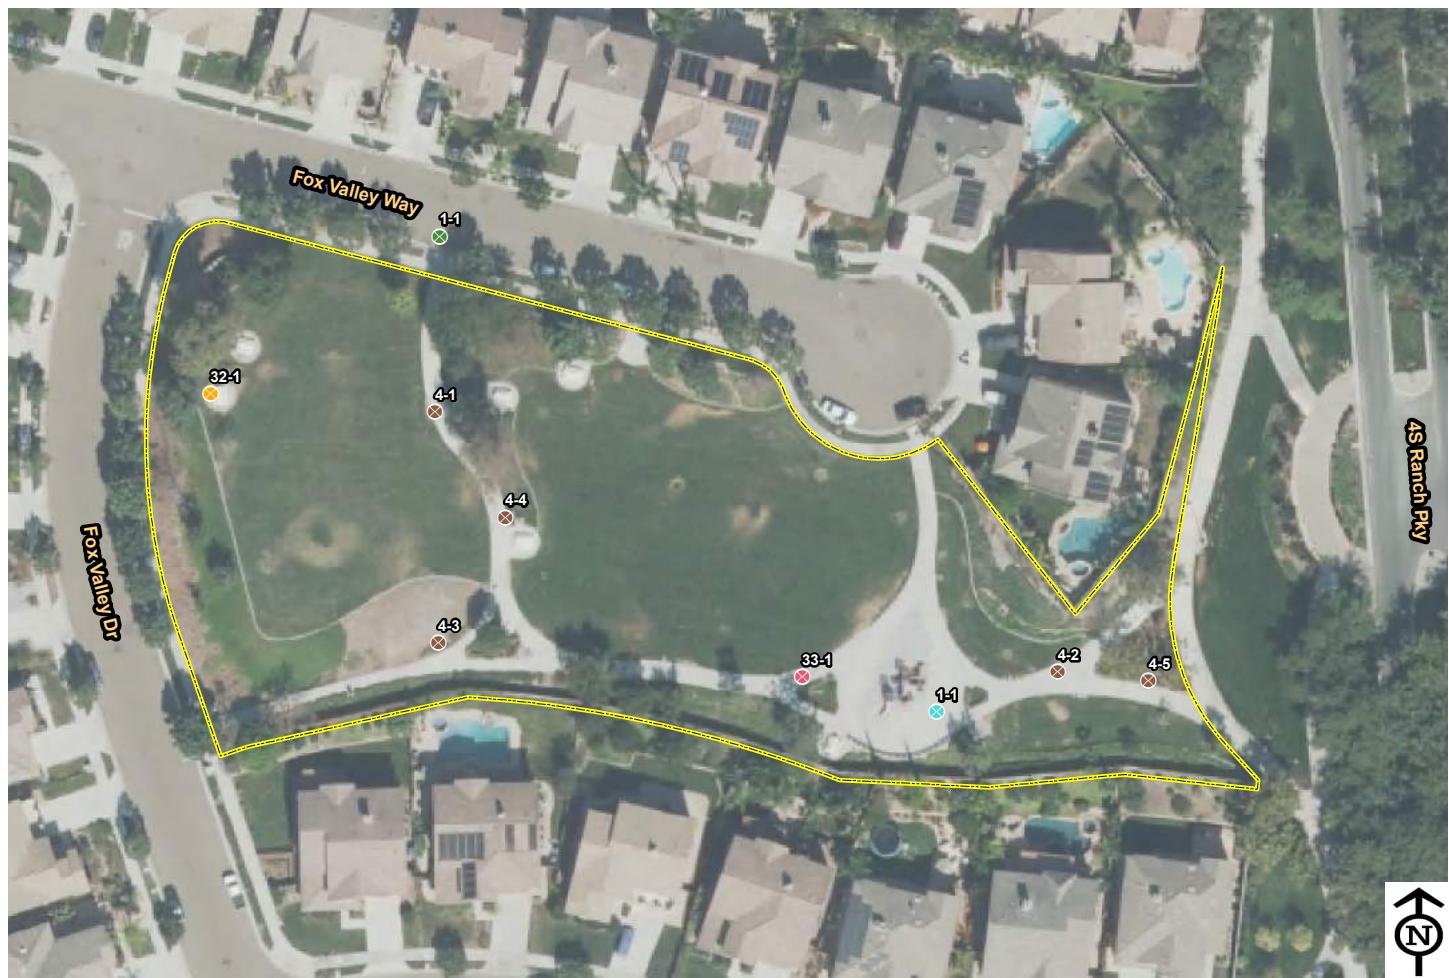
1-1 Parking Area**Category: 1****Issue:** No ADA parking stall provided at park.**Action:** Provide perpendicular ADA stall and van access aisle by nearest entrance to park with appropriate signage. All stalls shall comply to CBC 11B-502. Demolish sidewalk and replace to accomodate new ADA parking.

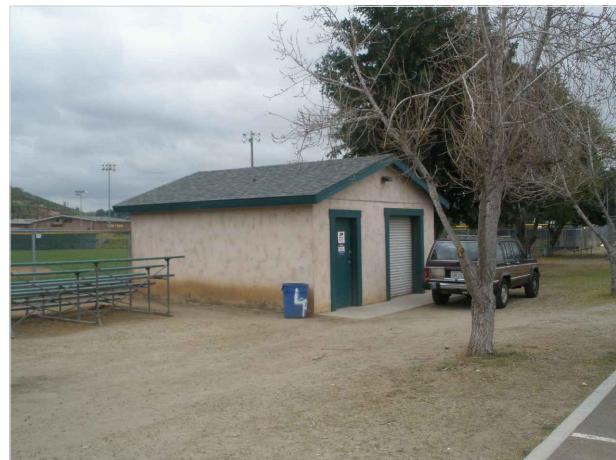
PONY FIELD HOUSE

ISA Signage is missing from Entry
CBC: 11B-216.6 / ADA 216

Install Latch side signage
CBC: 11B-216.2 / ADA 216

Add ISA Signage

Install or Modify Permanent Room Signage

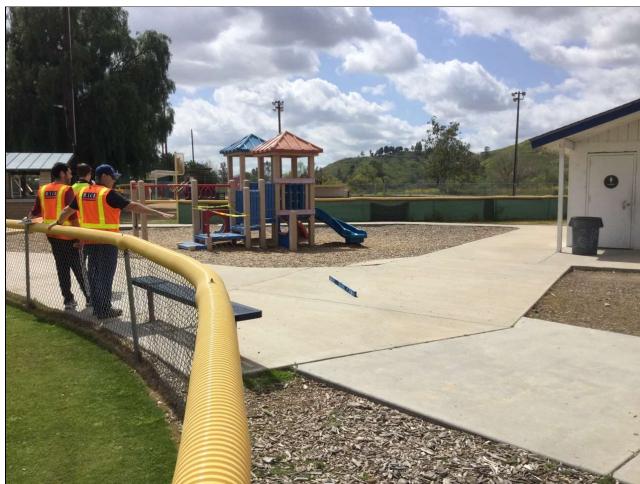
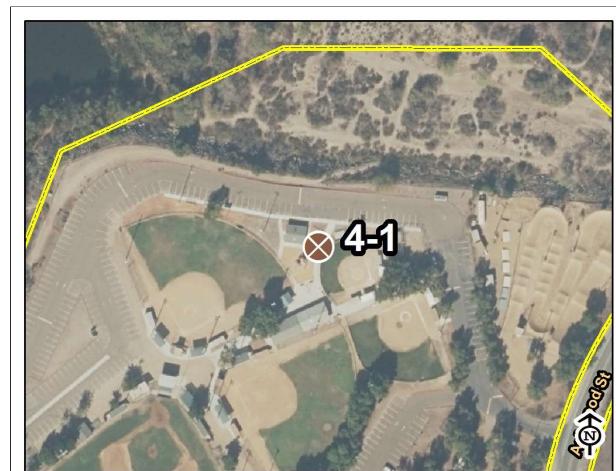
Cactus Park

4-1 Walk**Category: 1****Issue: Surface slope of turning space is 3.5%.****Action: Provide level surface at point of turning. Regrate and replace concrete.**

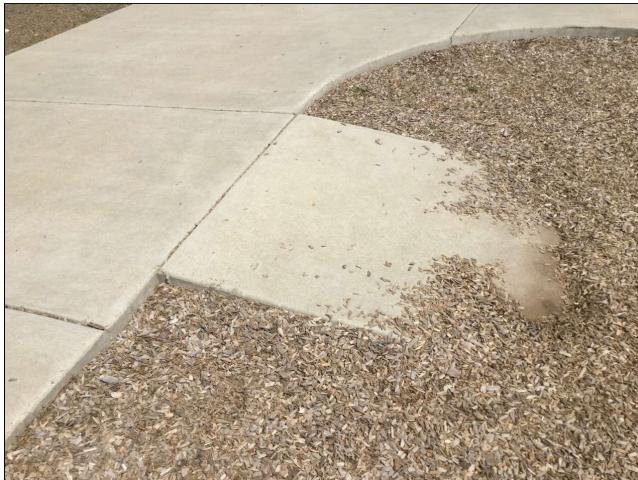
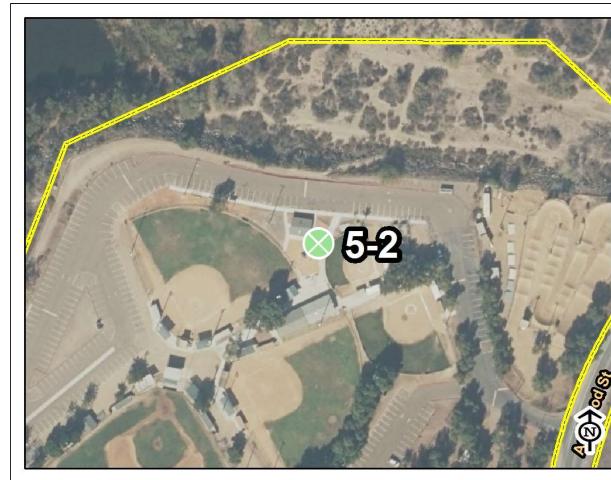
Cactus Park

5-2 Ramp**Category: 1****Issue: Tot lot ramp at 13%.****Action: Replace ramp.**

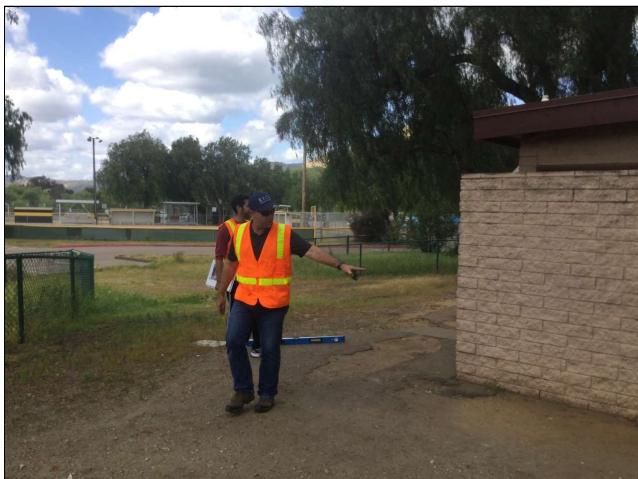
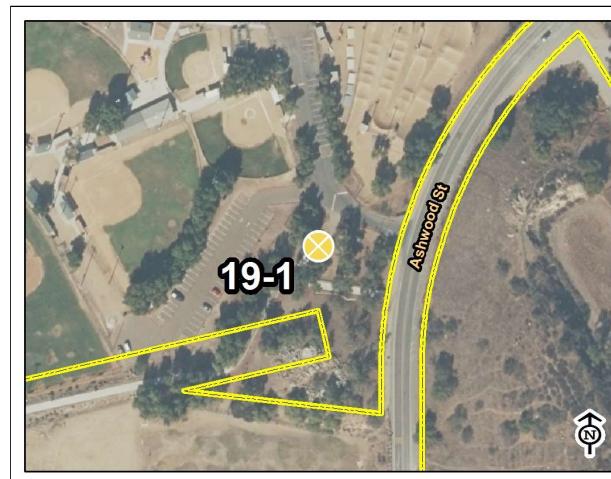
Cactus Park

19-1 Multi-User Restroom**Category: 1****Issue: No accessible route to restroom. Walkway to restroom is damaged.****Action: Provide 48" wide minimum accessible path of travel to restroom from ADA parking lot. Regrade area and replace pavement.**

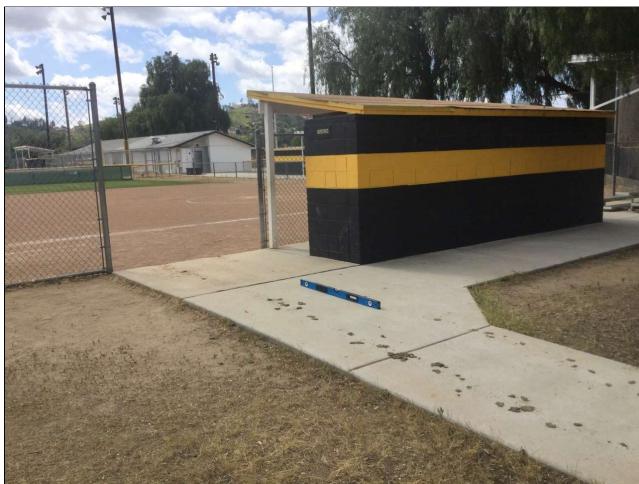
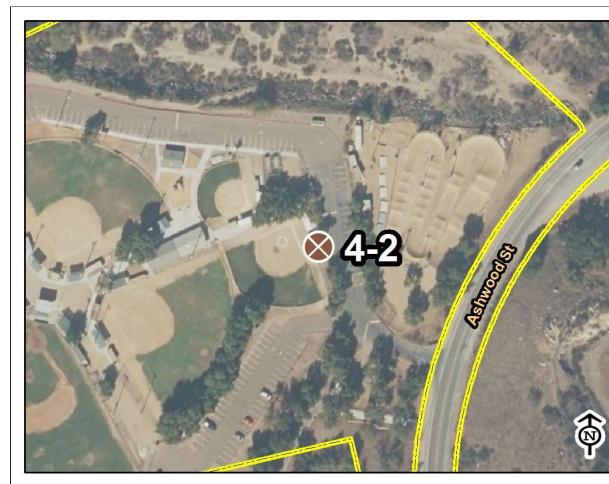
Cactus Park

4-2 Walk**Category: 2****Issue: Surface slope of turning space is 2.4%.****Action: Provide level surface at point of turning. Regrade and replace concrete.**

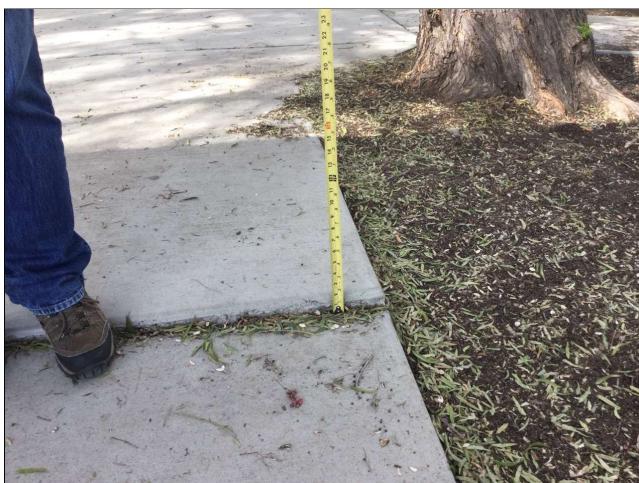
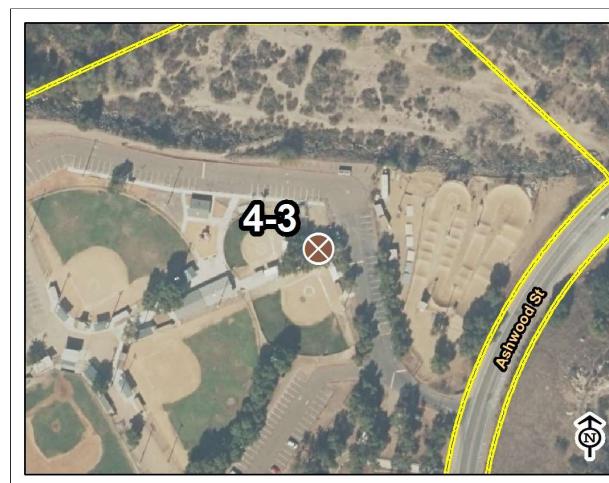
Cactus Park

4-3 Walk**Category: 2****Issue: Vertical changes in walkway exceed 1/2".****Action: Grind or patch vertical change of grade, or replace concrete panels.**

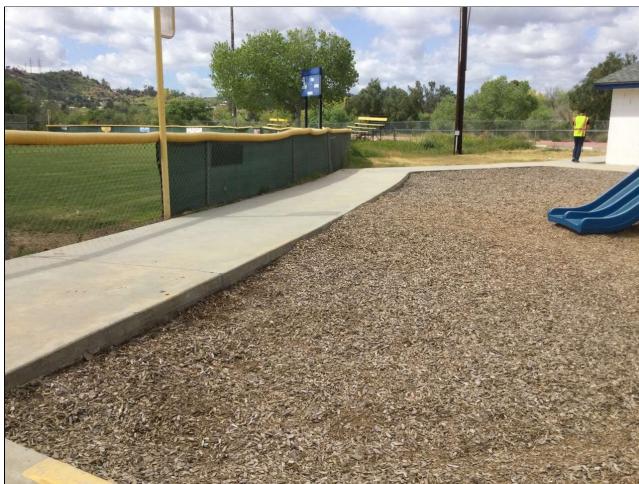
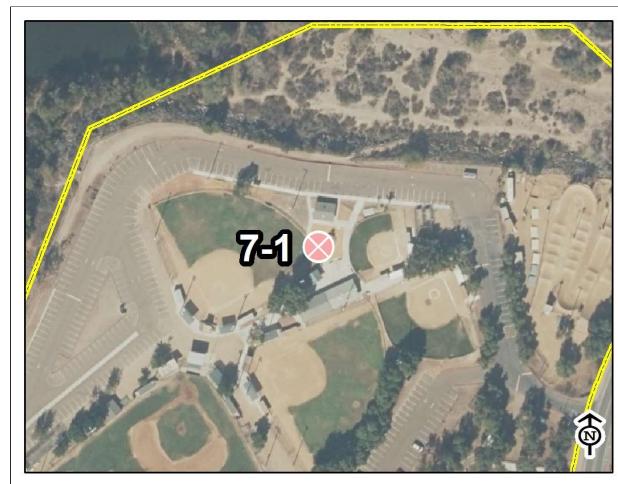
Cactus Park

7-1 Hazard**Category: 2****Issue: Abrupt 4" or more of vertical change.****Action: Regrade adjacent surface.**

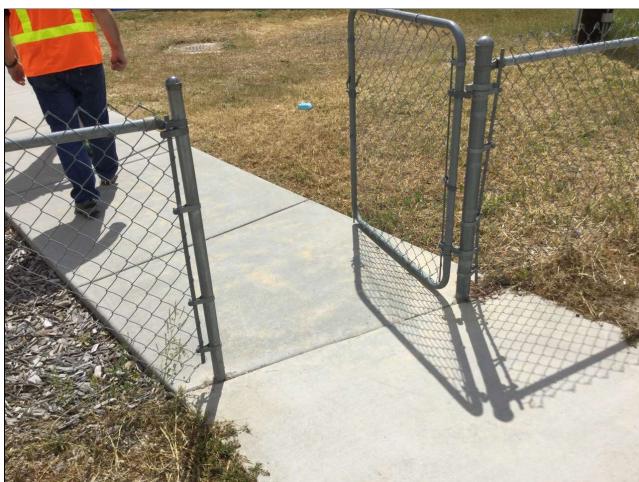
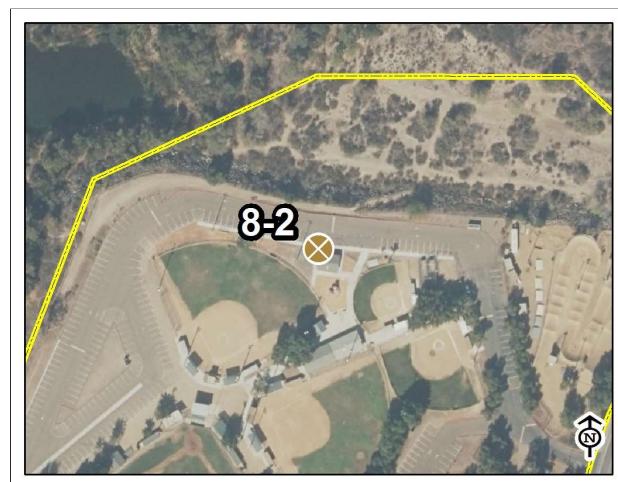
Cactus Park

8-2 Door/Gate**Category: 2****Issue: Gate hardware is not accessible/No ADA signage posted****Action: Replace or modify gate and provide ADA access sign.**

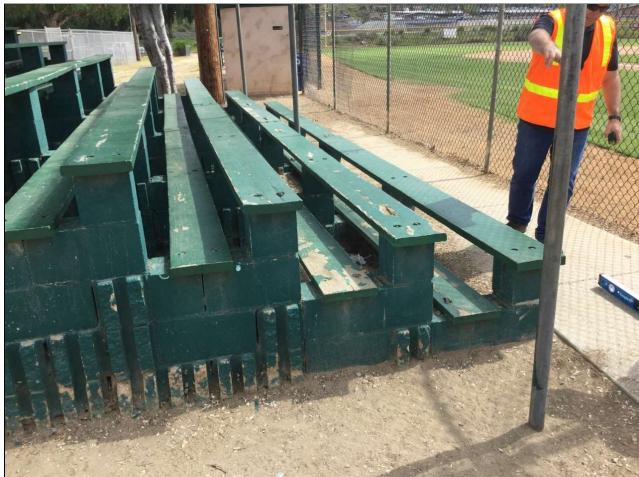
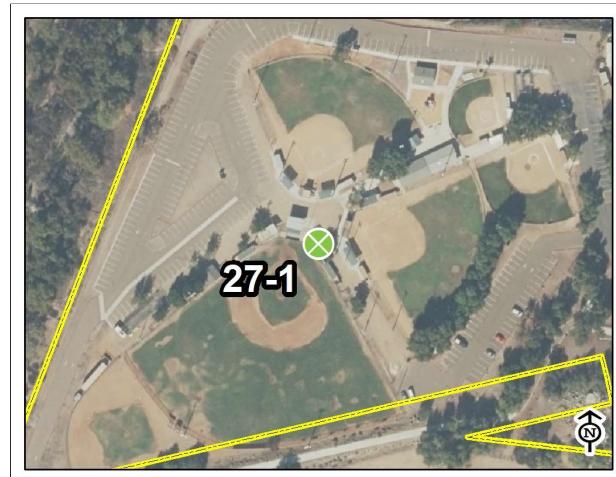
Cactus Park

27-1 Assembly Area**Category: 3****Issue:** No companion seating provided at bleachers. Recommend accessible notch on these bleachers similar to the other ones on site.**Action:** Provide companion seating area by bleachers.

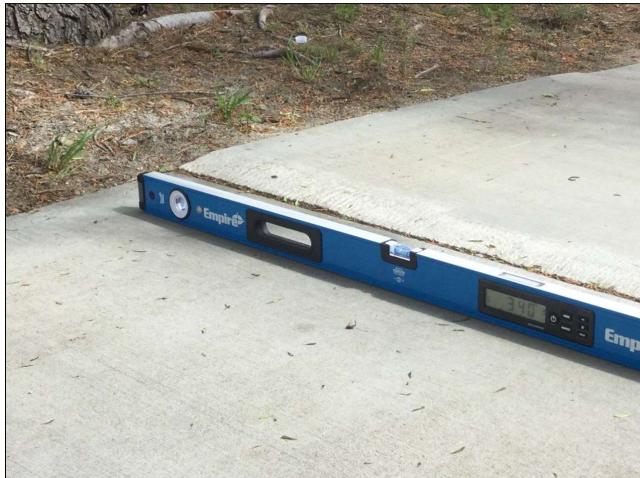
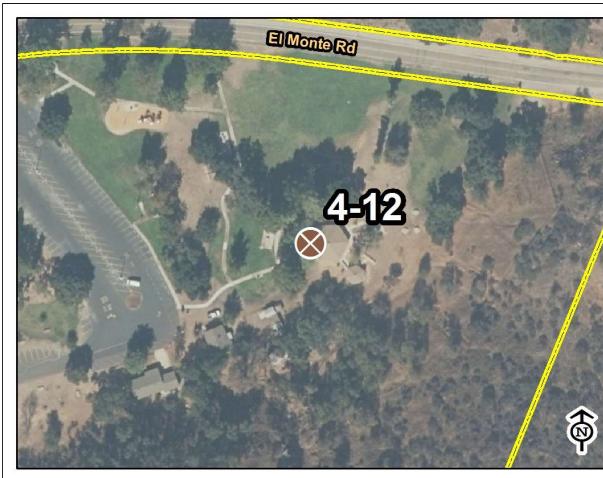
Map: 2 Grid: G4

4-12 Walk**Category: 1****Issue: Cross slope at 3.4%.****Action: Regrade walkway and replace concrete.**

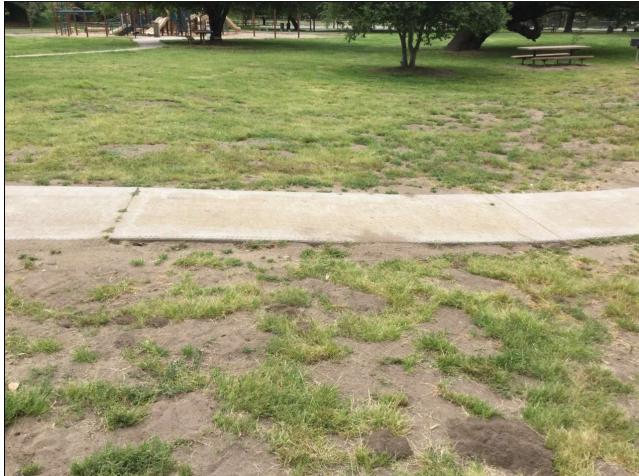
4-15 Walk**Category: 1****Issue: Walkway running slope is 7.5%.****Action: Regrade section of walkway and replace concrete. Install handrails and landings if needed.**

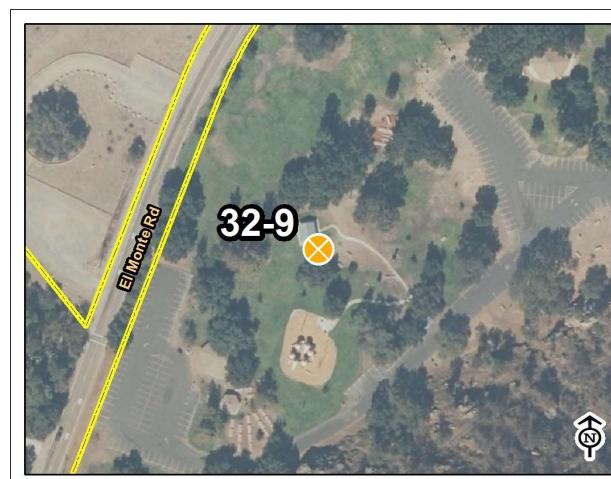
Map: 4 Grid: D1

Issue: No detectable warnings provided. Some stalls are missing signage.

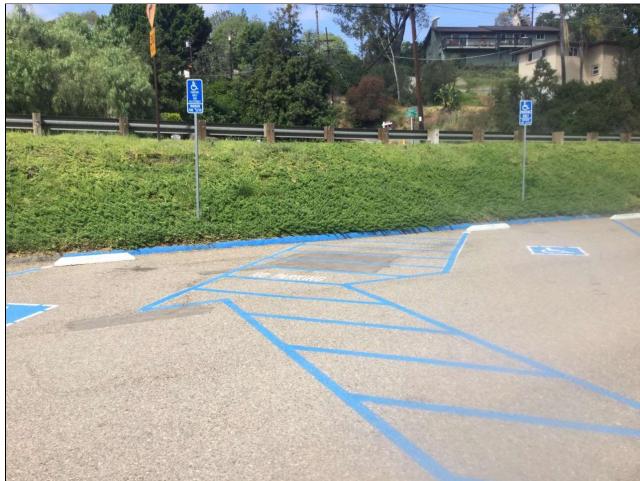
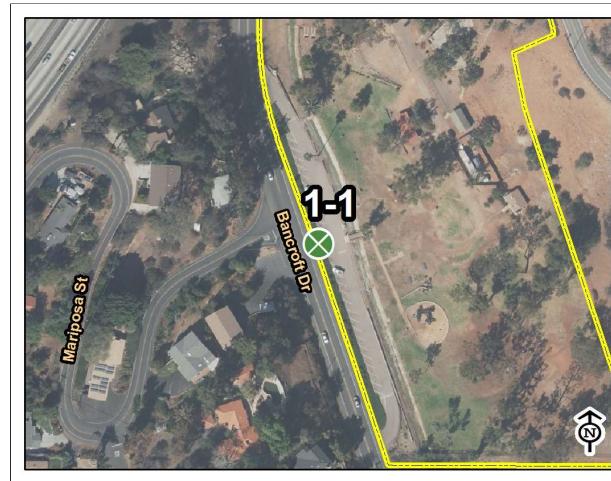
Map: 3 Grid: C1

1-1 Parking Area**Category: 1****Issue:** Surface slope is at 2.7%.**Action:** Regrade parking stall and replace AC pavement.

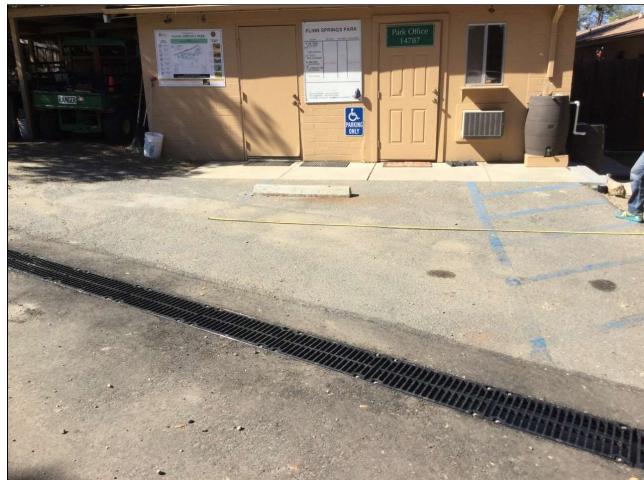
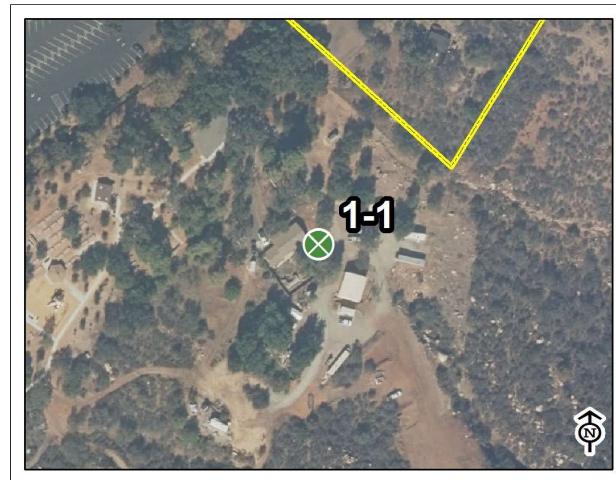
Map: 2 Grid: H5

Action: Provide level parking stall and access aisle across the street with a crosswalk. Replace drainage grate.

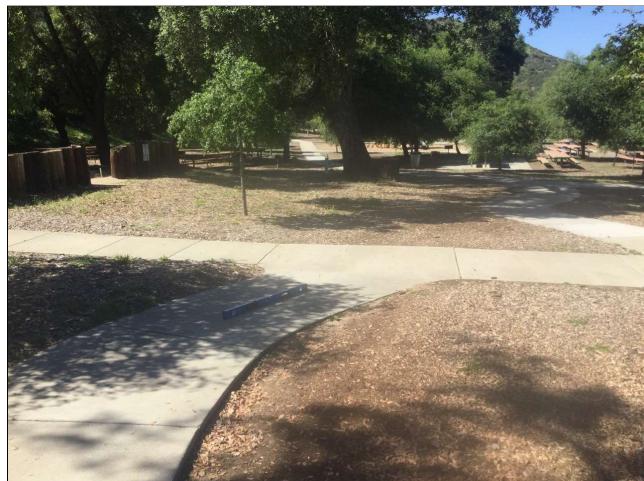
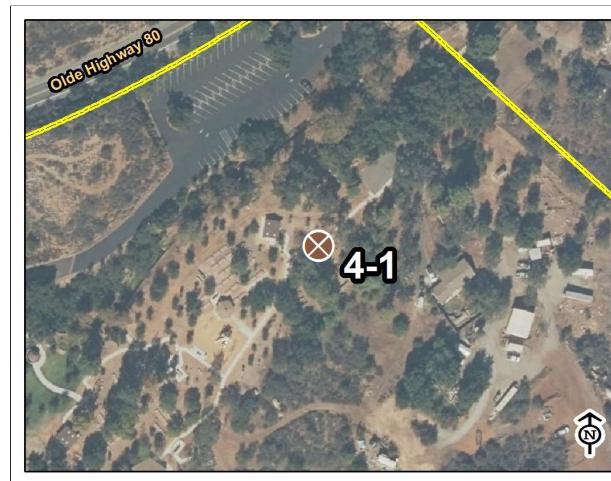
Map: 2 Grid: F5

Action: Provide level surface at point of turning. Regrade and replace concrete.

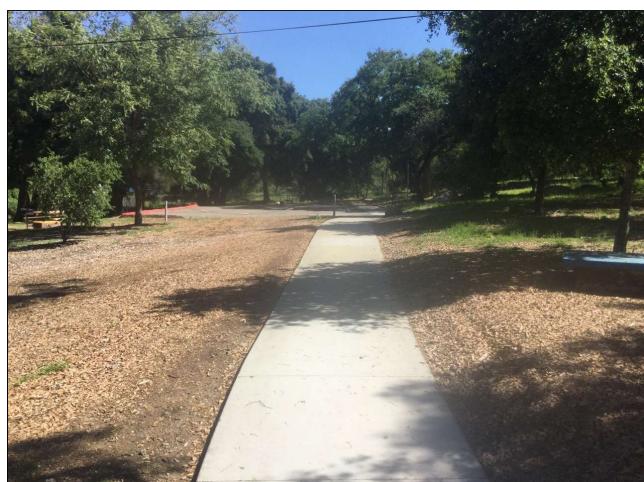
Map: 2 Grid: F4

4-3 Walk**Category: 1****Issue:** Surface slope of turning space is 3.8%.**Action:** Provide level surface at point of turning. Regrade and replace concrete.

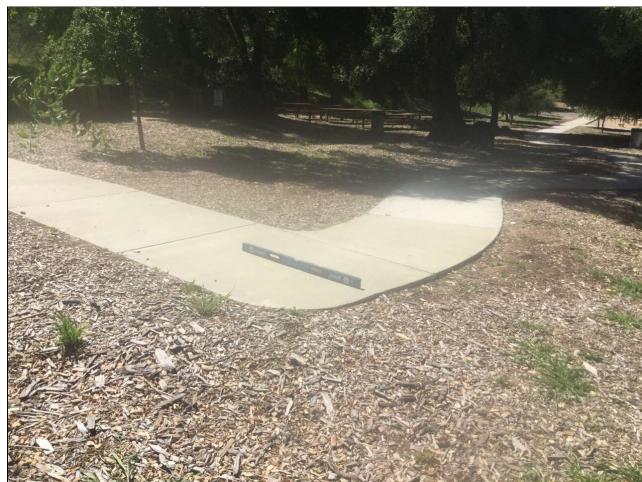
Map: 2 Grid: F4

4-6 Walk**Category: 1****Issue:** Cross slope at 3%.**Action:** Regrade walkway and replace concrete.

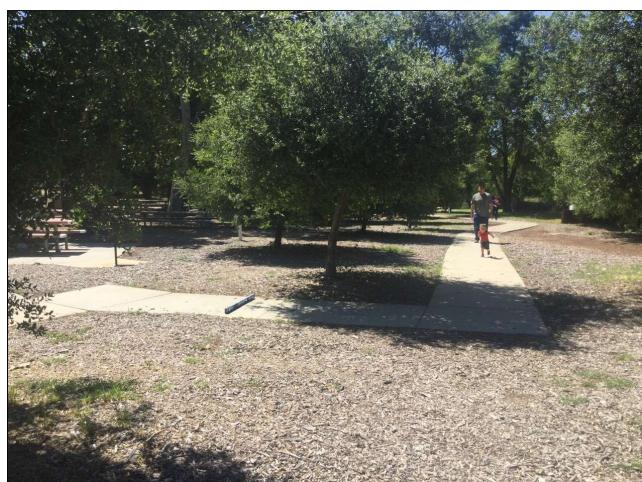
Map: 4 Grid: D1

4-7 Walk**Category: 1****Issue: Surface slope of turning space is 3%.****Action: Provide level surface at point of turning. Regrade and replace concrete.**

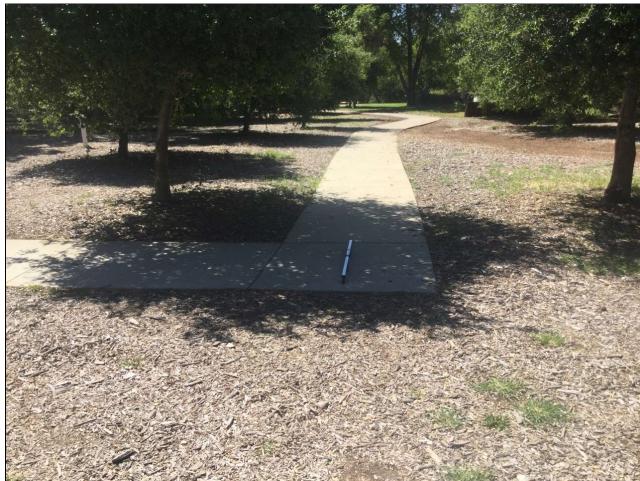
Map: 4 Grid: D1

4-10 Walk**Category: 1****Issue: Surface slope of turning space is 3%.****Action: Provide level surface at point of turning. Regrade and replace concrete.**

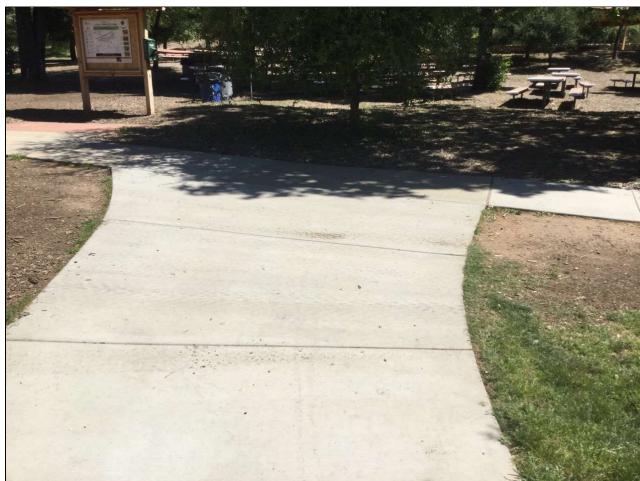
Map: 4 Grid: B2

5-3 Ramp**Category: 1****Issue: Walkway running slope is 6% to playground.****Action: Regrade and replace concrete or make into ramp.**

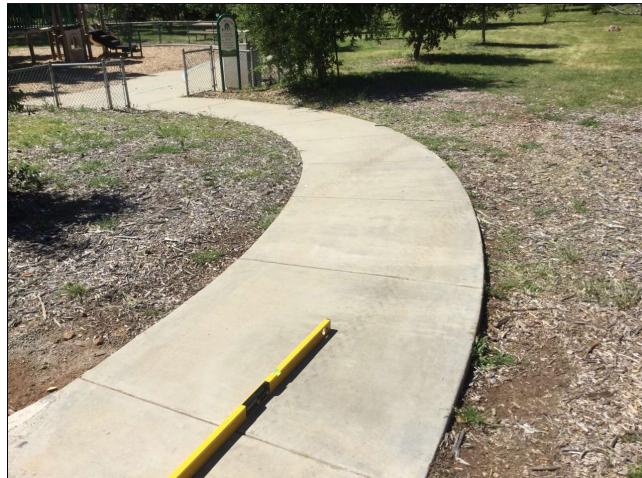
Map: 3 Grid: A3

19-1 Multi-User Restroom**Category: 1****Issue: Cross slope at 3%.****Action: Regrade walkway and replace concrete.**

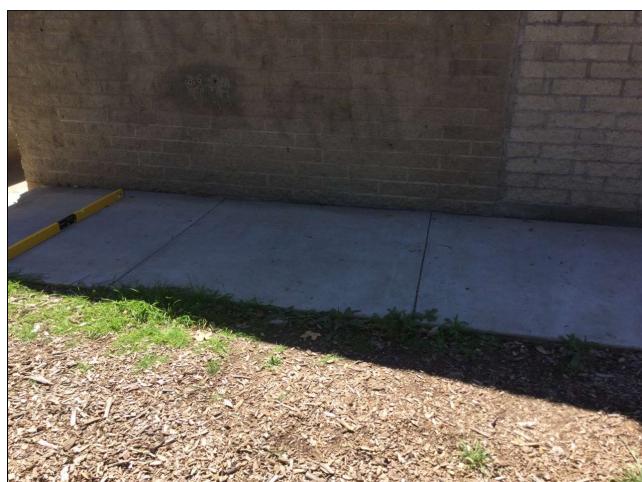
Map: 2 Grid: E4

19-2 Multi-User Restroom**Category: 1****Issue: Cross slope at 3%. 1" gap in concrete.****Action: Regrade walkway and replace concrete in a way to still have access to valve.**CBC: 11B-302.3 - Openings in floor or ground surfaces shall not allow passage of a sphere more than $\frac{1}{2}$ inch.

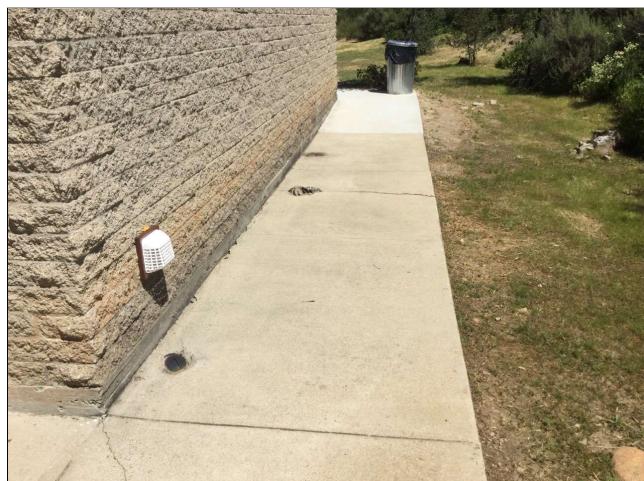
Map: 4 Grid: B4

19-3 Multi-User Restroom**Category: 1****Issue: Vertical changes in walkway exceed 1/2". Cross slope at 4%.****Action: Regrade walkway around restroom and replace concrete.**CBC: 11B-303.2 - Vertical changes must be $\frac{1}{4}$ " max, up to $\frac{1}{2}$ " with a bevel.

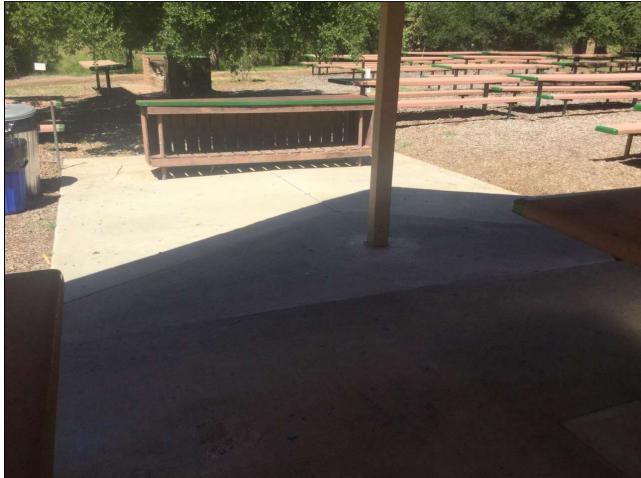
Map: 4 Grid: D1

4-4 Walk**Category: 2****Issue: Cross slope at 2.4%.****Action: Regrade walkway and replace concrete.**

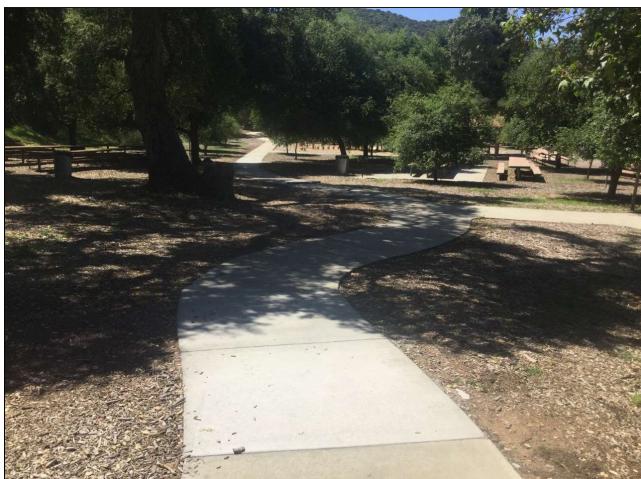
Map: 2 Grid: E5

4-5 Walk**Category: 2****Issue:** 1" gap in concrete.**Action:** Replace concrete panels or add sealant to fill gaps.CBC: 11B-302.3 - Openings in floor or ground surfaces shall not allow passage of a sphere more than $\frac{1}{2}$ inch.

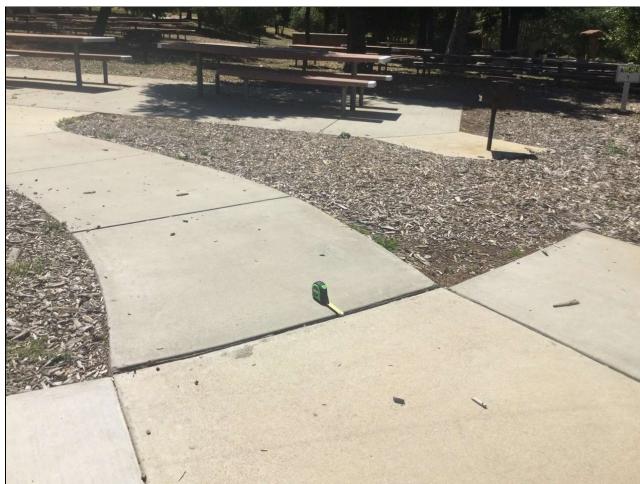
Map: 4 Grid: D1

4-8 Walk**Category: 2****Issue:** Surface slope of turning space is 2.75%.**Action:** Provide level surface at point of turning. Regrade and replace concrete.

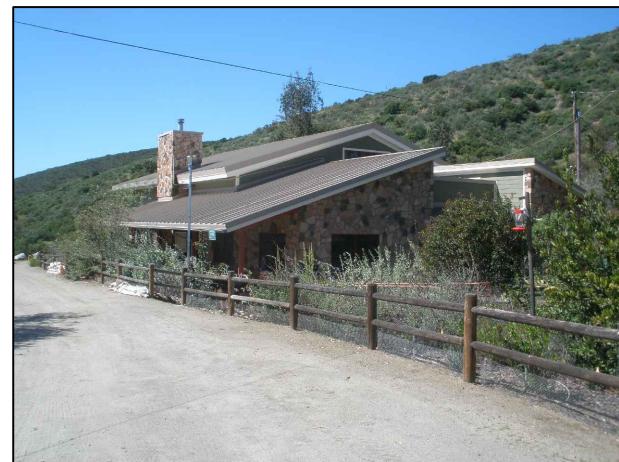
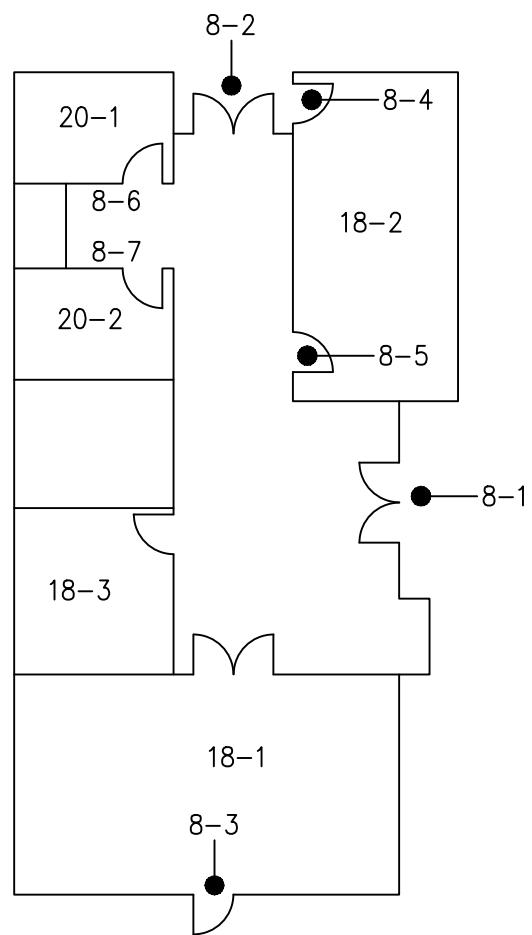
VISITOR CENTER

ISA Signage is missing from Entry
CBC: 11B-216.6 / ADA 216

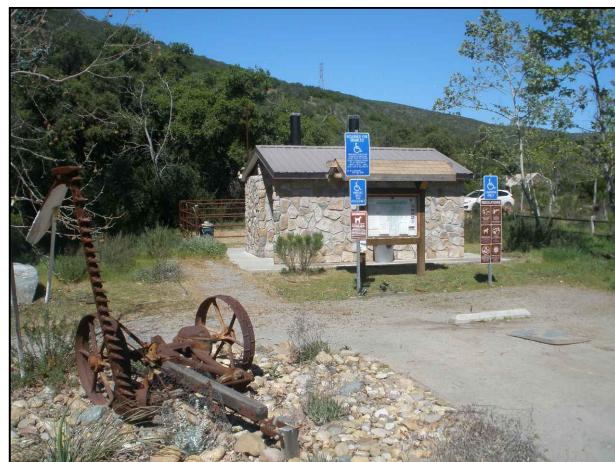
RESTROOM #1

ISA Signage is missing from Entry
CBC: 11B-216.6 / ADA 216

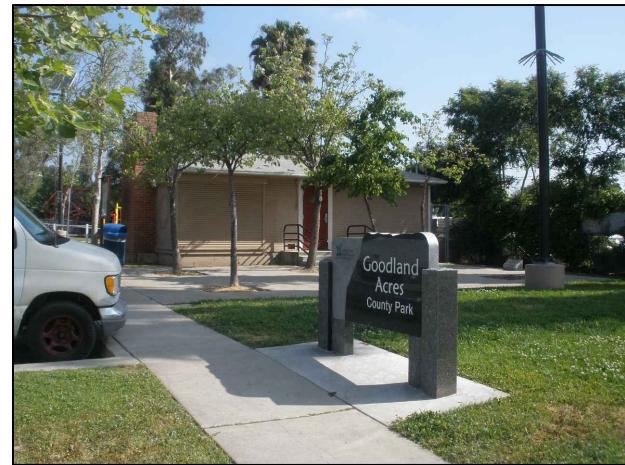
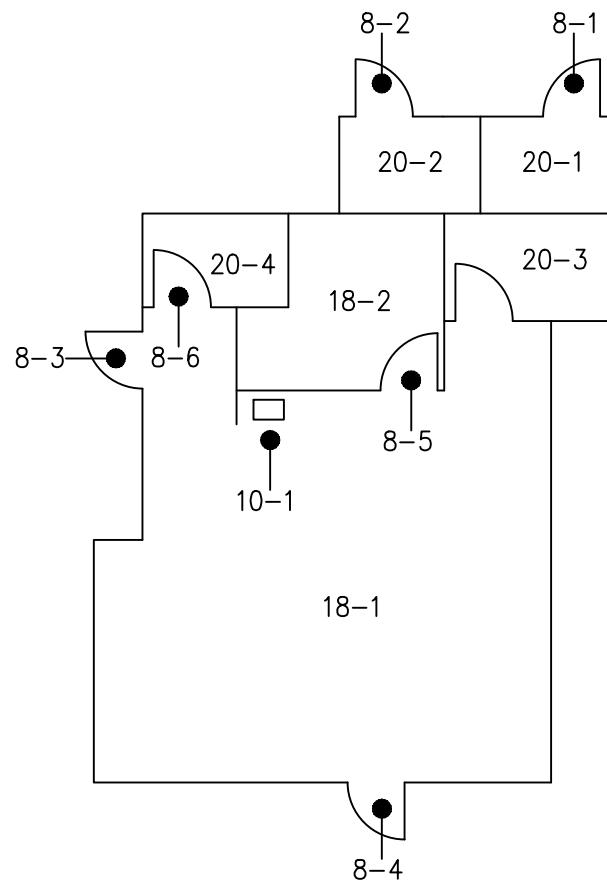
COMMUNITY CENTER

Replace Lav faucet handle with lever type.
CBC 11B-309.4 / ADA 309

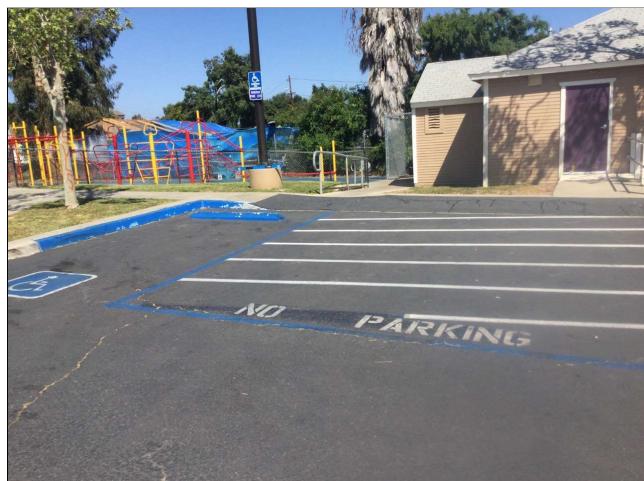
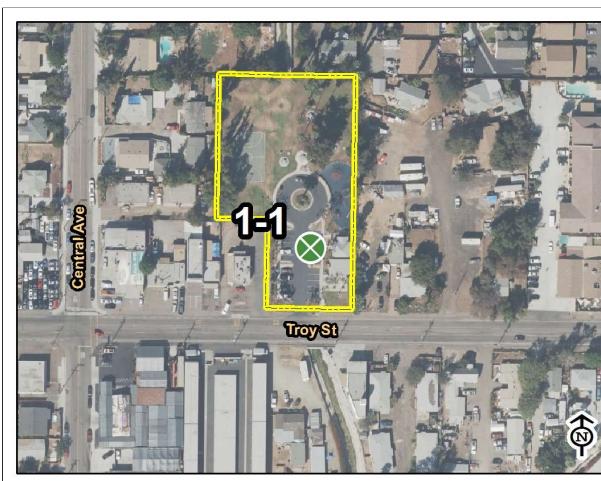
Map: 2 Grid: E4

1-1 Parking Area**Category: 1****Issue: Surface slope is at 4%. No van parking sign.****Action: Regrade parking stall and replace AC pavement. Install "Van Parking" sign to existing pole.**

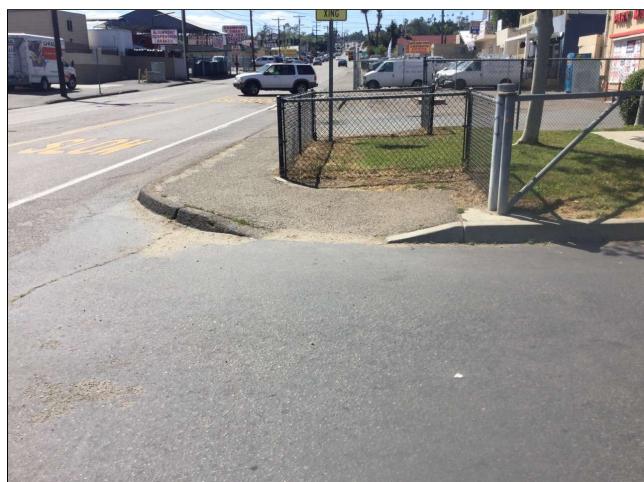
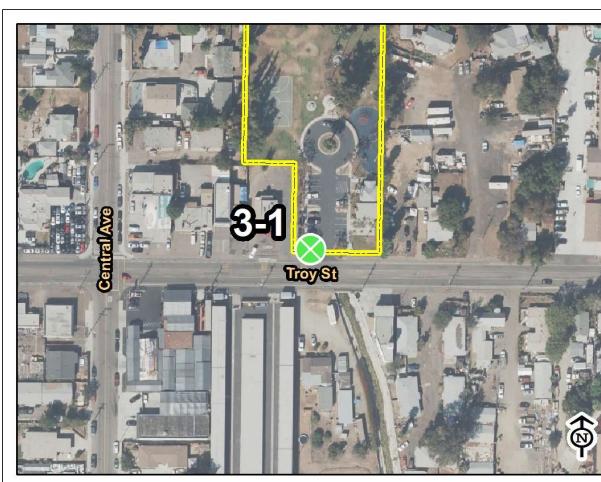
Map: 2 Grid: E5

3-1 Curb Ramps**Category: 1****Issue: Curb ramp flares at 15% and 18%. No detectable warnings provided. No leveled landing.****Action: Replace curb ramp.**

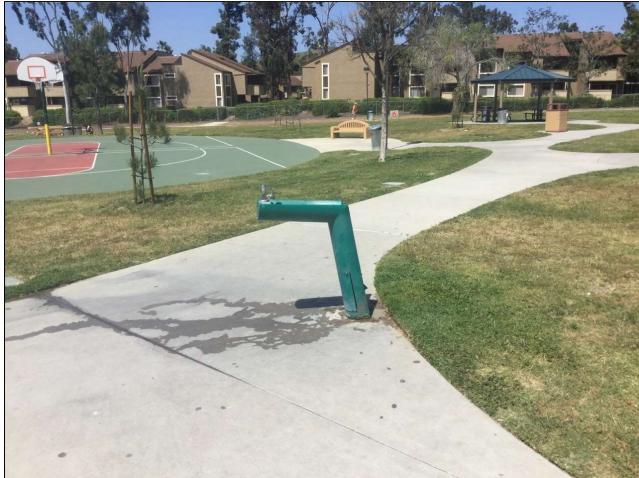
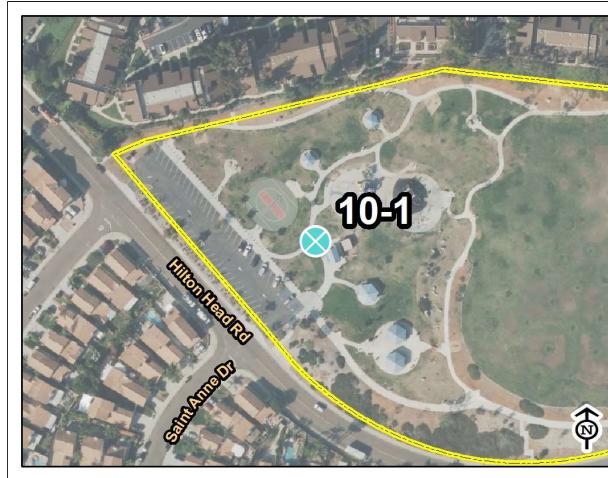
Map: 2 Grid: E3

10-2 Drinking Fountain**Category: 3****Issue: No High-Low fountain provided.****Action: Replace drinking fountain.**

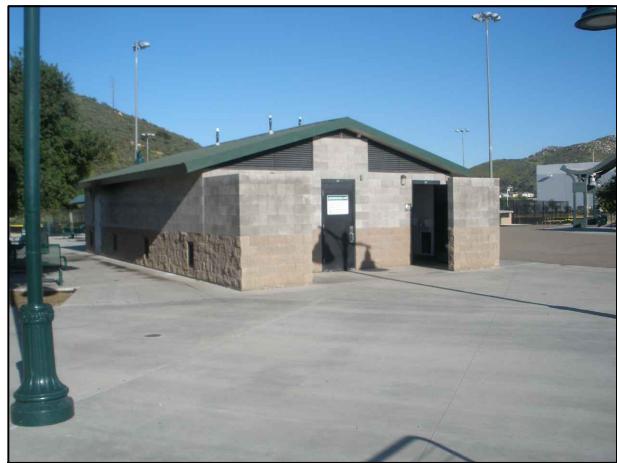
RESTROOM

100% COMPLIANT

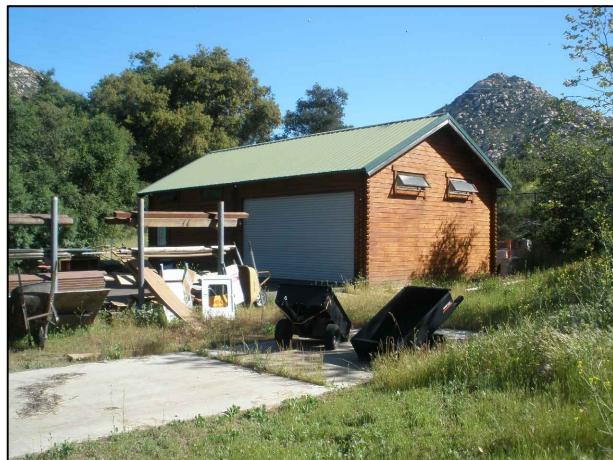
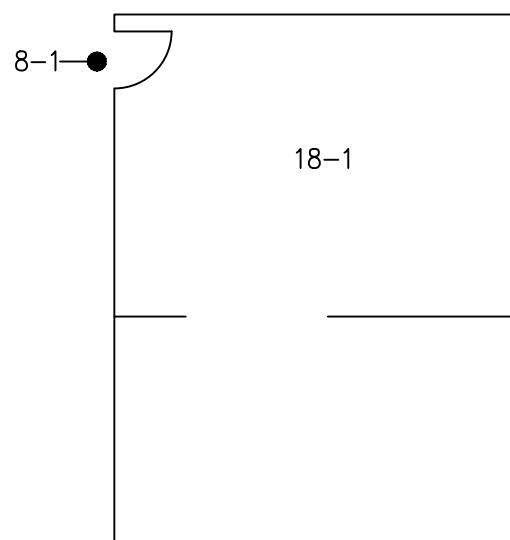
SHOP

The Workbench is 37" aff (34" aff max by recommended min. 60" long).
CBC: 11B-902 / ADA 902

Replace Door Hardware

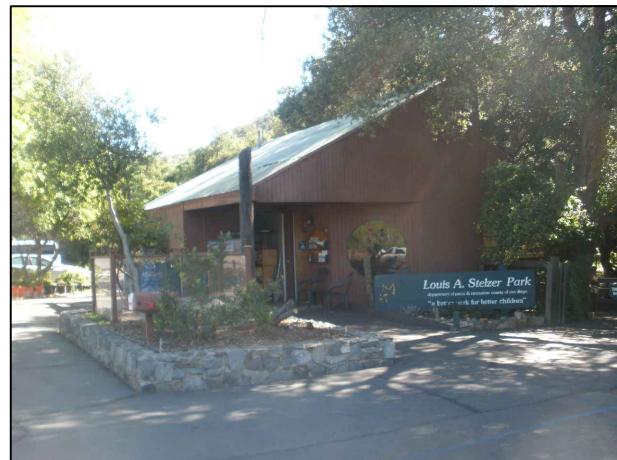
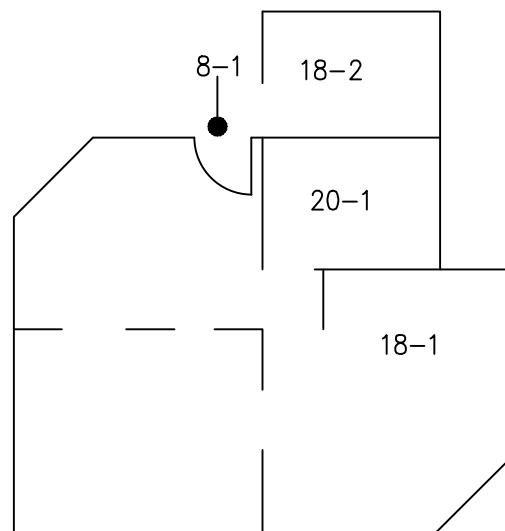
RANGER

Replace or reposition Plumbing fixtures
42" clear from WC side wall to adjacent fixture or wall (60" min)
CBC 11B-604.3.1 / ADA 604

Replace Door Hardware

Replace or reposition Plumbing fixtures

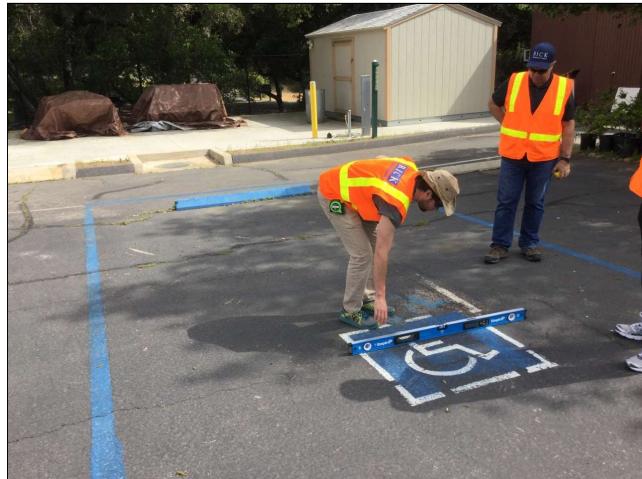
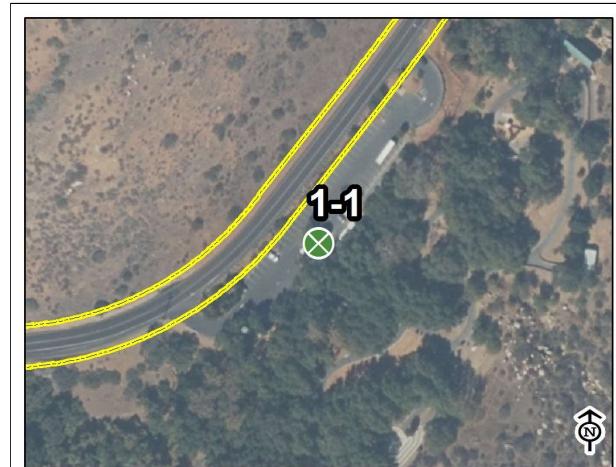
Map: 3 Grid: C1

Issue: Surface slope is at 4.3%. Paint for parking stall is faded. Missing ISA sign and loading zone. No detectable warning provided.

Action: Regrade parking stalls, replace AC pavement, and restripe. Loading zone needs to be included. Install ISA sign at stall missing sign. Install detectable warning tile.

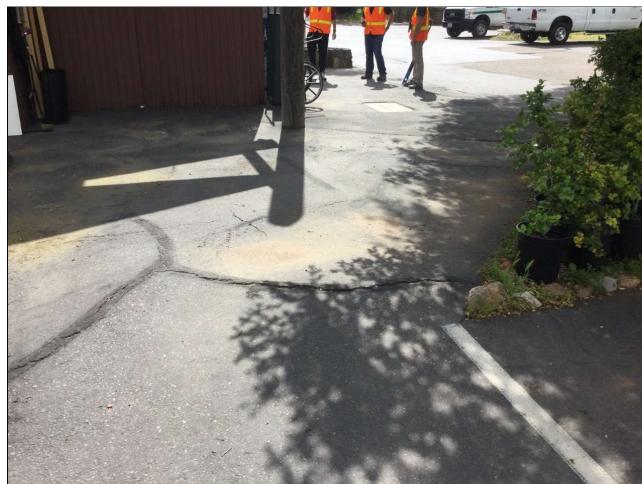
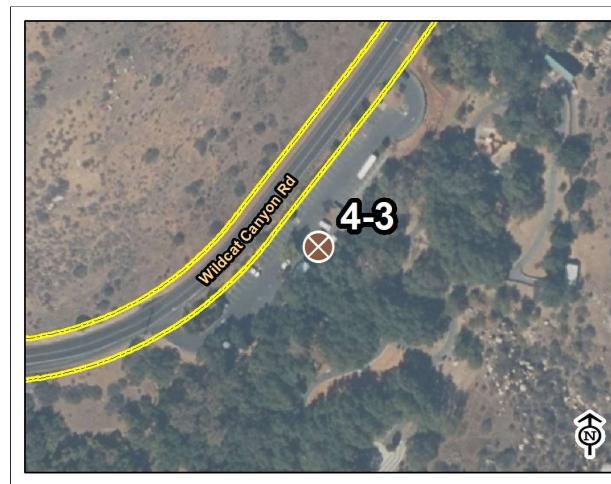
Map: 3 Grid: C1

4-3 Walk**Category: 1****Issue: Crack from tree root in the middle of walkway.****Action: Regrade and replace AC pavement from parking lot to ranger station.**

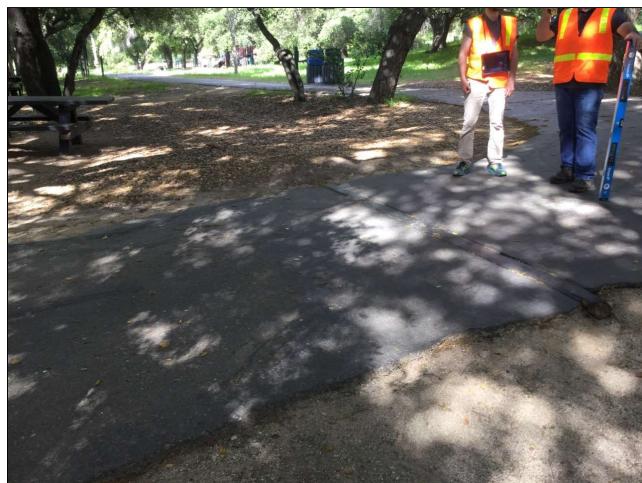
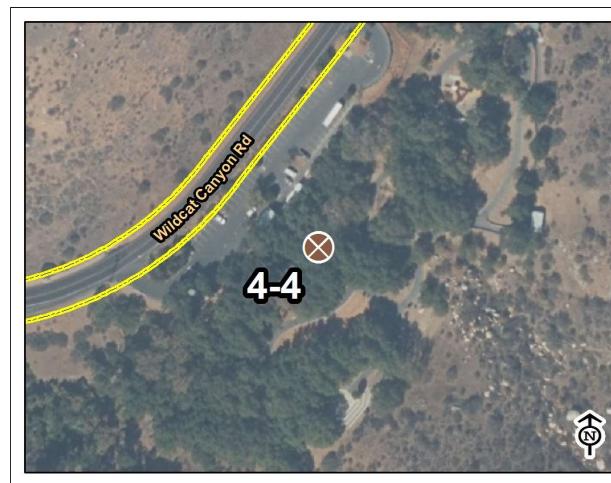
Map: 3 Grid: D2

4-4 Walk**Category: 1****Issue: Walkway running slope is 6.5%. Cross slope at 2.7%.****Action: Regrade walkway and replace AC pavement.**

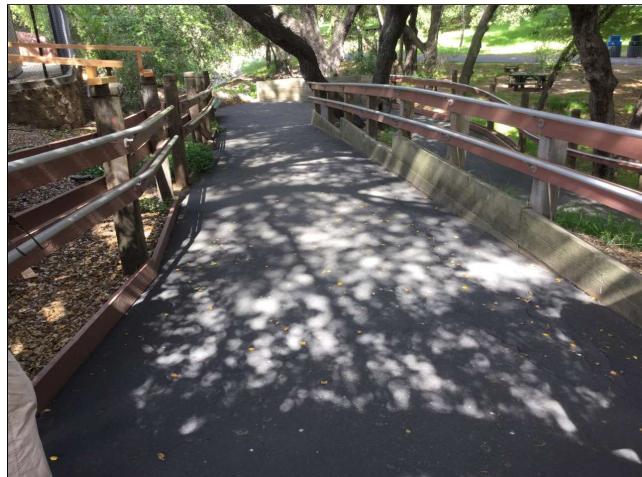
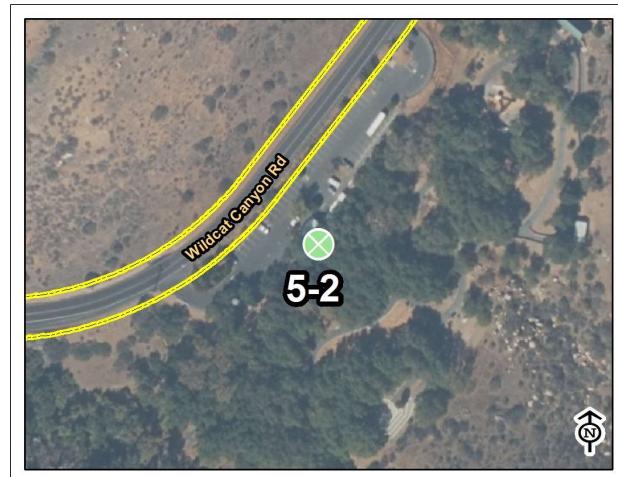
Map: 3 Grid: C1

5-2 Ramp**Category: 1****Issue:** No ramp landing. Cross slope at 3%.**Action:** Regrade ramp to have level landings and replace AC pavement. Replace handrails.

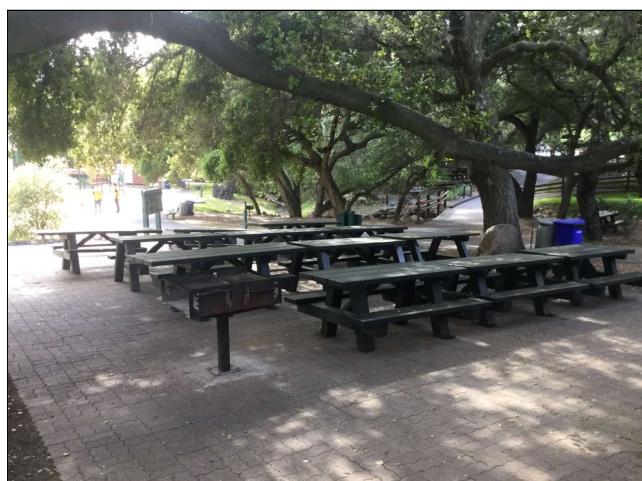
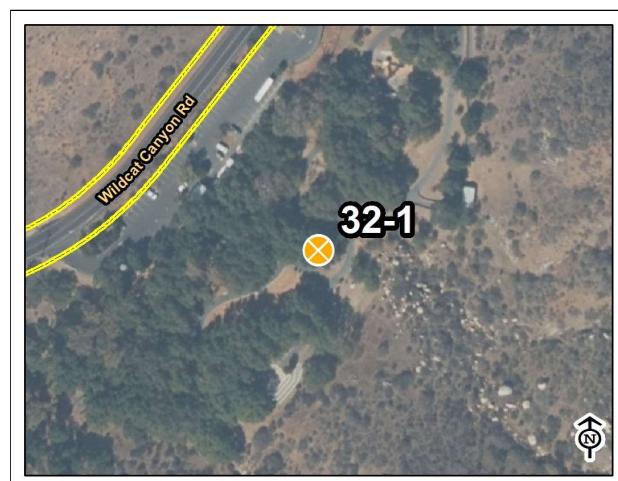
Map: 3 Grid: E2

32-1 Picnic Area**Category: 1****Issue:** Picnic area slopes 4%. No accessible tables in picnic area. *See footnote.**Action:** Regrade picnic area and replace pavers or concrete. Provide 2 ADA accessible tables in vicinity, locate tables 48" away from grills.
