SAN DIEGO COUNTRY PARKS
AMERICANS WITH DISABILITIES ACT
AUDIT & TRANSITION PLAN
PHASE 2

THE COUNTY OF SAN DIEGO ADA AUDIT AND TRANSITION PLAN PHASE 2

Rick Engineering Company
5620 Friars Road
San Diego, California 92110
(619) 291-0707

Roy Davies Architect
8348 Center Drive, Suite B
La Mesa CA 91942

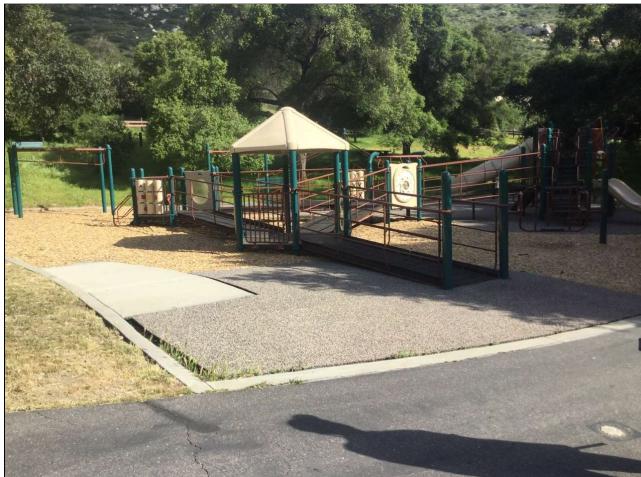
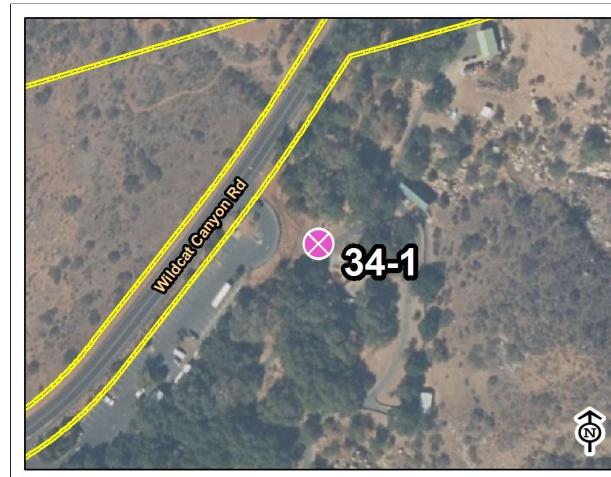
Map: 2 Grid: F4

34-1 Play Equipment Area**Category: 1****Issue: Cross slope at 4-10%. 6" gap in concrete.****Action: Regrade area and walkway, and replace AC pavement and rubberized surface.**

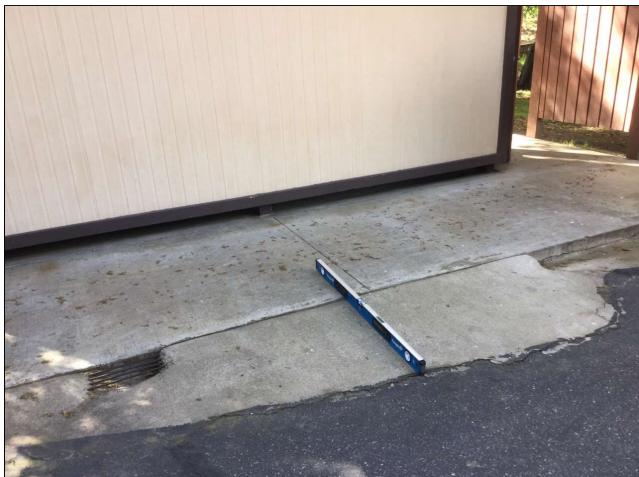
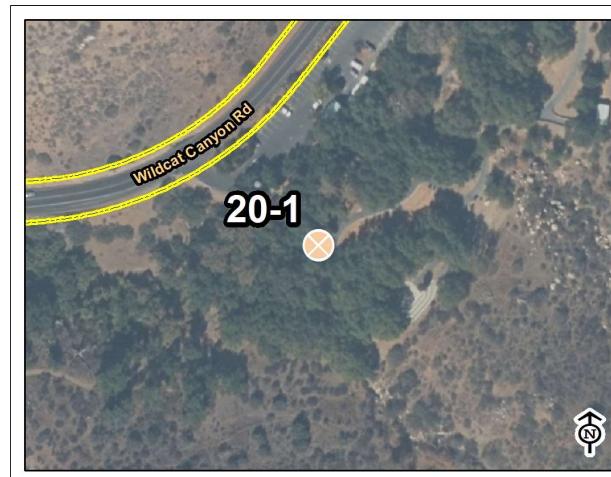
Map: 3 Grid: C3

20-1 Single-User Restroom**Category: 2****Issue: Walkway around restroom slopes 3%.****Action: Regrade and replace concrete leading to and encompassing restroom.**

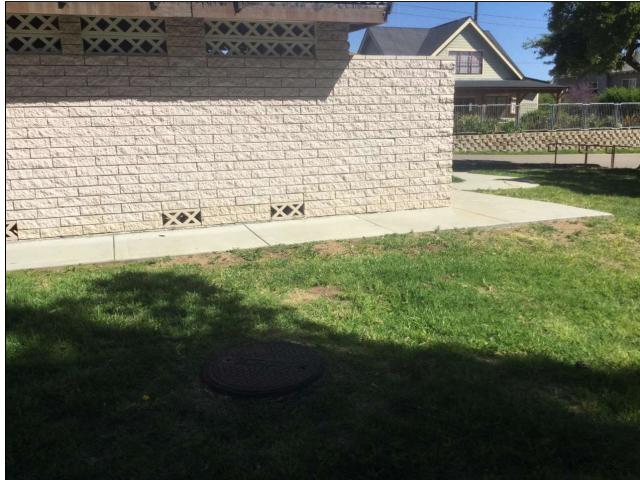
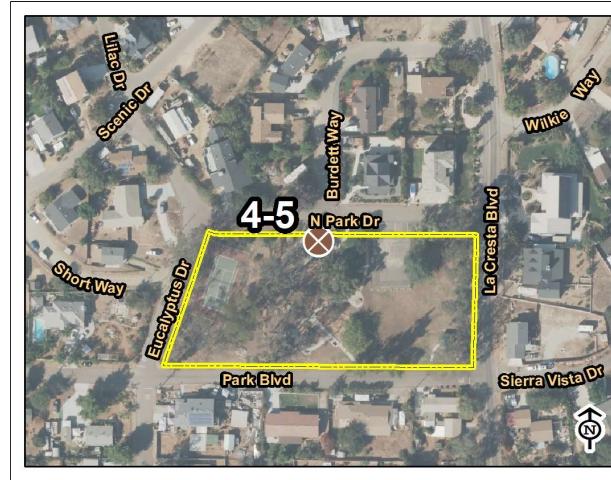
Map: 2 Grid: E2

4-5 Walk**Category: 1****Issue: Cross slope at 3%.****Action: Regrade walkway and replace concrete.**

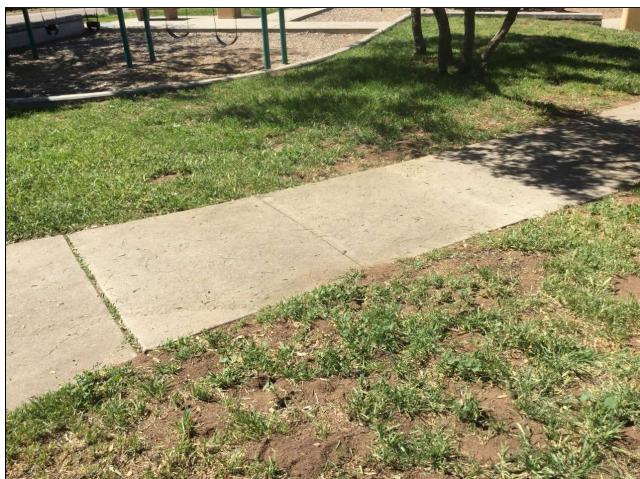
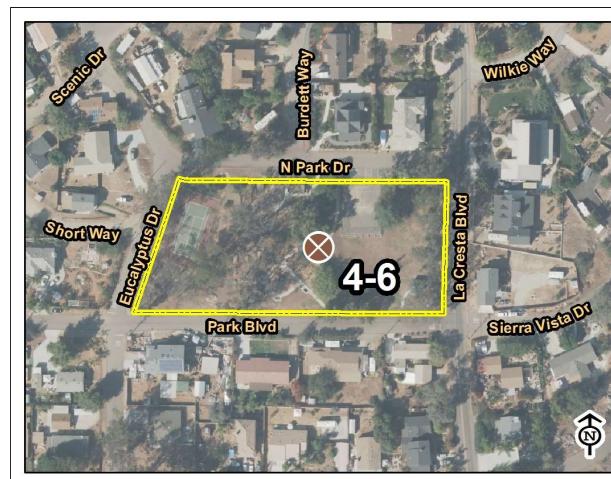
Map: 2 Grid: E3

4-6 Walk**Category: 1****Issue: Cross slope at 3%.****Action: Regrade walkway and replace concrete.**

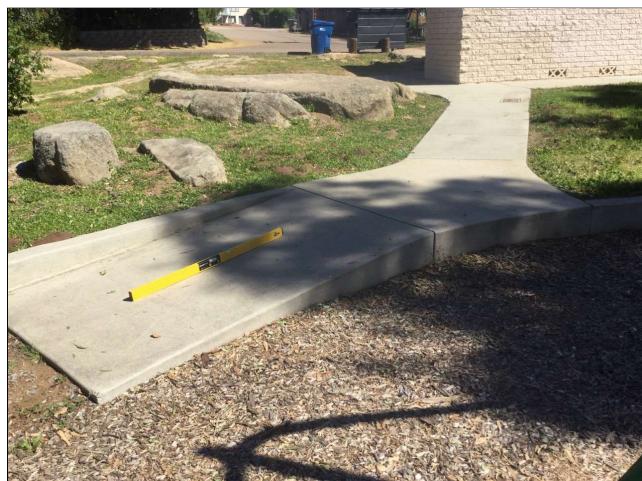
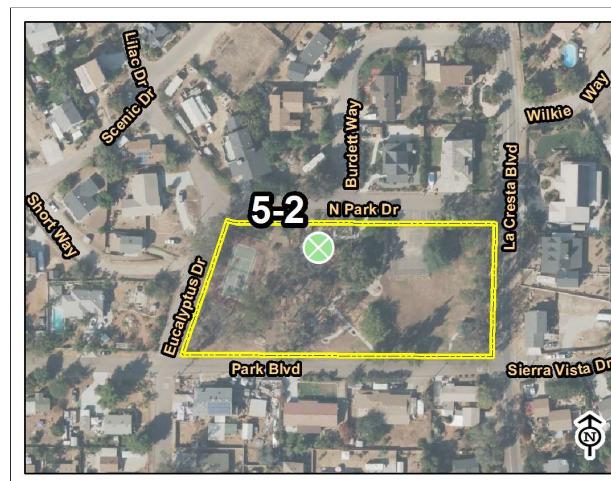
Map: 2 Grid: D3

Action: Rergrade or replace ramp.

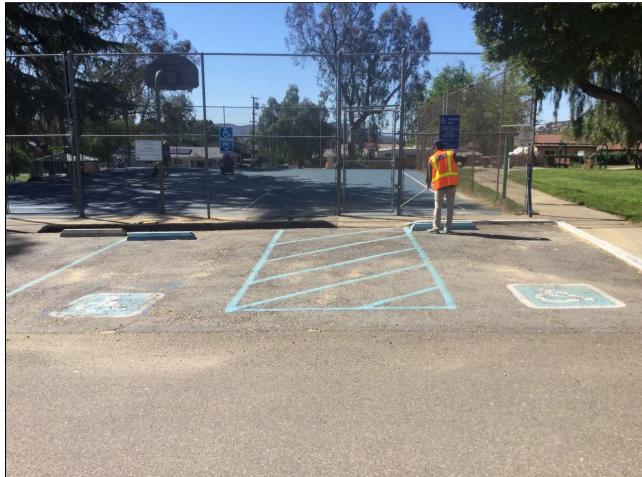
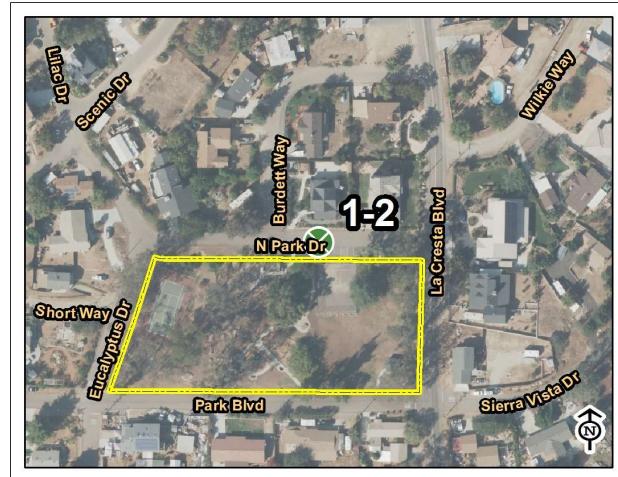
Map: 2 Grid: E2

Action: Grind or patch vertical change of grade, or replace concrete panels.

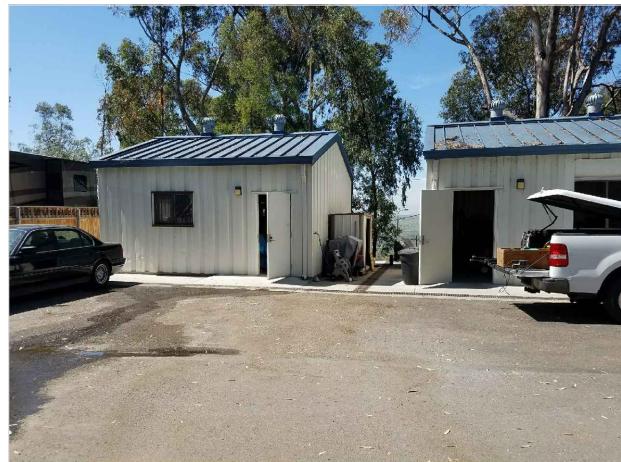
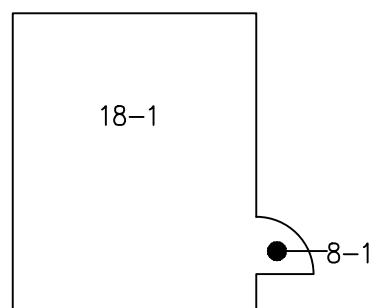
WORKSHOPS

The Workbench is 37" aff (34" aff max by recommended min. 60" long).
CBC: 11B-902 / ADA 902

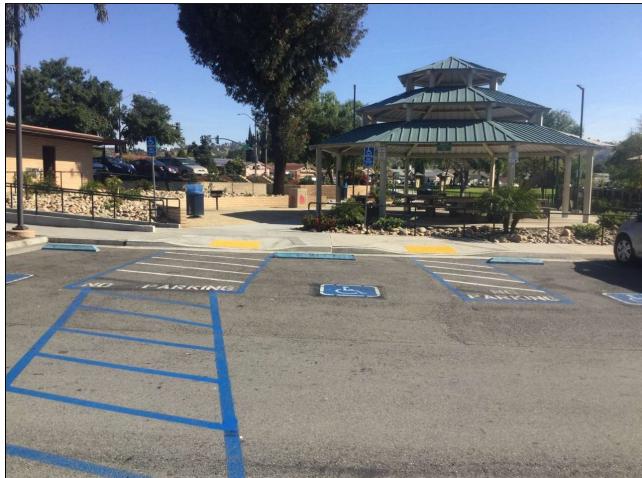
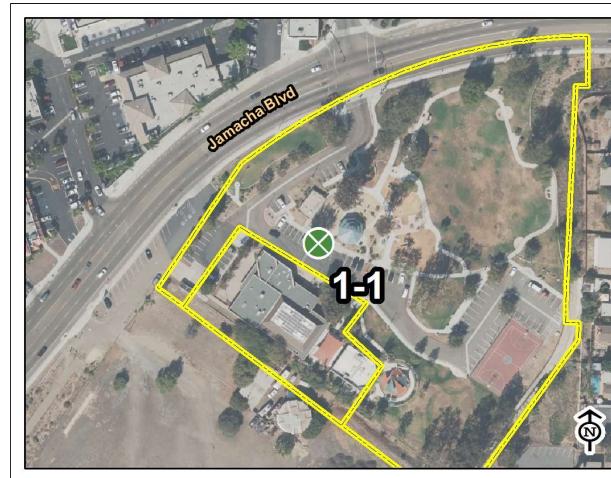
Map: 2 Grid: C3

1-1 Parking Area**Category: 1****Issue: Surface slope is at 3%. Missing ISA sign.****Action: Regrade parking stalls, replace AC pavement, and restripe. Install ISA sign at stall missing sign.**

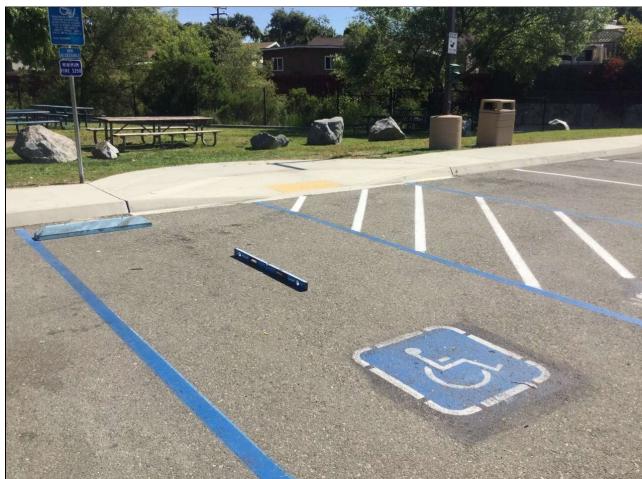
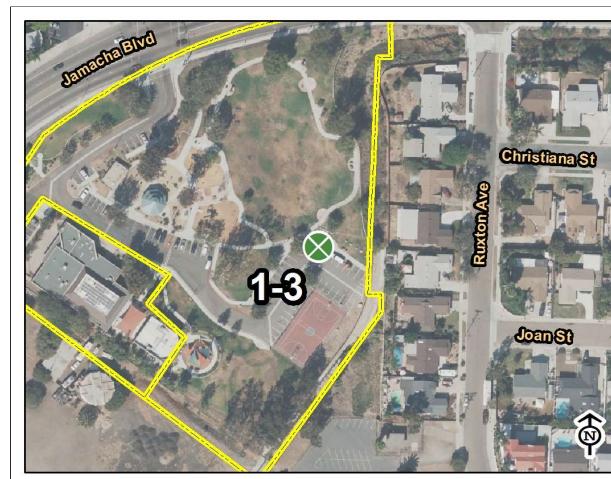
Map: 2 Grid: F4

1-3 Parking Area**Category: 1****Issue: Surface slope is at 3.5%****Action: Regrade parking stall and replace AC pavement.**

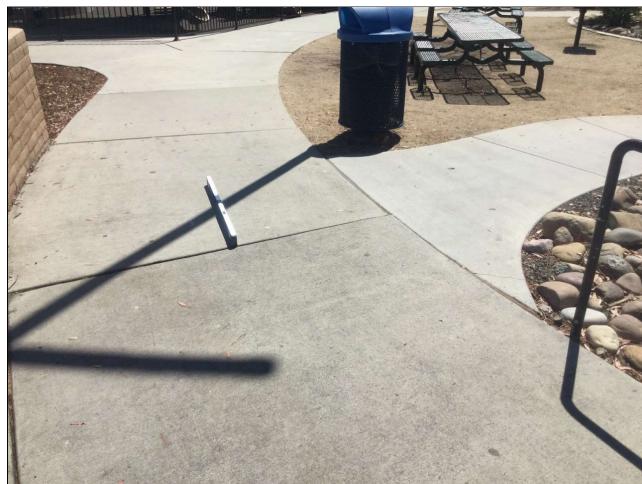
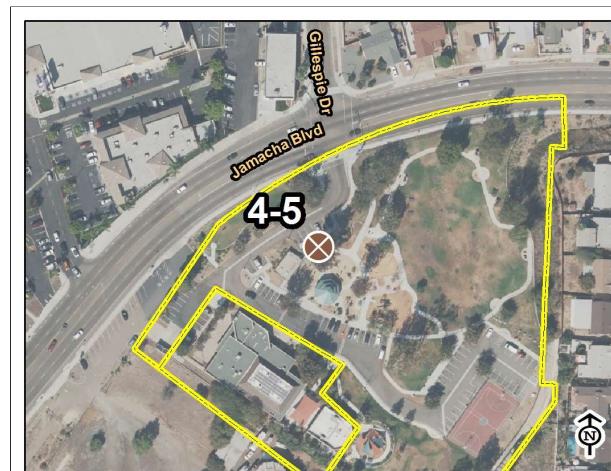
Map: 2 Grid: C2

4-5 Walk**Category: 1****Issue:** Surface slope of turning space is 6%.**Action:** Provide level surface at point of turning. Regrade and replace concrete.

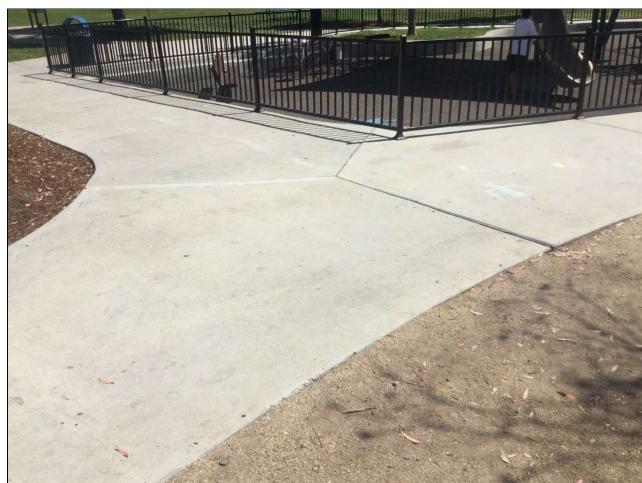
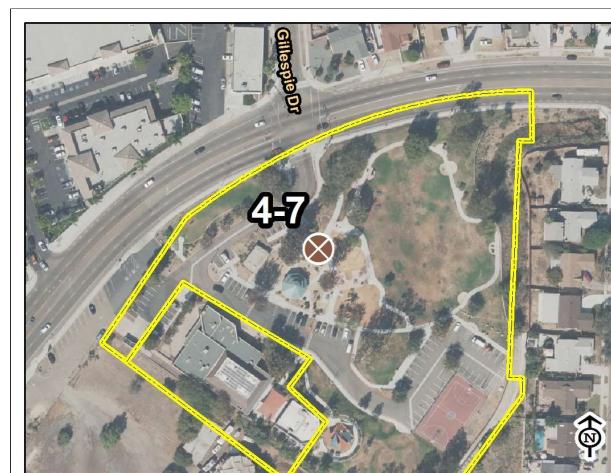
Map: 2 Grid: D2

4-7 Walk**Category: 1****Issue:** Surface slope of turning space is 4%.**Action:** Provide level surface at point of turning. Regrade and replace concrete.

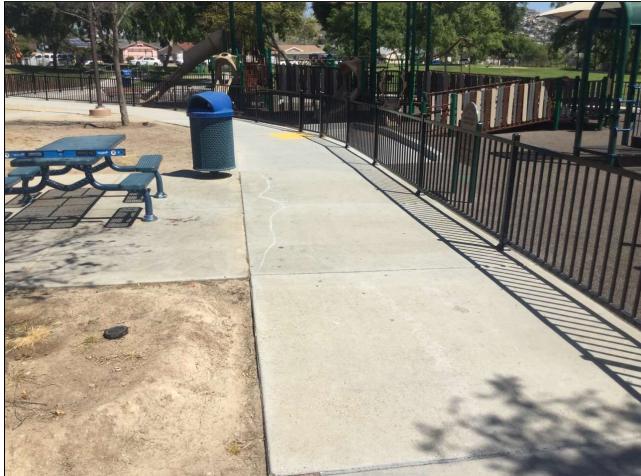
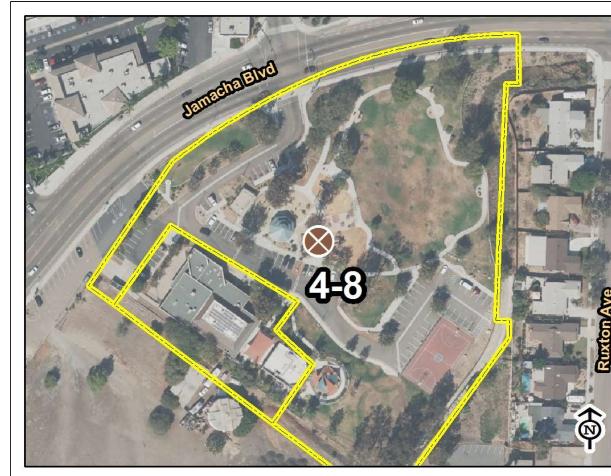
Map: 2 Grid: D3

4-8 Walk**Category: 1****Issue: Cross slope at 3%.****Action: Regrade walkway and replace concrete.**

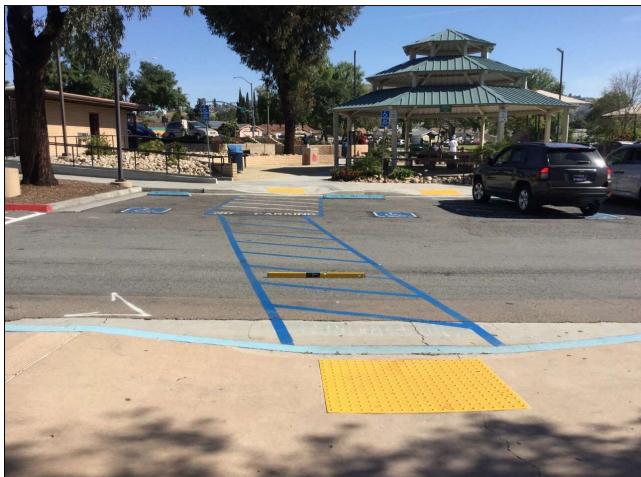
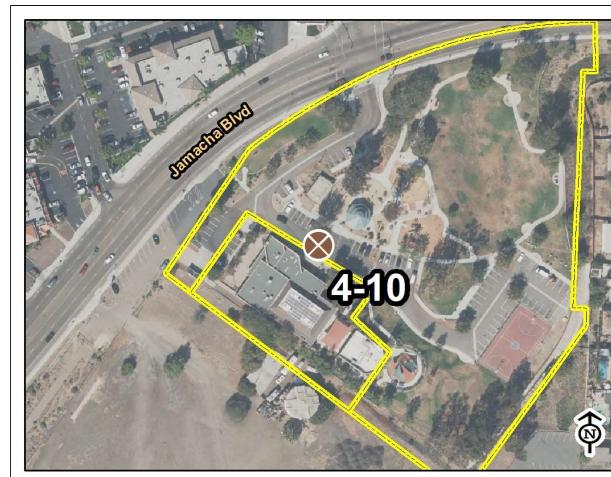
Map: 2 Grid: C3

4-10 Walk**Category: 1****Issue: Cross slope at 3%.****Action: Regrade crosswalk and replace AC pavement.**

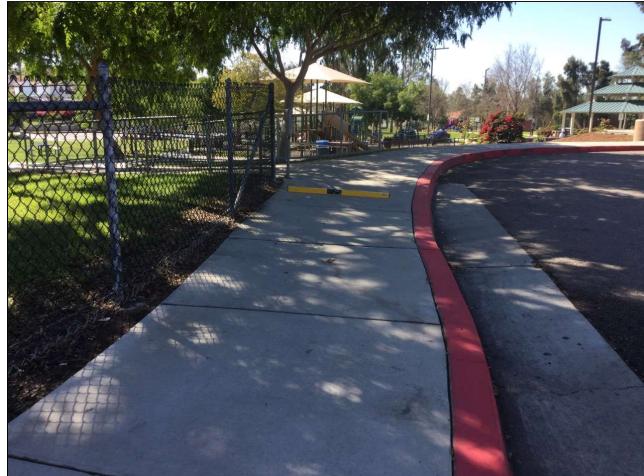
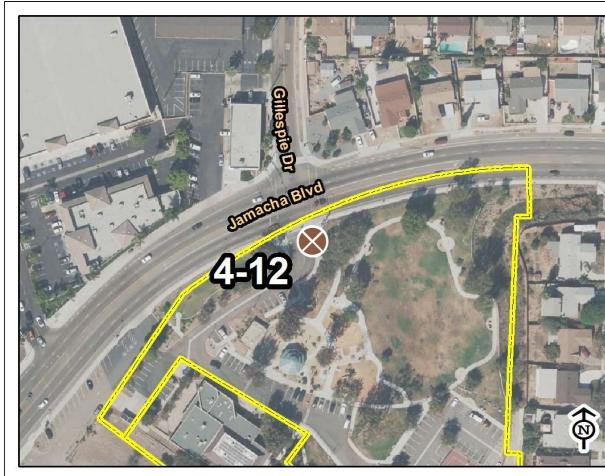
Map: 2 Grid: D1

4-12 Walk**Category: 1****Issue: Cross slope at 3.5%.****Action: Regrade sidewalk and replace concrete.**

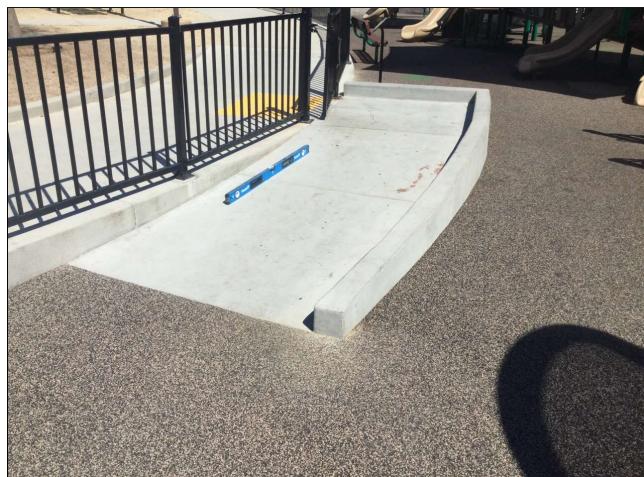
5-1 Ramp**Category: 1****Issue: Tot lot ramp at 7%.****Action: Regrade or replace ramp.**

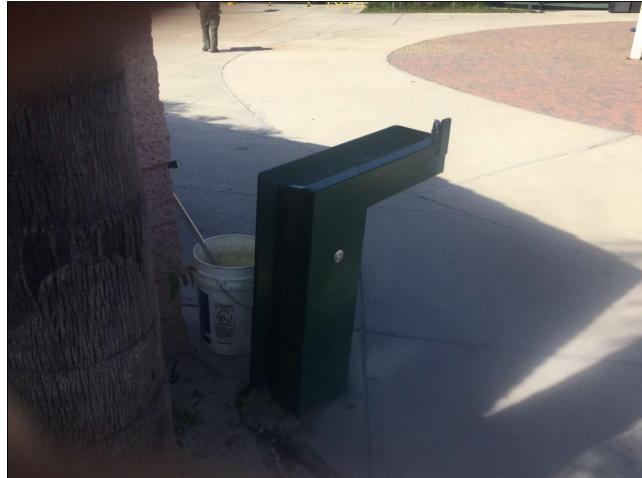
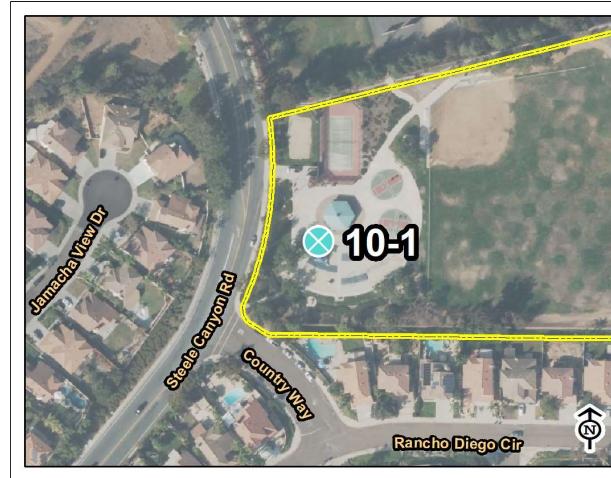
Map: 3 Grid: C3

10-2 Drinking Fountain**Category: 3****Issue: No High-Low fountain provided.****Action: Replace drinking fountain.**

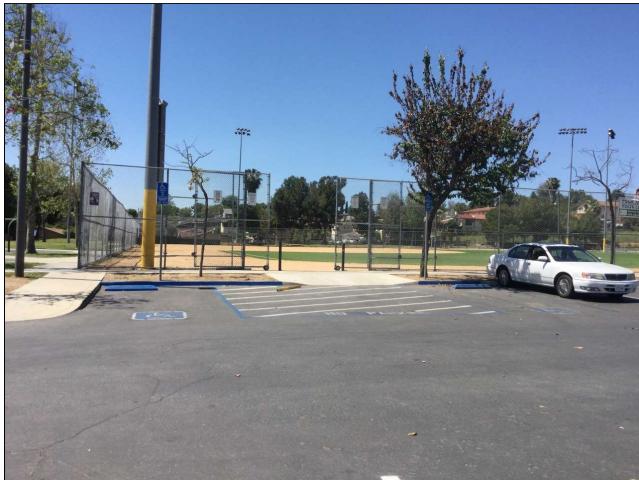
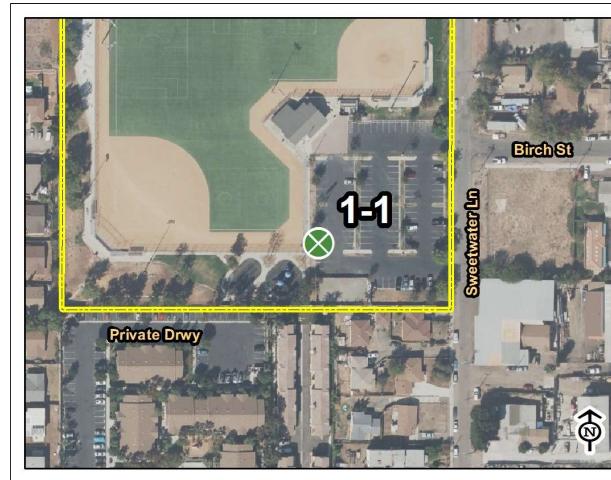
Map: 3 Grid: E4

1-1 Parking Area**Category: 1****Issue: Surface slope is at 3.5%****Action: Regrade parking stall and replace AC pavement.**

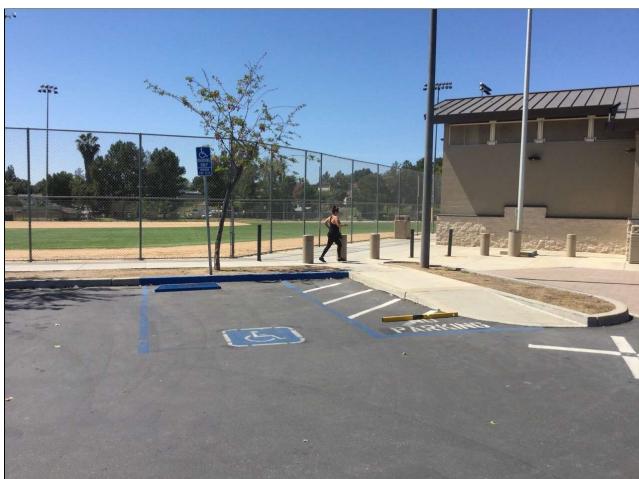
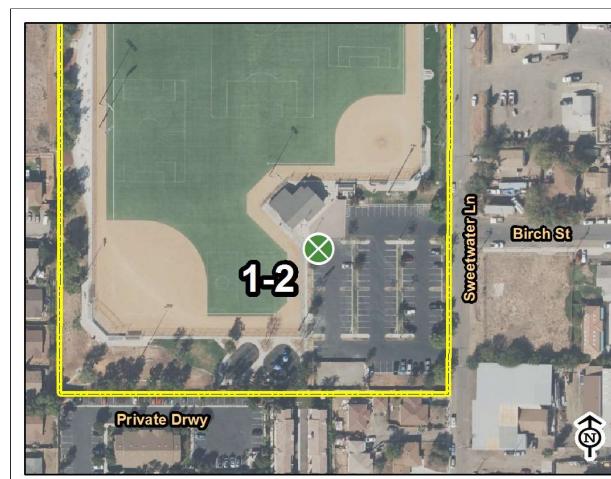
Map: 3 Grid: E3

1-2 Parking Area**Category: 1****Issue: Surface slope is at 3%****Action: Regrade parking stall and replace AC pavement.**

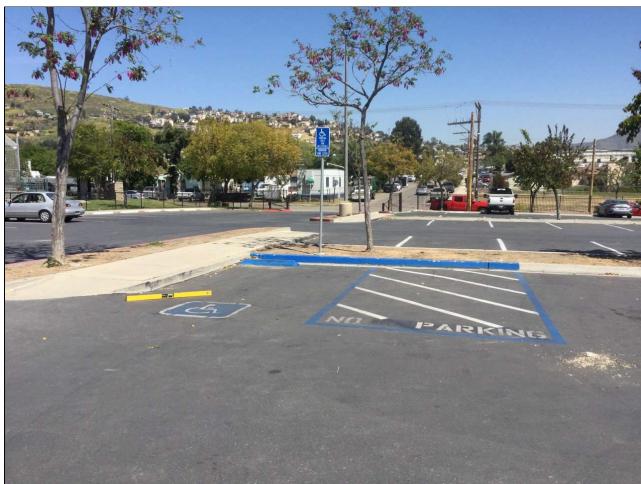
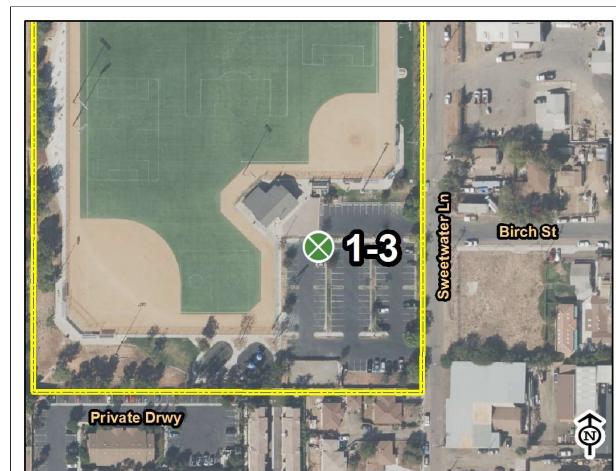
Map: 3 Grid: F3

1-3 Parking Area**Category: 1****Issue:** Surface slope is at 6%**Action:** Regrade parking stall and replace AC pavement.

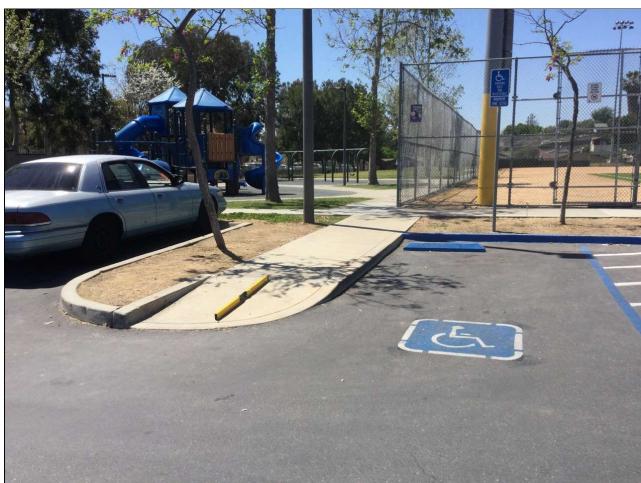
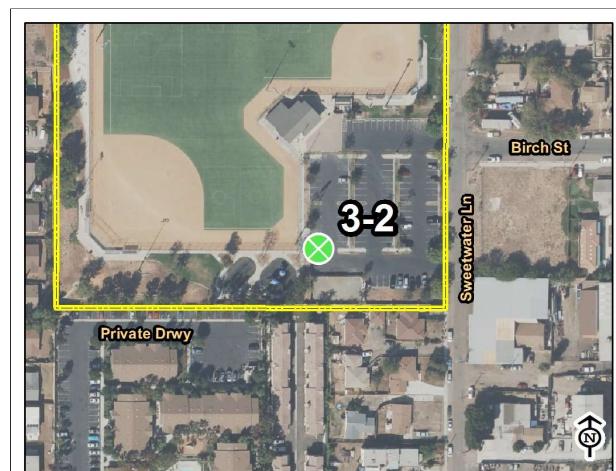
Map: 3 Grid: E4

3-2 Curb Ramps**Category: 1****Issue:** Running slope is 12%. No detectable warnings provided.**Action:** Replace curb ramp.

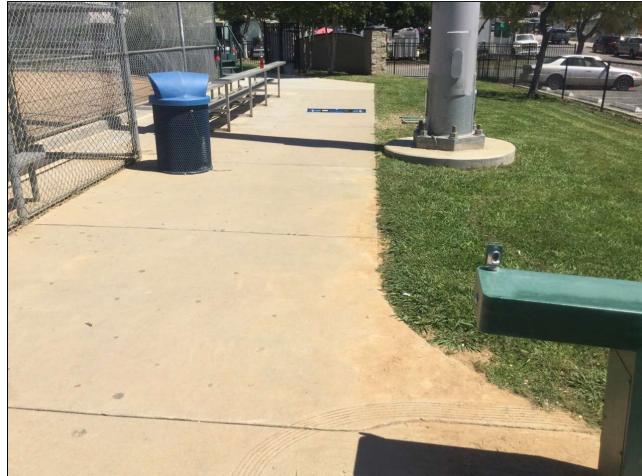
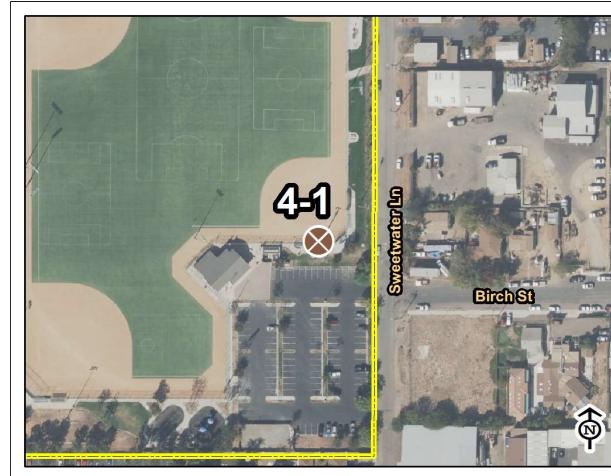
Map: 3 Grid: F2

4-1 Walk**Category: 1****Issue: Cross slope at 3.2%.****Action: Regrade walkway and replace concrete.**

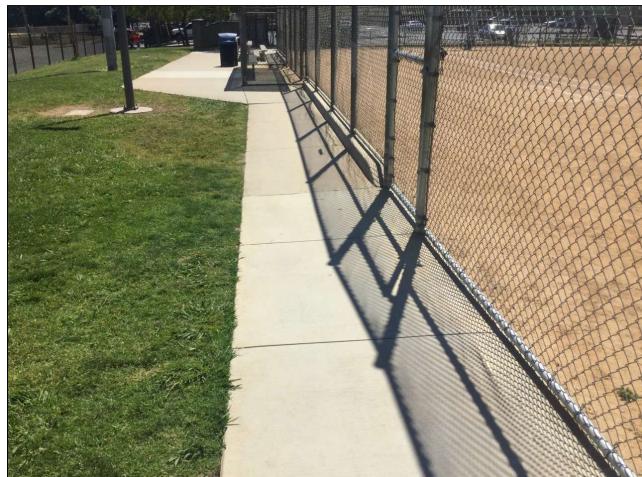
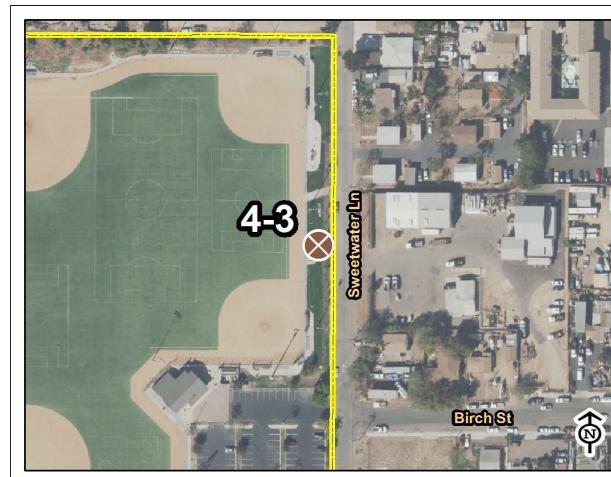
Map: 2 Grid: G5

4-3 Walk**Category: 1****Issue: Cross slope at 5%.****Action: Regrade walkway and replace concrete.**

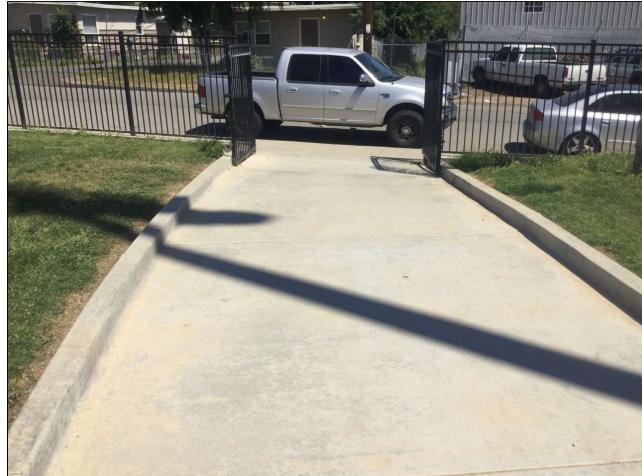
4-4 Walk**Category: 1****Issue: Walkway running slope is 7.5% into park.****Action: Regrade pathway into the park from right of way and replace concrete. Install handrails.**

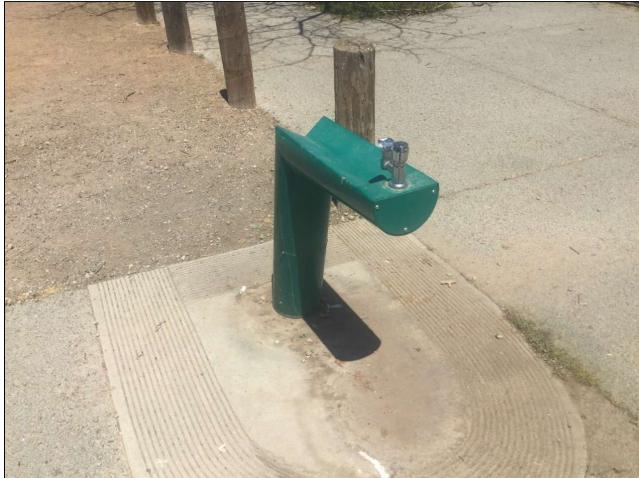
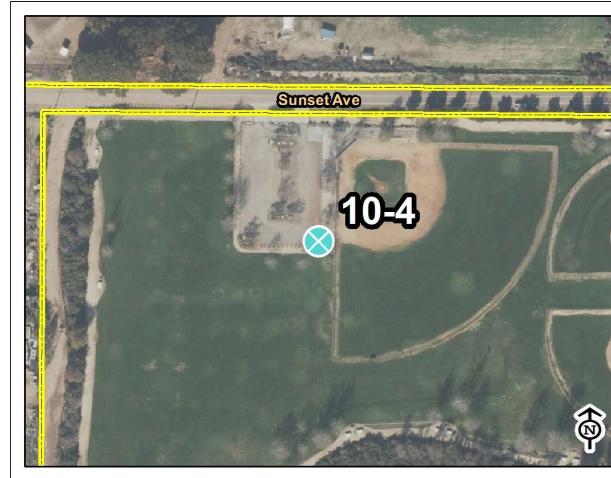
Tijuana River Valley Regional Park
Baseball Fields

10-4 Drinking Fountain**Category: 3****Issue: No High-Low fountain provided.****Action: Replace drinking fountain.**

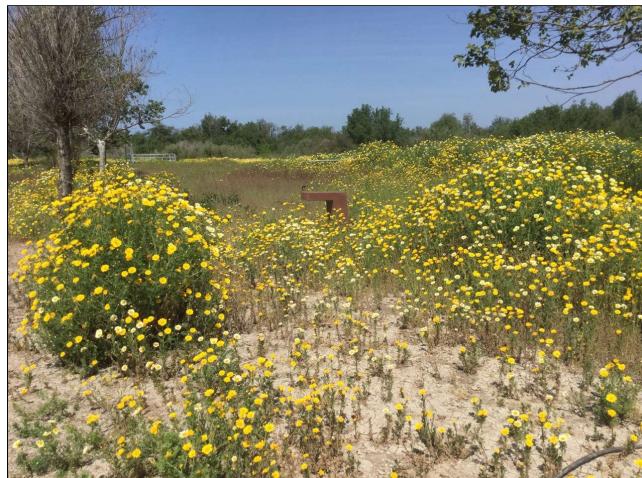
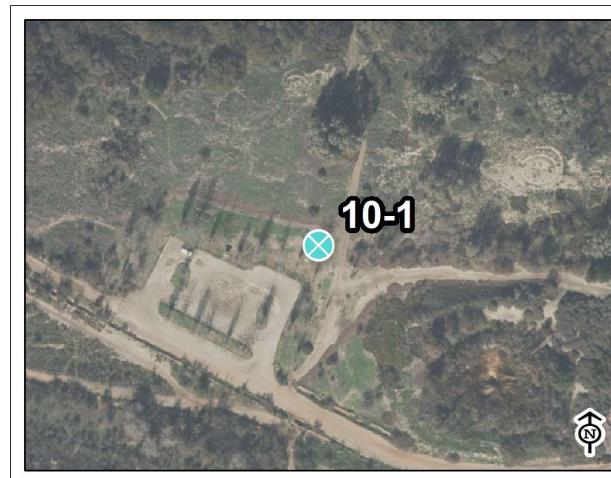
Tijuana River Valley Regional Park
Bird and Butterfly Garden

10-1 Drinking Fountain**Category: 3****Issue: No accessible route to drinking fountain. No High-Low fountain provided.****Action: Provide 48" wide minimum accessible path of travel to fountain and replace or modify drinking fountain.**

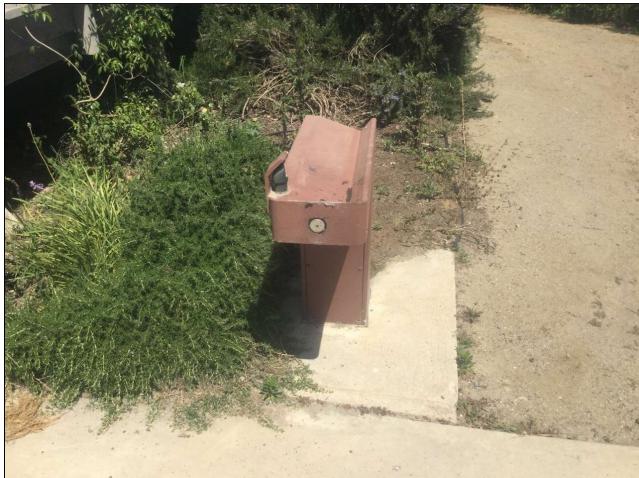
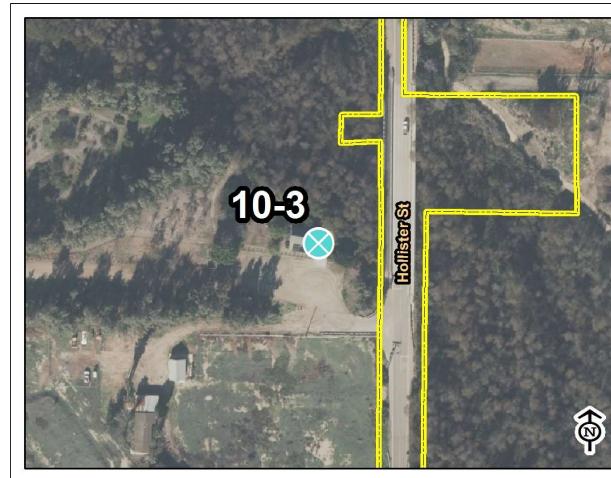
Tijuana River Valley Regional Park
Bird and Butterfly Garden

10-3 Drinking Fountain**Category: 3****Issue: No High-Low fountain provided.****Action: Replace drinking fountain.**

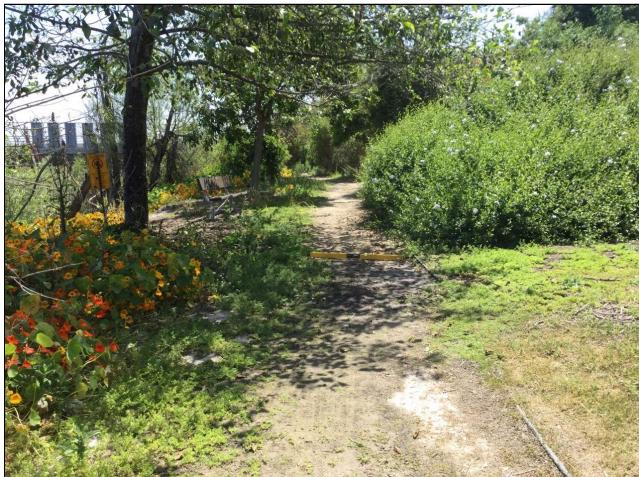
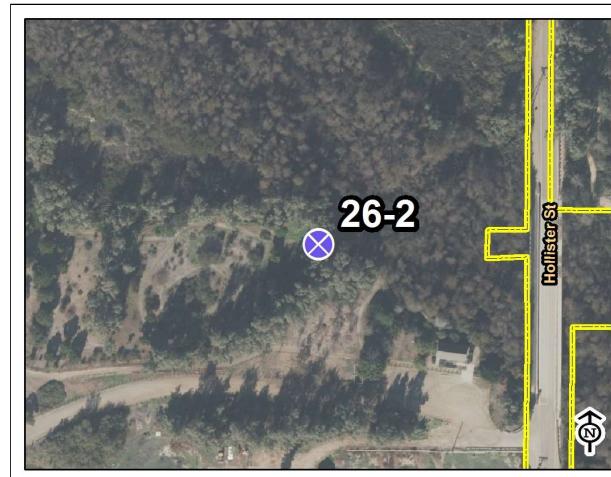
Tijuana River Valley Regional Park
Bird and Butterfly Garden

26-2 Trails**Category: 3****Issue: Existing trail is not accessible. Cross slope at 3%.****Action: Regrade and replace DG trail through bird and butterfly garden.**

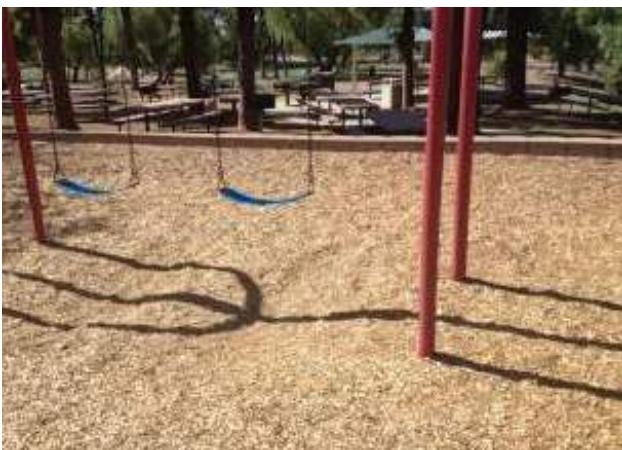
GRADE ISSUES AT SWINGS AND PLAY STRUCTURES

NON COMPLIANT

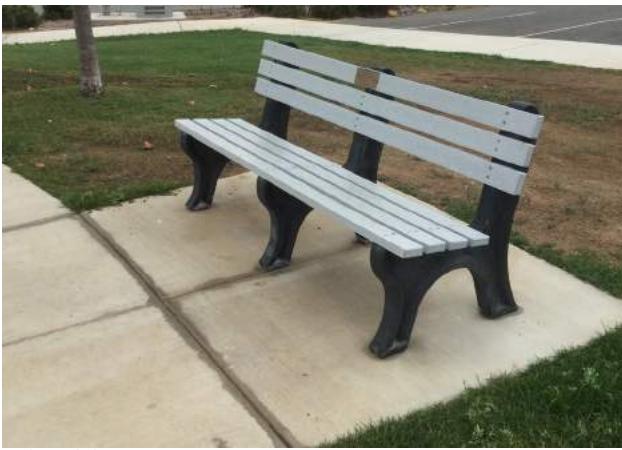
NO COMPANION SEATING AT ADJACENT TO BENCHES

NON COMPLIANT

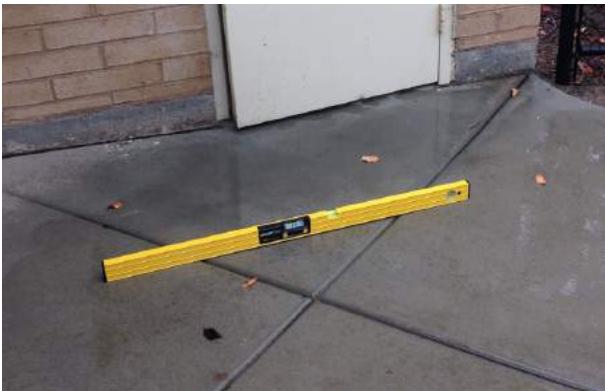
LEVEL LANDINGS NOT PROVIDED AT DOORS, GATES, AND OTHER REQUIRED LOCATIONS

NON COMPLIANT - SLOPES EXCEEDING THE ALLOWABLE % PER CODE

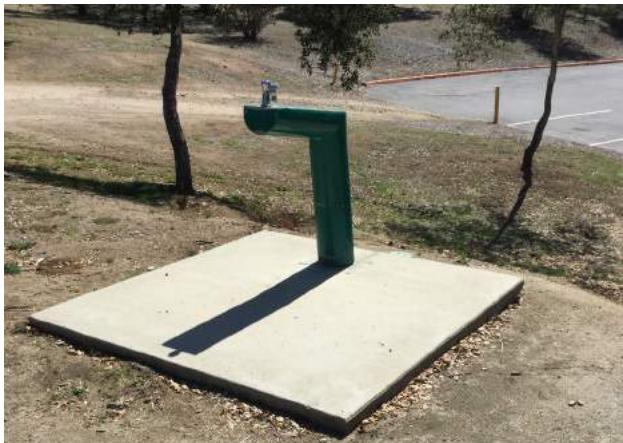
NO HIGH LOW WATER FEATURES/NO ACCESS TO WATER FOUNTAIN

NON COMPLIANT

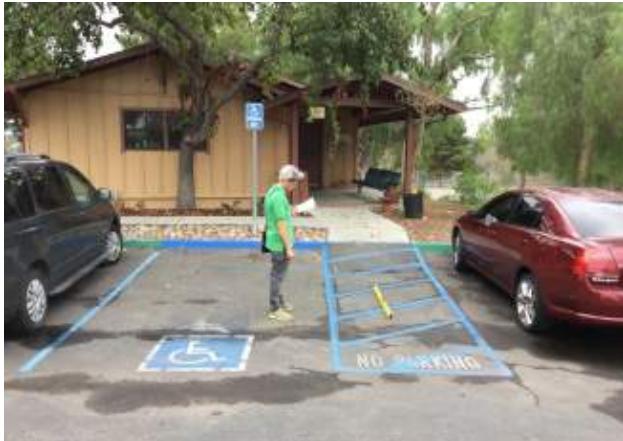
SLOPE ISSUES ON PARKING AND WALKING SURFACES

NON COMPLIANT

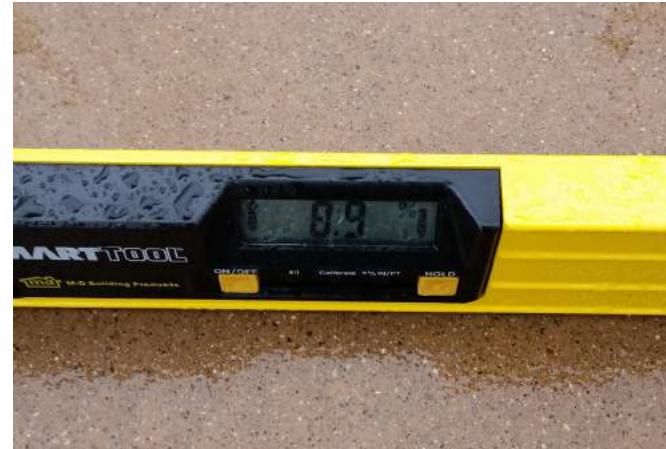
NON COMPLIANT

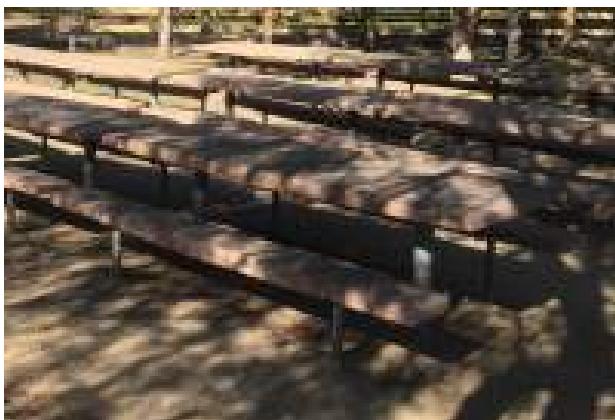
NON-ACCESSIBLE PICNIC BENCHES

NON COMPLIANT

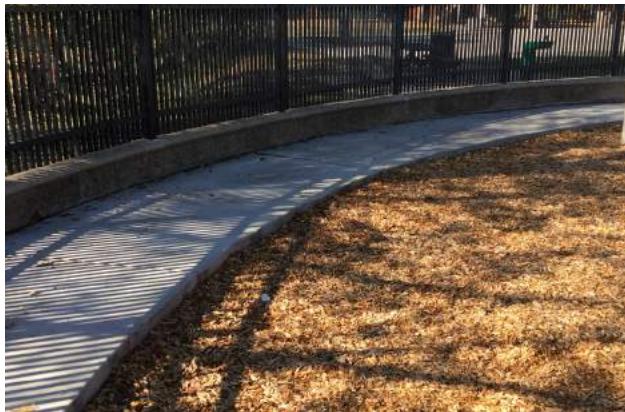
GRADE CHANGES EXCEEDING 4" ALONG WALKWAYS REQUIRING WARNING CURB OR GRADE CHANGE

NON COMPLIANT

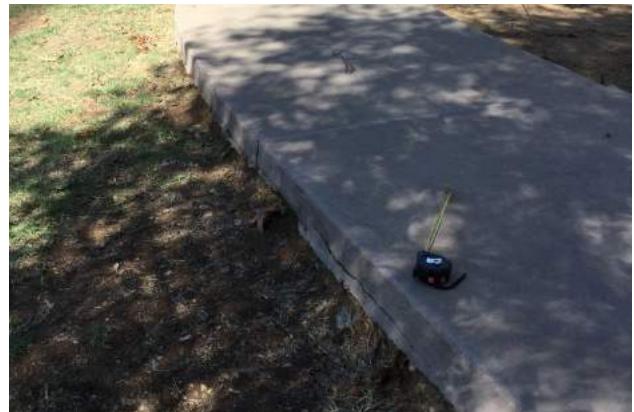
NON COMPLIANT

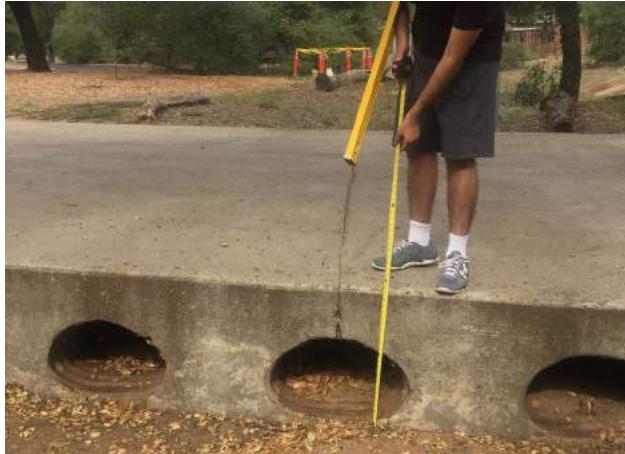
GRADE CHANGES REQUIRING GUARDRAIL

NON COMPLIANT

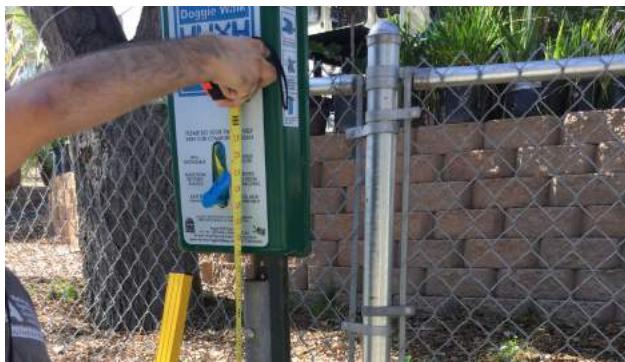
DOG WASTE BAGS/EXHIBITS OUT OF REACH

NON COMPLIANT

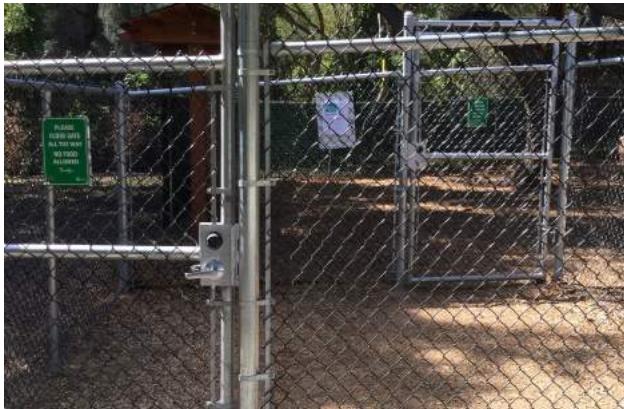
DOOR/GATE HARDWARE REQUIRING TIGHT GRASPING, PINCHING, OR TWISTING OF THE WRIST

NON COMPLIANT

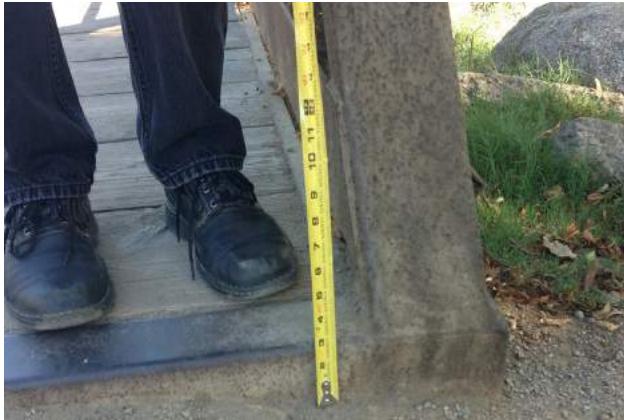
VERTICAL CHANGES ON WALKING SURFACES

NON COMPLIANT

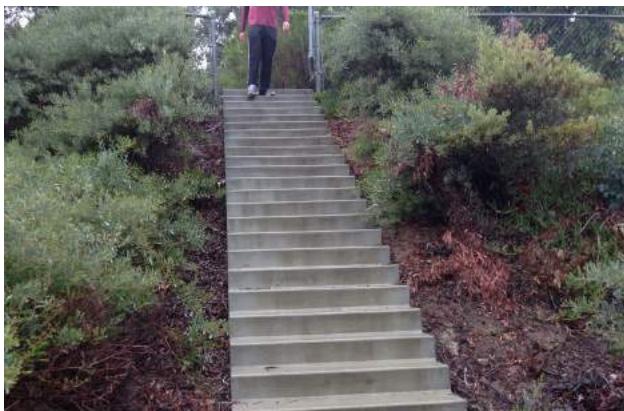
NO HANDRAILS AND/OR VISUAL CONTRASTING STRIPES ON STAIRS

NON COMPLIANT

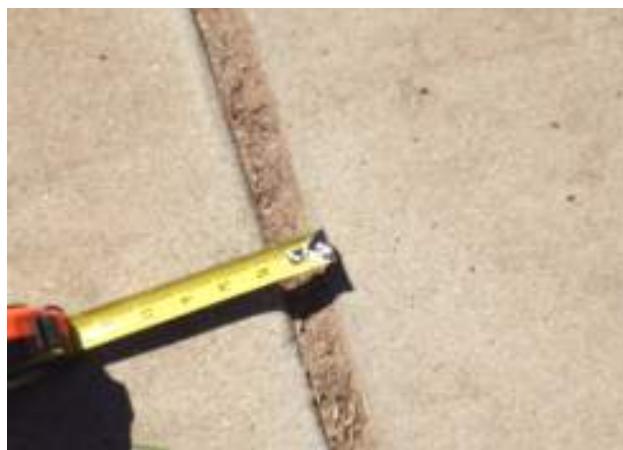
GAPS IN CONCRETE EXCEED 1/2"

NON COMPLIANT

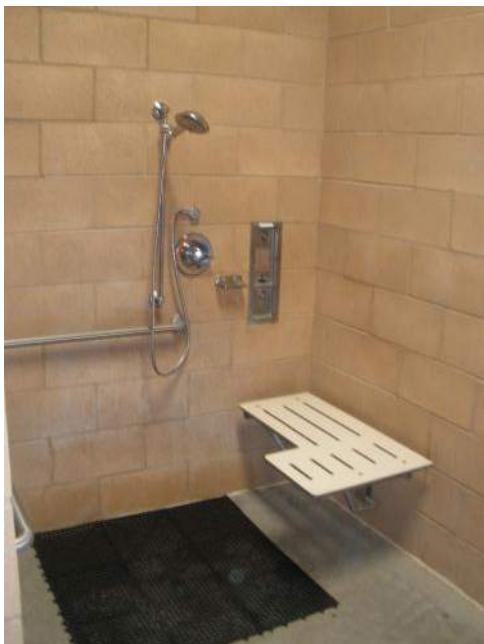
Perfect, except the seat is installed backwards.
